**HISTORIC STRUCTURE REPORT  
FOR  
MISSION POINT LIGHT STATION  
PENINSULA TOWNSHIP, MICHIGAN**

**Prepared by:  
U.P. Engineers & Architects, Inc.  
102 W. Washington Street, Suite 217  
Marquette, MI 49855**

**Final Report  
October 31, 2012**

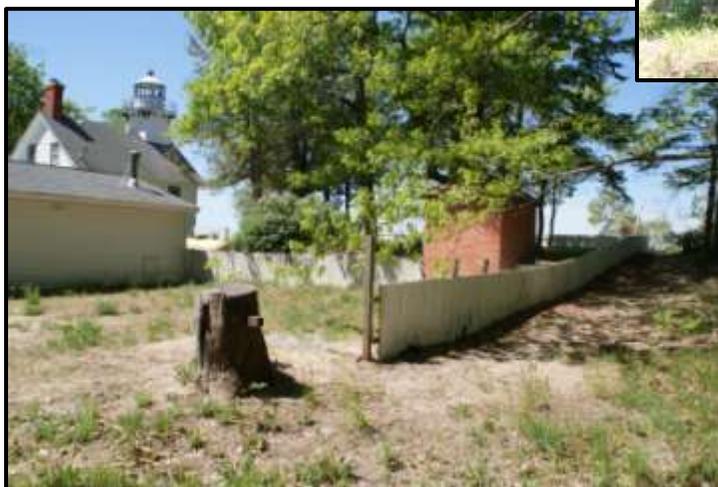
**Photo III-A-14**

At the time of the second site visit on May 22, 2012 it was observed that the gasoline storage tank and fenced enclosure have been removed, as shown in Photo III-A-14.

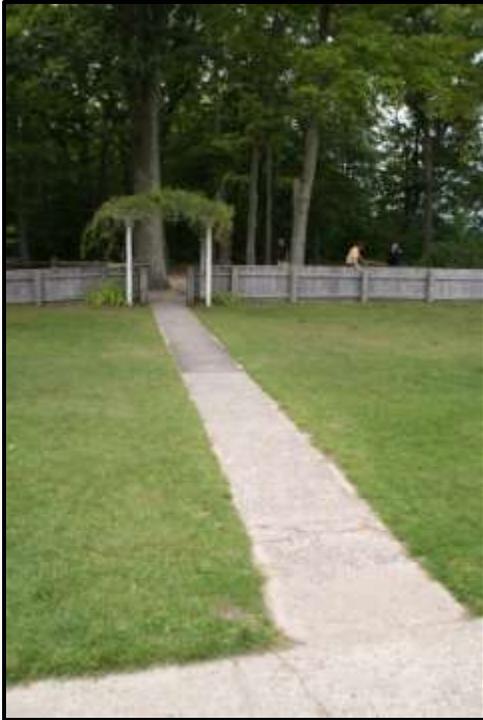
Photo III-A-15

A number of concrete sidewalks are present on the site, both new and old. An early sidewalk that runs west to the fence, Photo III-A-15, terminates at an 8'x10' concrete pad outside the fenced yard as seen in Photo III-A-16. This early sidewalk also runs north-south past the Well House, Photo III-A-17, and west of the Light Tower/Keepers Dwelling, Photo III-A-18. A new concrete sidewalk is found at the front entry to the Light Tower/Keeper's Dwelling. This new section of sidewalk, which is seen in Photo III-A-19, terminates at a gate in the wood fence. All concrete sidewalks are in reasonably good condition.

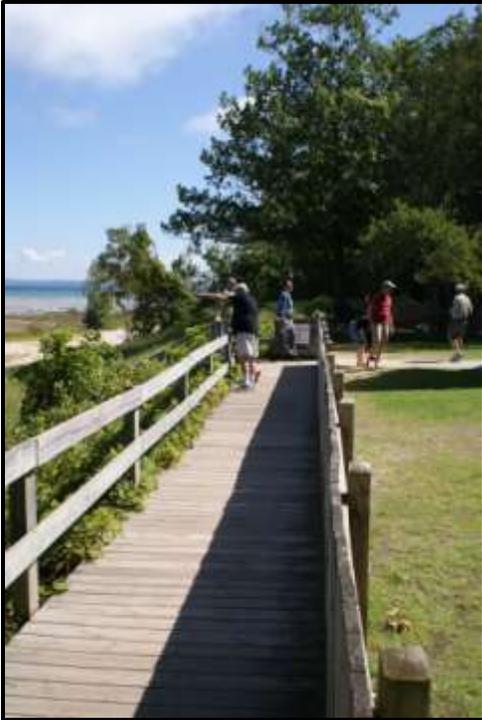
**Photo III-A-34**

In addition to the asphalt paved walkways there is a wood boardwalk at the northwest corner of the Light Station site that is the primary approach for visitors to the Light Tower/Keeper's Dwelling. Refer to Photo III-A-34. This boardwalk is also seen in previous Photos III-A-5 and III-A-19. A wood stairway, as seen in Photo III-A-35 allows visitors to easily access the popular beach area as seen in Photo III-A-36. There are no walkways on the lower dunes and foot traffic has eroded some of the dune vegetation. The boardwalk, fence, and stair are all in reasonably good condition.

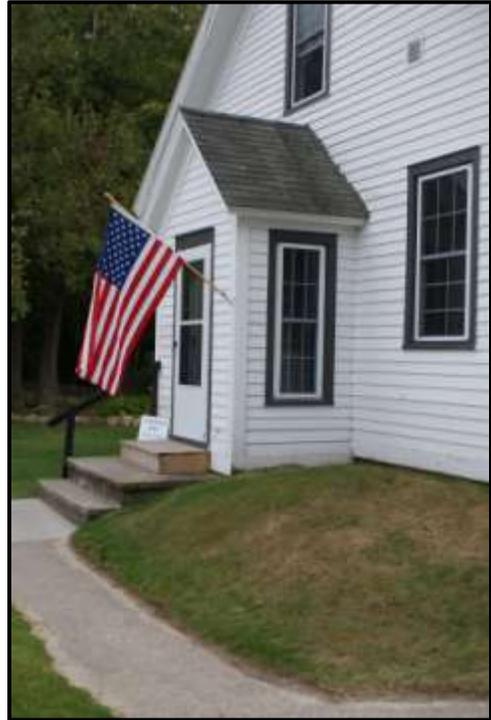
Photo III-B-20

The exterior walls of the Light Tower/Keeper's Dwelling and the Light Tower are covered with horizontal wood siding with a 4" exposure on the main building and 4<sup>3</sup>/<sub>4</sub>" exposure on the lean-to structure. Paint finish on the siding and trim is in poor condition, with many areas of peeling and flaking paint as seen in Photo III-B-18. The earth berm along the west and partial north side of the building is in close contact with the wood water table trim, resulting in some rot and deterioration. Refer to Photos III-B-19 and III-B-20.

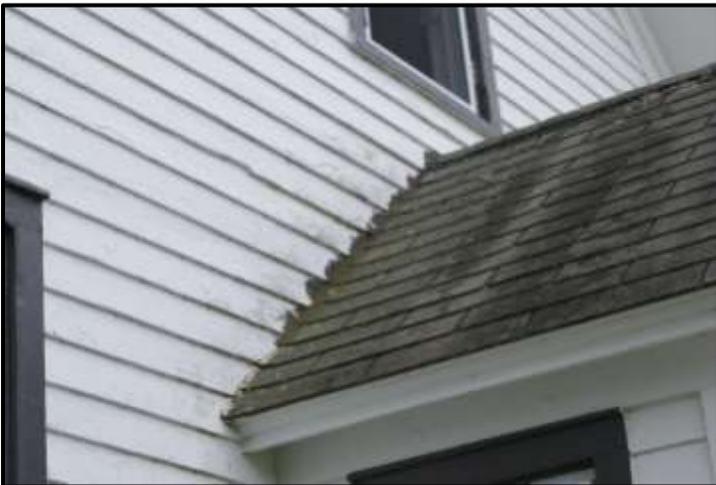
Photo III-B-21

Photos III-B-21 and III-B-22 show a lack of metal flashing at roof/wall intersections and the resulting deterioration of the wood siding. Painted wood trim around many windows is in poor condition with rotted wood and peeling paint. Deterioration of vinyl window trim flashing and caulking, as seen in Photos III-B-23, III-B-24, and III-B-25 allow water penetration into the wood sills.

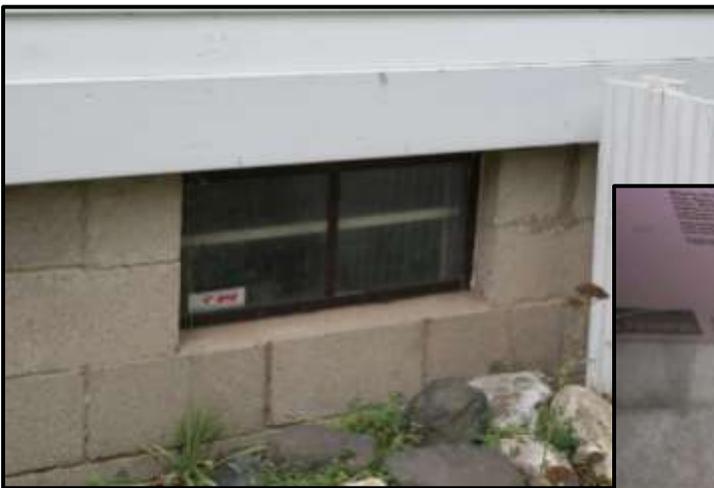
**Photo III-B-35**

Basement windows are inward swinging, top-hinged metal casement as seen in Photos III-B-35 and III-B-36. These window units, which are set into the concrete masonry unit walls, are in good condition, although the paint finish is in poor condition.

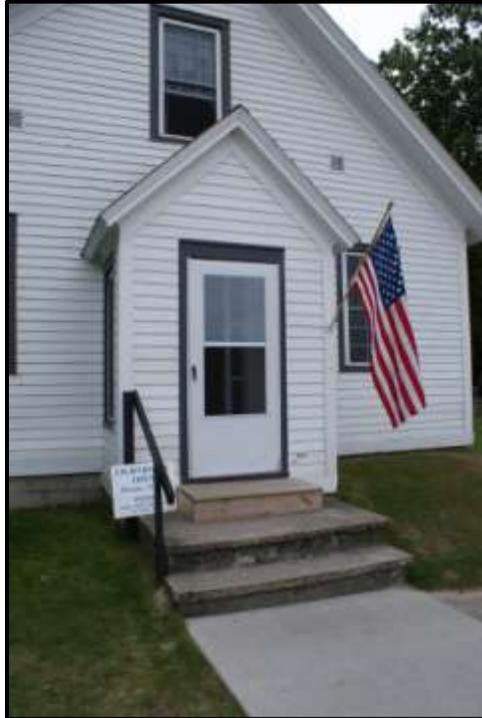
**Photo III-B-37**

There are two exterior doors on the building and both have outward swinging metal storm/screen doors, as seen in Photo III-B-37. The inside, inner swinging exterior doors are both insulated metal doors with glass. These doors are all in good condition but not an appropriate style or material for the building.

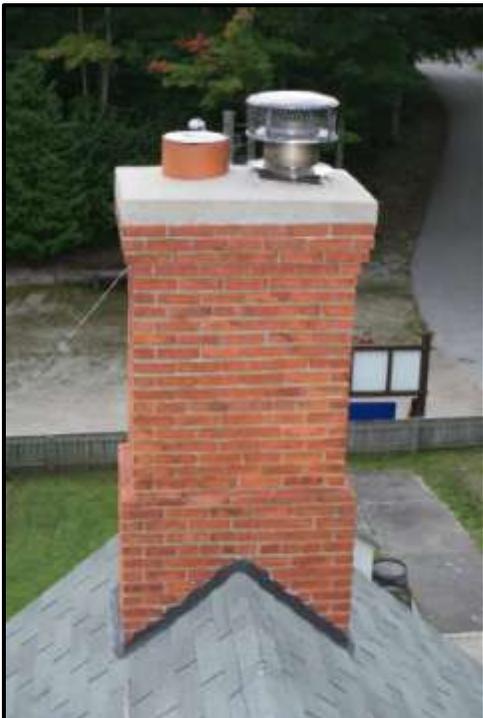
**Photo III-B-40**

The brick masonry chimney is in good condition with some minor mortar joint deterioration. An interesting detail is the bevel cut brick above the chimney base where it narrows. Refer to Photos III-B-40 and III-B-41.

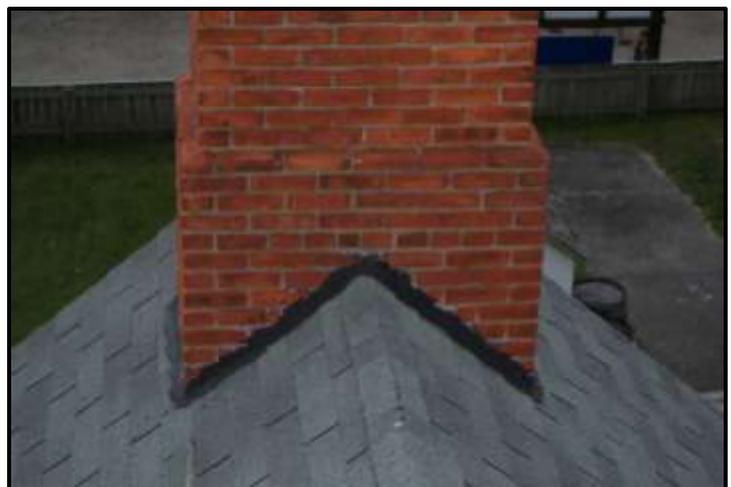
**Photo III-B-41**

The metal flashing at the base of the chimney has been removed and a tarred joint provides the weather seal which is subject to deterioration. The cement mortar chimney cap, metal flue and clay flue appear in good condition.

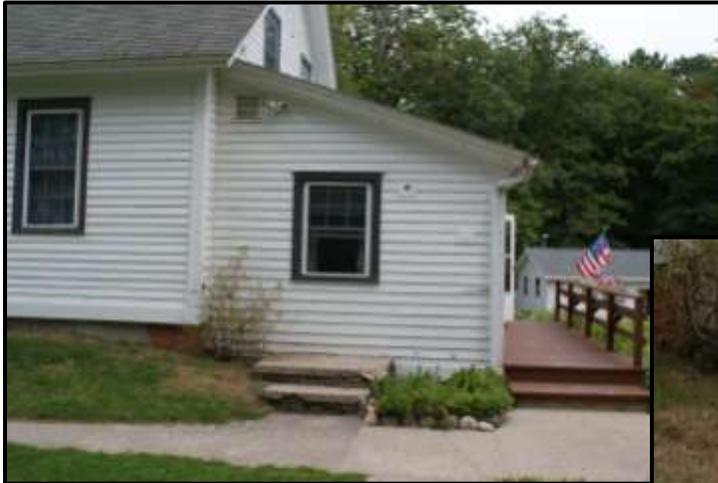
Photo III-B-45

The second concrete porch is located on the west side of the lean-to structure, as seen in Photos III-B-45 and III-B-46, and was located at an entry door, no longer extant. This porch is constructed of stone masonry with a concrete step and landing surface. There is considerable deterioration of the concrete surfaces and the stone masonry walls.

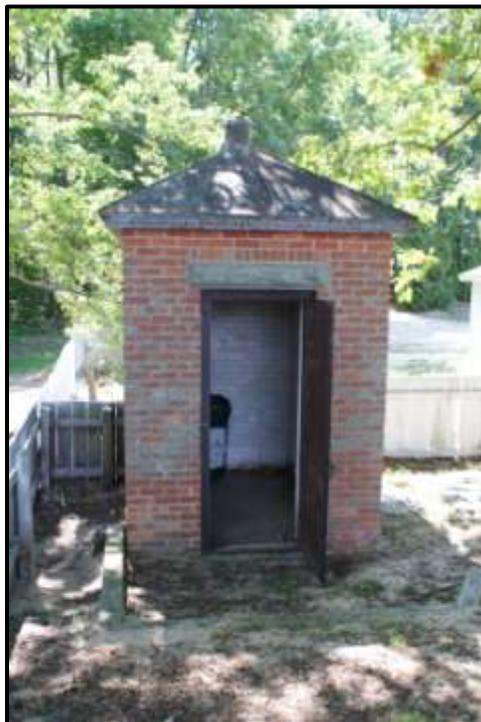
**Photo III-C-3**

Drifting sand has encroached on the Oilhouse and the surrounding grade is higher than the floor elevation. A short retaining wall constructed of 4" x 6" treated wood timbers is located in front of the door to hold back the sand as seen in Photo III-C-3.

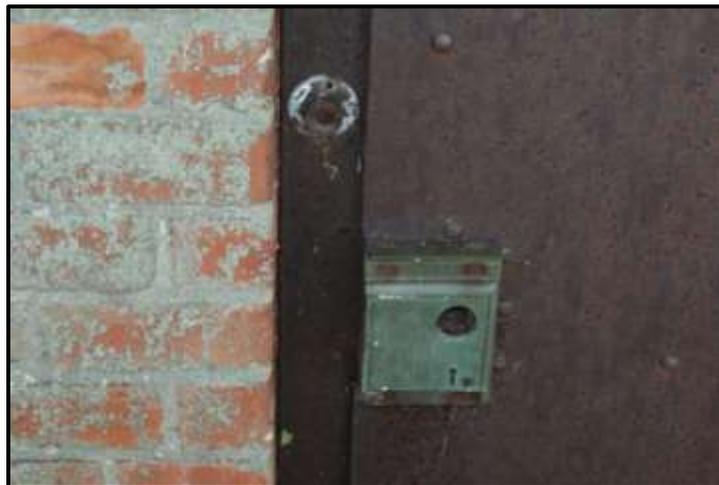
Photo III-C-10

The Oilhouse has a heavy metal door and frame that is in good structural condition however, interior and exterior surfaces are pitted and rusted with peeling paint as seen in Photos III-C-8 and III-C-9. There is a metal threshold on top of the stone sill. Door hinges are in good working order, however, the original lock mechanism is missing, with a surface mounted lock mechanism applied to the door face as seen in Photo III-C-10.

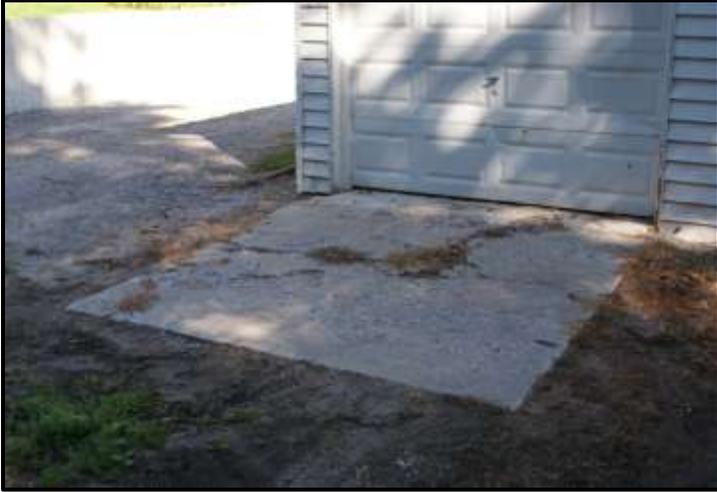
**Photo III-D-6**

Exterior concrete slabs located outside of the overhead door, Photo III-D-6, at the southeast corner of the building, Photo III-D-7, and at the pedestrian door on the west wall are all in poor condition and of poor quality workmanship. The thickness of all exterior slabs is undetermined. There is evidence of rodent holes burrowed beneath the building in some areas.

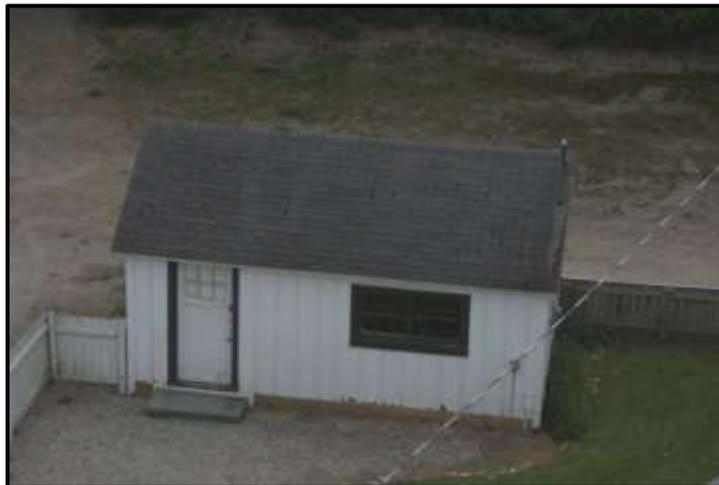
**Photo III-E-10**

The roof of the Storage Building is a three-tab asphalt shingle roof, as seen in Photo III-E-10. The shingles are in average condition but are supporting moss growth on the north side.

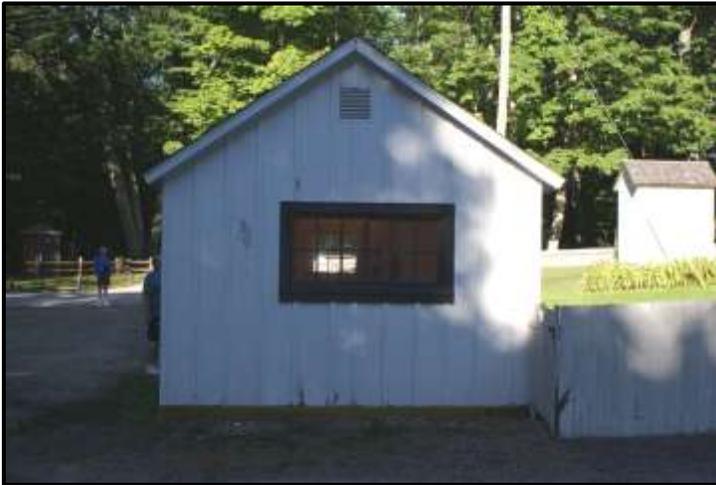
**Photo III-E-14**

There are a number of wood windows in the Storage Building, consisting of both horizontal sliding type units and in-swinging units as seen in Photos III-E-14 and III-E-15. All window units are single glazed with six divided lights per sash. An interior view of the top-hinged in-swinging window on the west wall is shown in Photo III-E-16 and the horizontal sliding window on the east wall is shown in Photo III-E-17. With deteriorated paint finish and glazing putty, all windows are in poor condition. Exterior window sills are also in poor condition. A rotted sill is shown in Photo III-E-18.

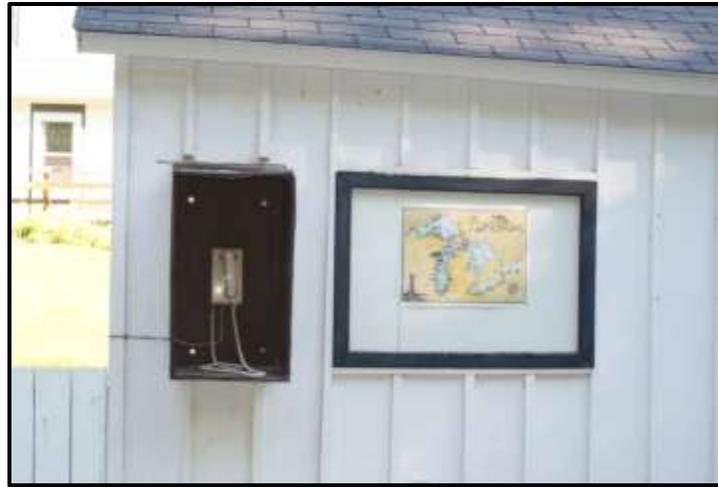
Photo III-E-19

On the south wall a possible window has been covered with wood paneling on the interior and a fixed display board panel on the exterior as seen in Photo III-E-19. It is not known if a window exists in this location.

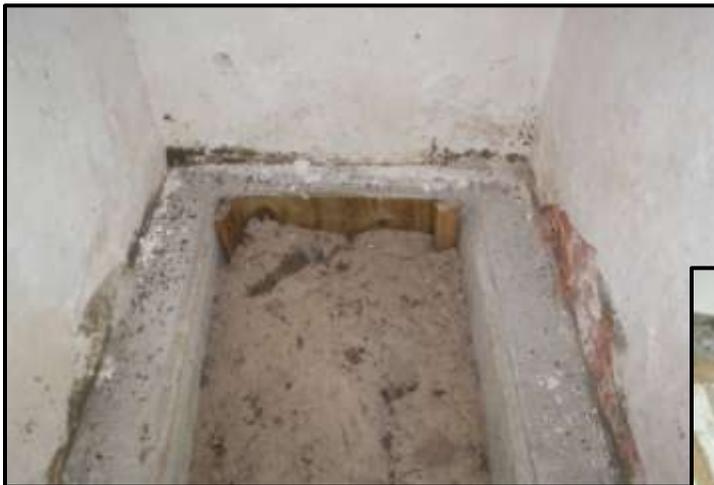
Photo III-F-4

There is no floor in the Well House and a narrow concrete strip has been poured around the perimeter of the interior as seen in Photos III-F-4 and III-F-5. This work appears to have been done in the recent past based on the appearance of the concrete and formwork still in place. The purpose of this recent work is not known or obvious.

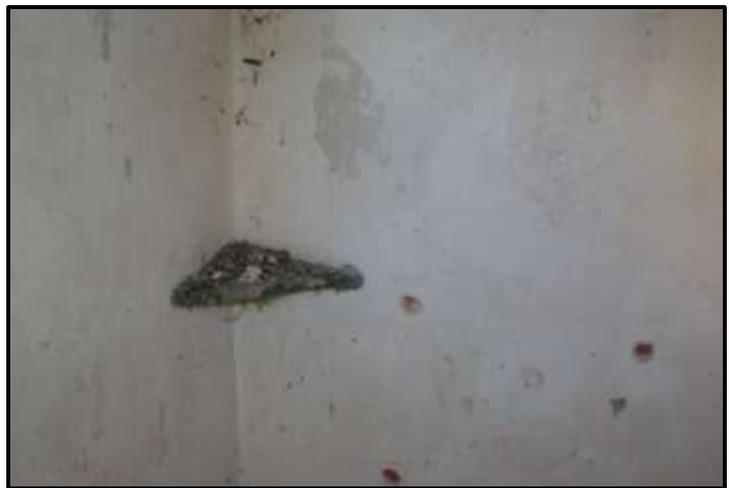
Photo III-F-12

The interior surfaces of the brick masonry walls are coated with plaster which is applied directly to the brick surface. This surface is in poor condition with many sections of damaged, loose or missing plaster as seen in Photos III-F-11 and III-F-12. The exposed wood rafters and roof sheathing have remnants of a paint finish, however it is in very poor condition. Refer to previous Photos III-F-6 and III-F-7. There are no interior features or elements other than a small wood bracket as seen in Photo III-F-12. There is an exposed sand floor.
