**HISTORIC STRUCTURE REPORT  
FOR  
MISSION POINT LIGHT STATION  
PENINSULA TOWNSHIP, MICHIGAN**

**Prepared by:  
U.P. Engineers & Architects, Inc.  
102 W. Washington Street, Suite 217  
Marquette, MI 49855**

**Final Report  
October 31, 2012**

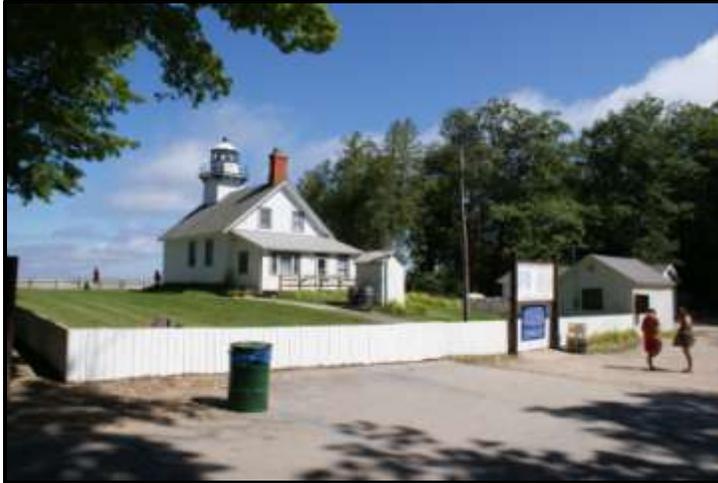
The historic light station site is defined by a simple wood fence as seen in Photo III-A-7 that surrounds the grounds. The Light Tower/Keeper's Dwelling, Well House, Oilhouse and Storage Building lie within this fenced enclosure. The Garage and some older concrete sidewalks/equipment pads lie outside of this enclosure. There are no other elements or structures beyond the fence.

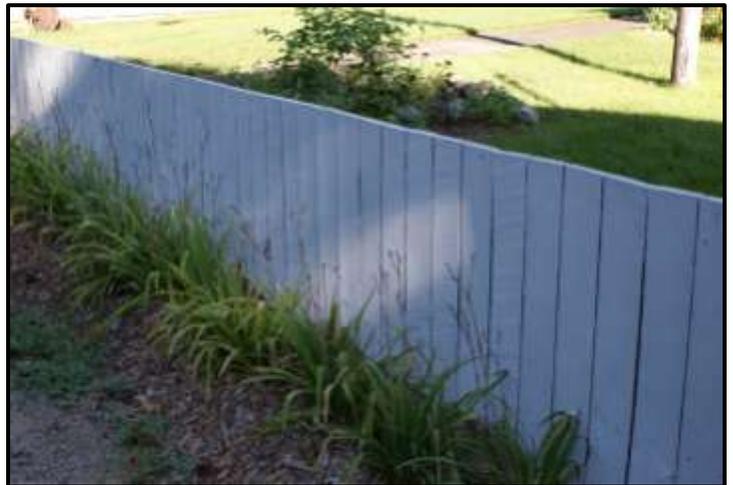
Photo III-A-8

The wood fence varies in height at different locations from 3'-0" to 3'-11" and is constructed of vertical boards with actual dimensions of 1¼" x 5", as seen in Photo III-A-8. Some sections of fence have 4" diameter wood posts, likely to be cedar, while other sections have treated 4 x 6 wood posts. The outer face of the fence is painted or whitewashed while the inside, or yard face is natural. The fence is in average condition although there are areas where boards and posts are damaged. There are a number of gates, as seen in Photos III-A-9, III-A-10 and III-A11, that control pedestrian traffic into the yard.

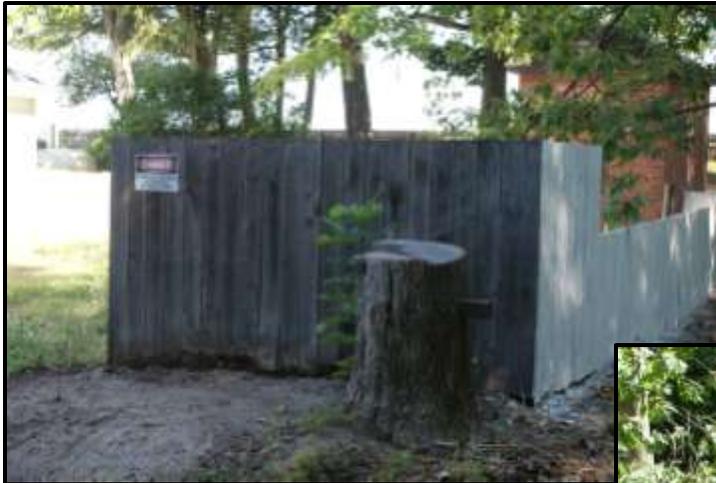
**Photo III-A-12**

The wood fence terminates at the southeast corner of the site at a small enclosure that surrounds an above-ground gasoline storage tank. Refer to photos III-A-12, and III-A-13. The gasoline storage tank holds approximately 250 gallons and is used for park maintenance vehicles. The steel tanks rest on wood planks. There is no provision for spill containment. Many of the vertical boards around this enclosure, which is 5'-7" high, are in poor condition, particularly at the base.

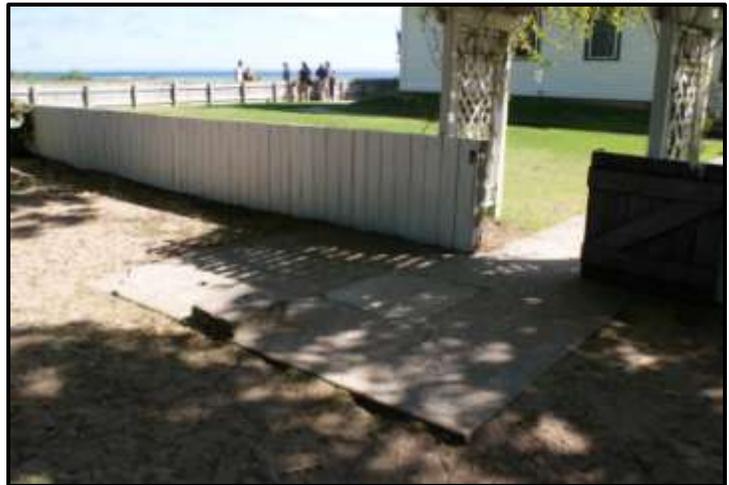
Photo III-A-16

A number of concrete sidewalks are present on the site, both new and old. An early sidewalk that runs west to the fence, Photo III-A-15, terminates at an 8'x10' concrete pad outside the fenced yard as seen in Photo III-A-16. This early sidewalk also runs north-south past the Well House, Photo III-A-17, and west of the Light Tower/Keepers Dwelling, Photo III-A-18. A new concrete sidewalk is found at the front entry to the Light Tower/Keeper's Dwelling. This new section of sidewalk, which is seen in Photo III-A-19, terminates at a gate in the wood fence. All concrete sidewalks are in reasonably good condition.

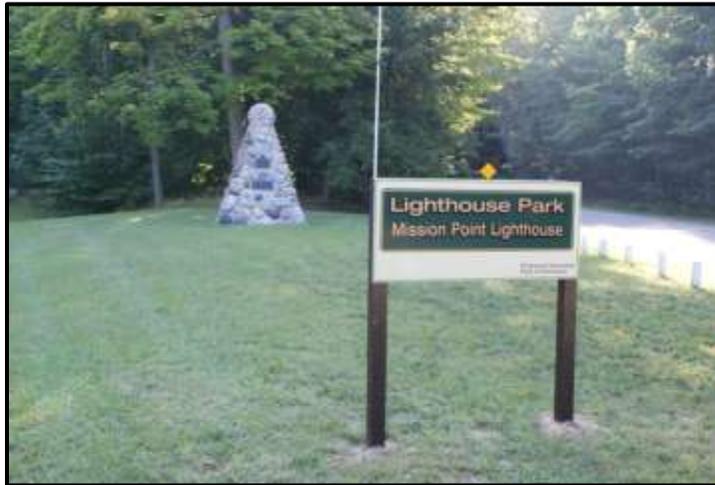
Photo III-A-29

A variety of signs are placed at the site in various locations at the entrance to Lighthouse Park along the road and adjacent to the fenced enclosure around the Light Station. Previous Photo III-A-1 shows a sign at the park entry approximately one-half mile south of the Light Station. Photos III-A-29 and III-A-30 show another sign and a fieldstone memorial located closer to the parking area for visitors. The stone memorial is dedicated to Peninsula Township residents that served in World Wars I and II. Photos III-A-31, III-A-32 and III-A-33 show signage immediately south of the fenced enclosure. All signage is in reasonably good condition but lacking in uniformity.

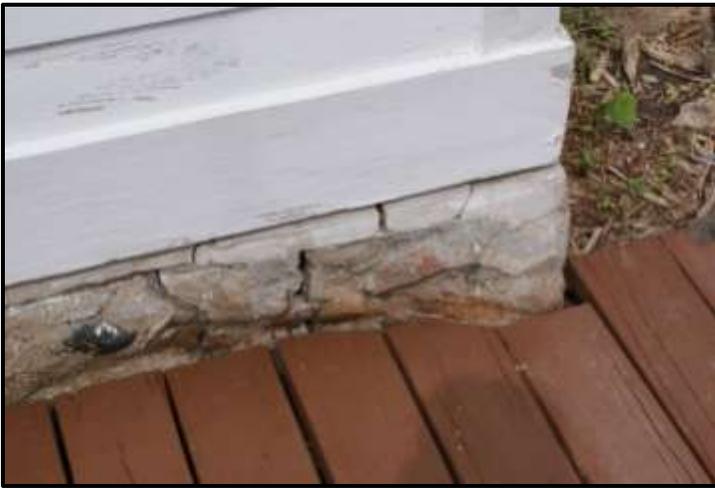
Photo III-B-4

The Light Tower/Keeper's Dwelling is a wood frame structure on a masonry foundation constructed of a variety of materials including brick, stone, and concrete masonry units (concrete blocks). The single story lean-to structure is constructed on a stone masonry foundation, as seen in Photos III-B-4 and III-B-5. Visible areas of the stone masonry at the southeast corner show signs of deterioration including cracks, loose stones and deteriorated masonry. Most of the exterior face stone foundation is concealed from view by the wood deck. The southeast corner of the wall has settled and cracked as seen in Photo III-B-6. The crawl space below this portion of the building is very shallow, with a dirt floor located approximately 12" below the bottom of the floor joists. The crawl space is accessed from a very small wall opening, seen in Photo III-B-7 from the basement.

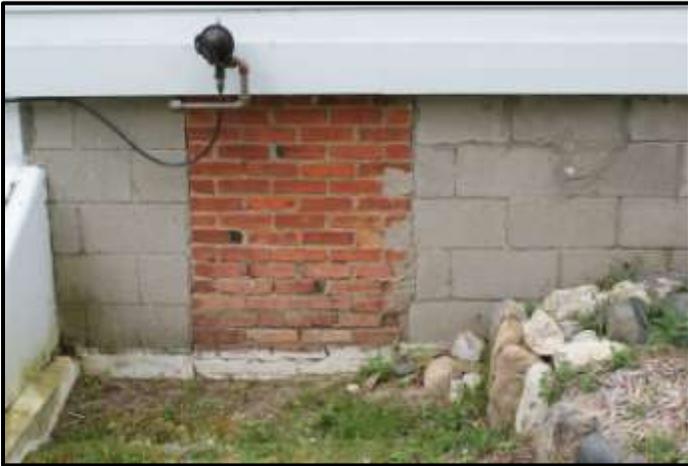
Photo III-B-8

The main structure of the Light Tower/Keeper's Dwelling is constructed on brick masonry piers which are filled in between with 8" concrete masonry units, indicating that the building was originally constructed with only a crawl space. Exterior views are seen in Photos III-B-8 and III-B-9, and interior views are seen in Photo III-B-10 at the crawl space and Photo III-B-11, showing a corner pier in the basement.

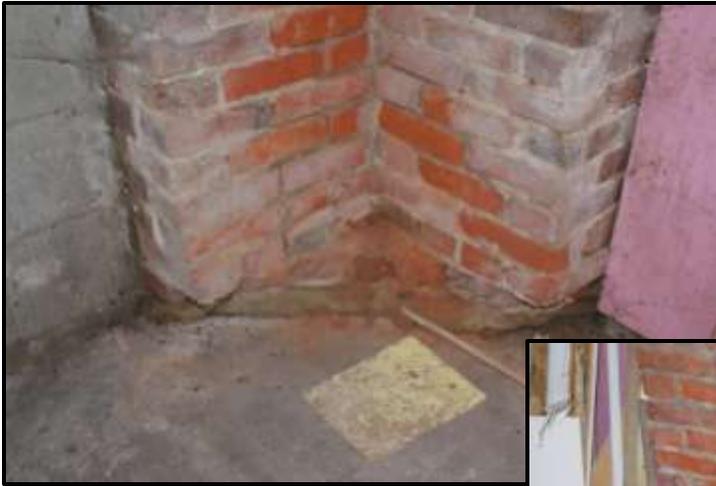
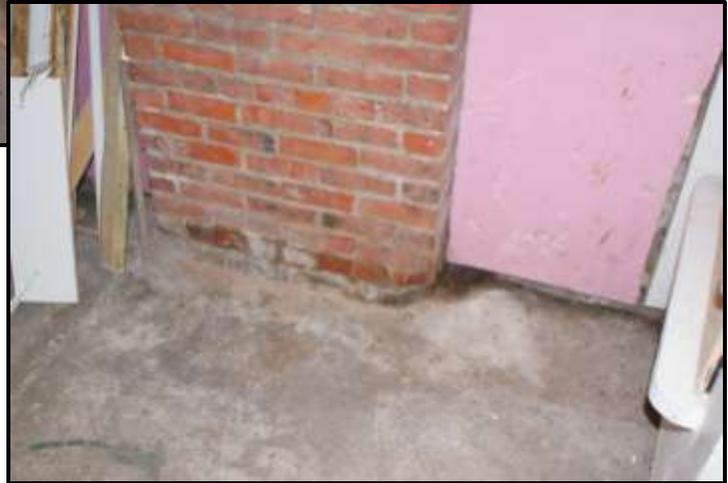
There is considerable deterioration of the brick masonry piers at the bottom sections as seen in Photos III-B-12 and III-B-13. The concrete masonry unit walls are in reasonably good condition with some minor areas of mortar joint deterioration.

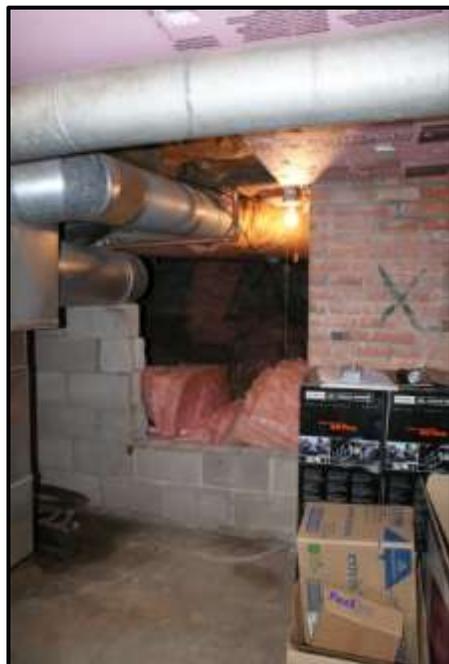
**Photo III-B-14**

At the center of the building there is a single brick masonry pier that has a partial concrete masonry wall framing into it. Refer to Photo III-B-14. The large opening in this wall leads from the full basement on the east half to the crawl space on the west half.

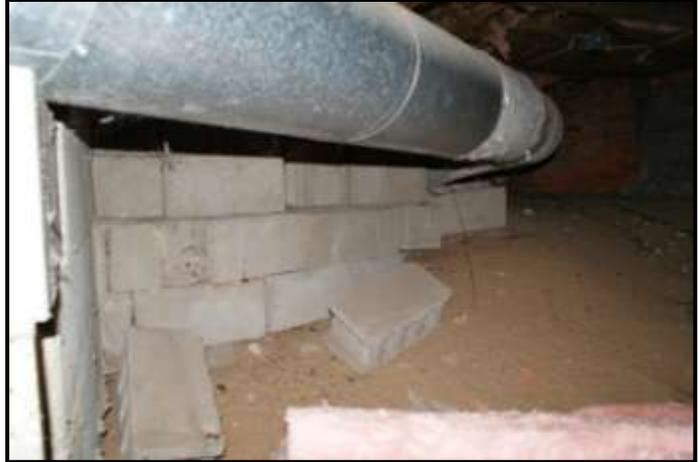
Photo III-B-16

The brick masonry chimney, seen in Photo III-B-15 is in sound condition with relatively minor deterioration. Adjacent to the chimney in the crawl space, a concrete masonry unit wall was constructed to support the fireplace hearth on the first floor. This wall, Photo III-B-16, is in poor condition with loose masonry units.

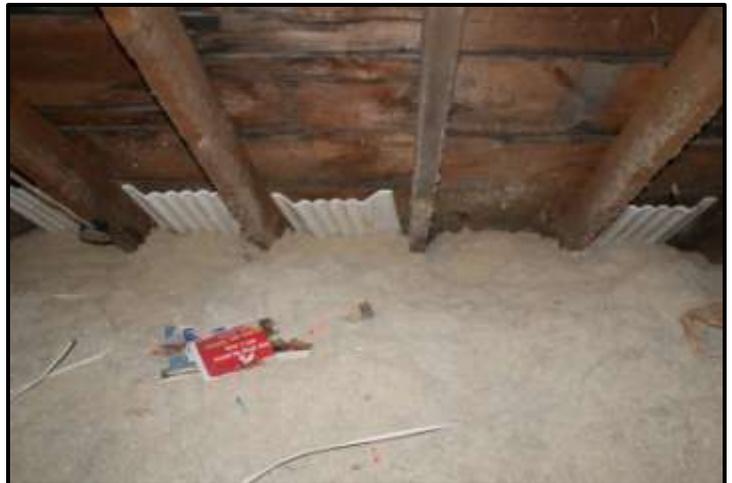
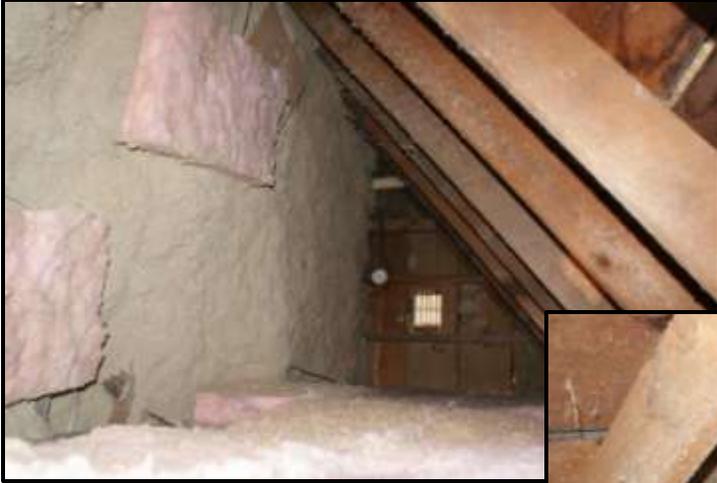
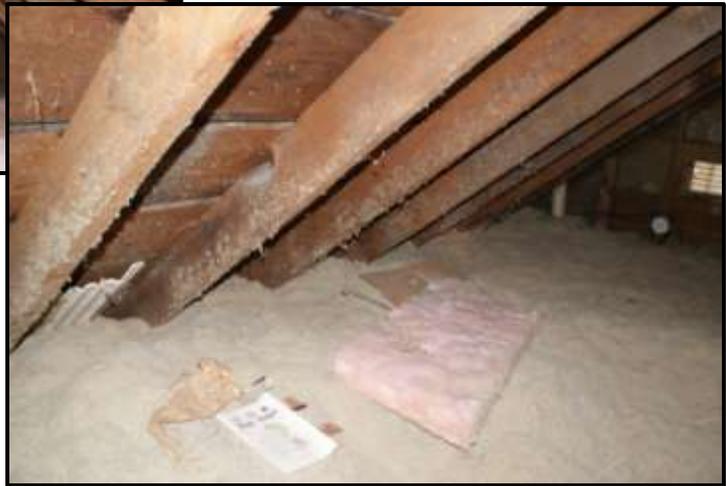
Attic insulation consists of a base layer of a poured vermiculite type material approximately two inches thick, covered by approximately 10" of blown cellulose insulation. Kneewalls and tower walls are covered with 2 layers of 3 1/2" unfaced fiberglass insulation. There were a few Styrofoam air baffles in place at the eave line however, the blown insulation appears to be blocking most of the air circulation space at the eaves. Gypsum board baffles were installed at the top of the kneewalls also preventing air circulation to the upper attic.

Attic conditions are shown in Photos III-B-17B, III-B-17C, and III-B-17D.

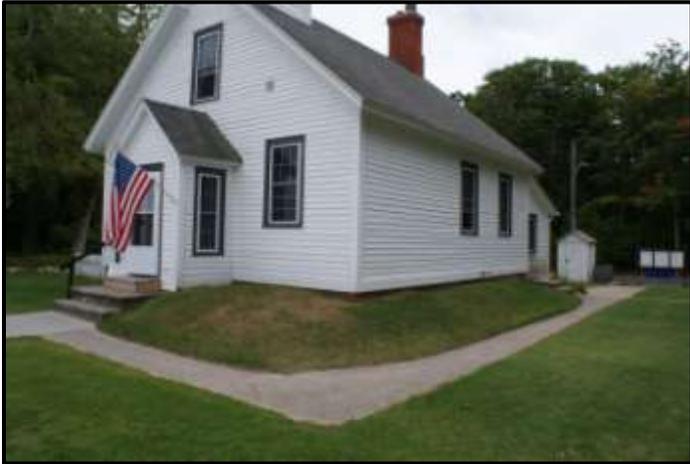
Photo III-B-19

The exterior walls of the Light Tower/Keeper's Dwelling and the Light Tower are covered with horizontal wood siding with a 4" exposure on the main building and 4<sup>3</sup>/<sub>4</sub>" exposure on the lean-to structure. Paint finish on the siding and trim is in poor condition, with many areas of peeling and flaking paint as seen in Photo III-B-18. The earth berm along the west and partial north side of the building is in close contact with the wood water table trim, resulting in some rot and deterioration. Refer to Photos III-B-19 and III-B-20.

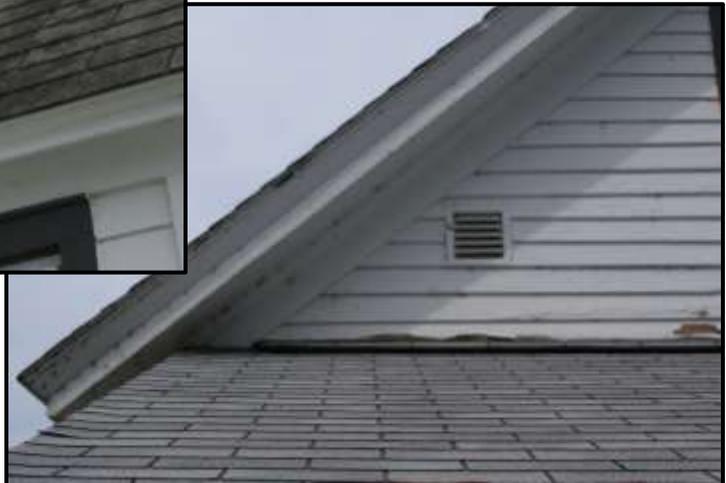
Photo III-B-22

Photos III-B-21 and III-B-22 show a lack of metal flashing at roof/wall intersections and the resulting deterioration of the wood siding. Painted wood trim around many windows is in poor condition with rotted wood and peeling paint. Deterioration of vinyl window trim flashing and caulking, as seen in Photos III-B-23, III-B-24, and III-B-25 allow water penetration into the wood sills.

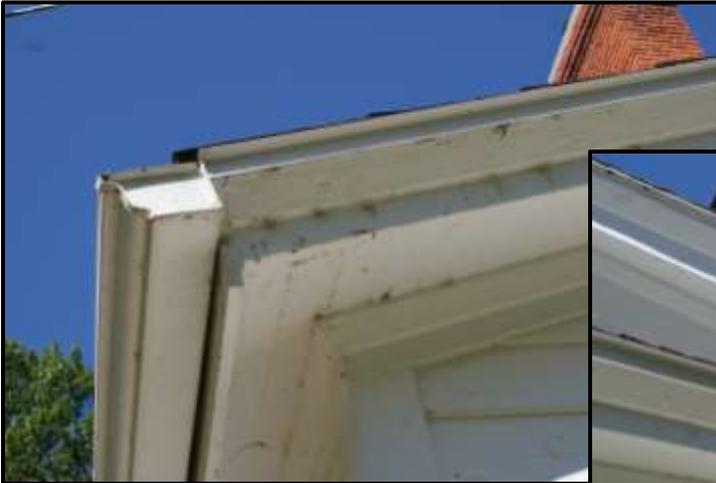
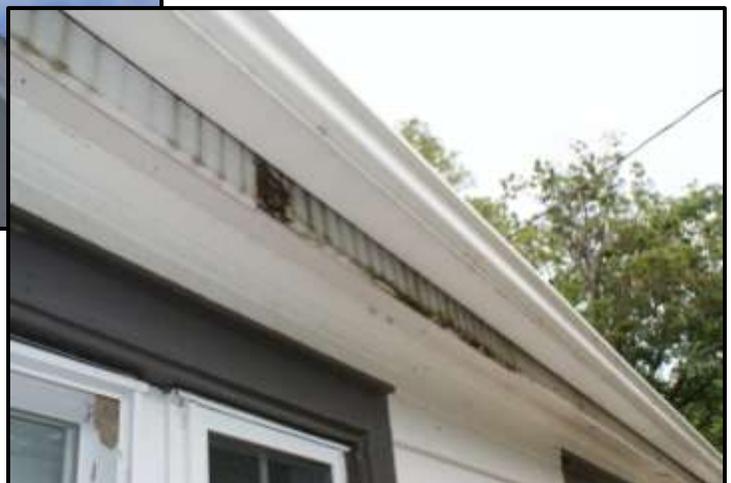
All fascia and soffits are painted wood trim as seen in Photos III-B-26, III-B-27, and III-B-28. All wood is in reasonably good condition with some minor deterioration. A single aluminum gutter is located along the edge of the lean-to roof. This gutter, which is seen in Photos III-B-26 and III-B-29, discharges at the southwest corner to a downspout and below grade drain pipe.

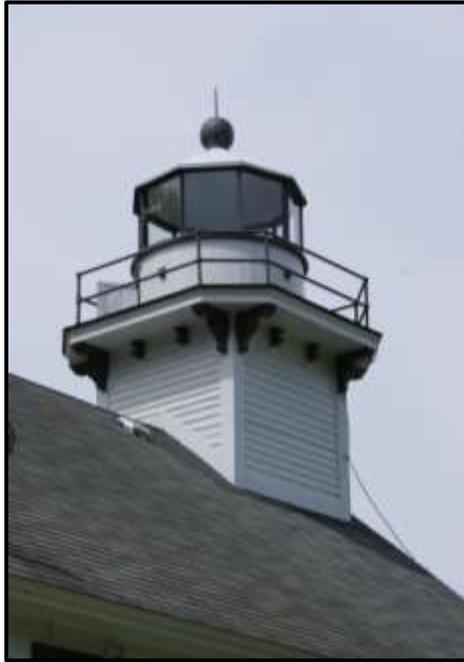
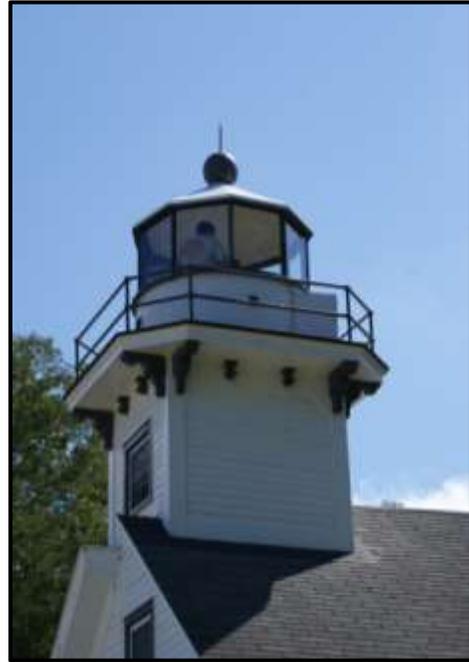
Wood siding and trim at the lantern tower appear in good condition. Refer to Photos III-B-30 and III-B-31. Wood trim does appear to be in contact with the asphalt shingle roof with no noticeable metal flashing.

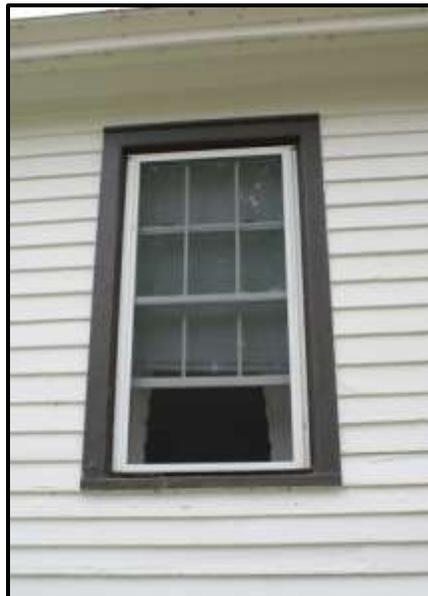
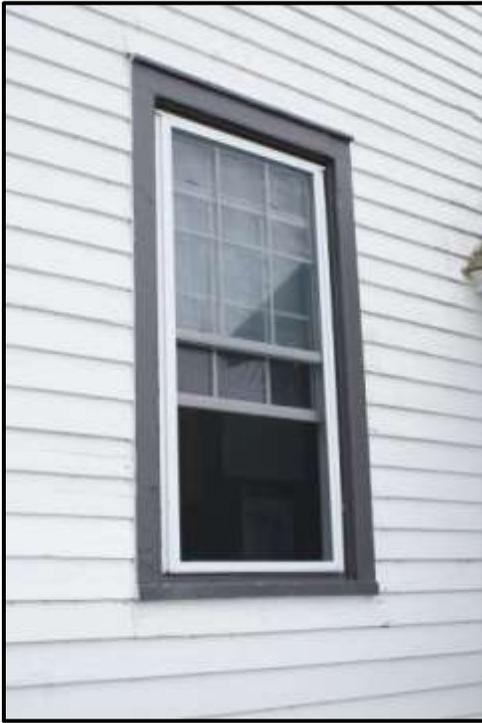
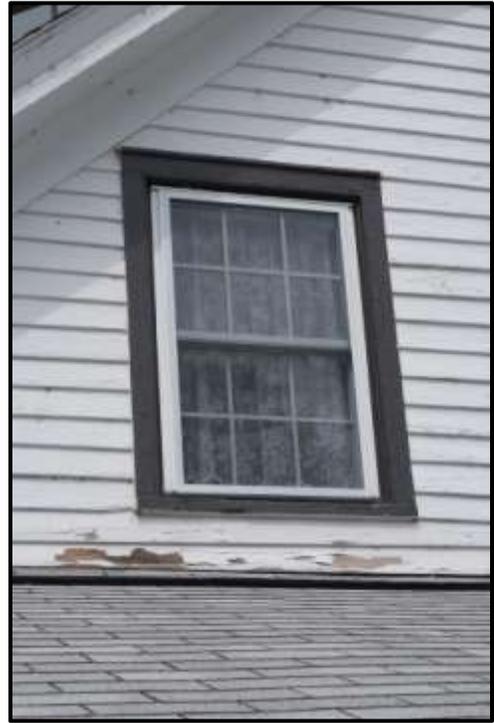
All windows on the first and second floor, and the tower are vinyl double hung units with simulated divided lights. Refer to Photos III-B-32, III-B-33, and III-B-34. All windows have metal screens. Most units are in good condition and are operational however the surrounding vinyl trim is in poor condition in many places. The vinyl windows are not an appropriate material for the building.

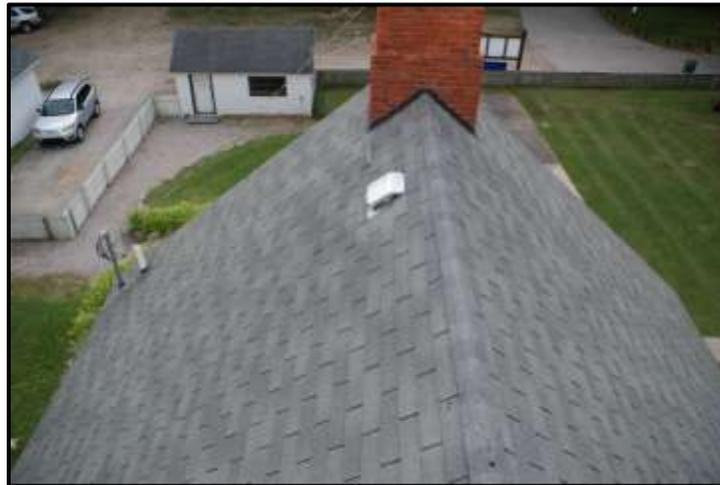
**Photo III-B-38**

The building roof is a standard 3-tab asphalt shingle roof on both the main dwelling, the lean-to and porch, as seen in previous photos and Photo III-B-38.

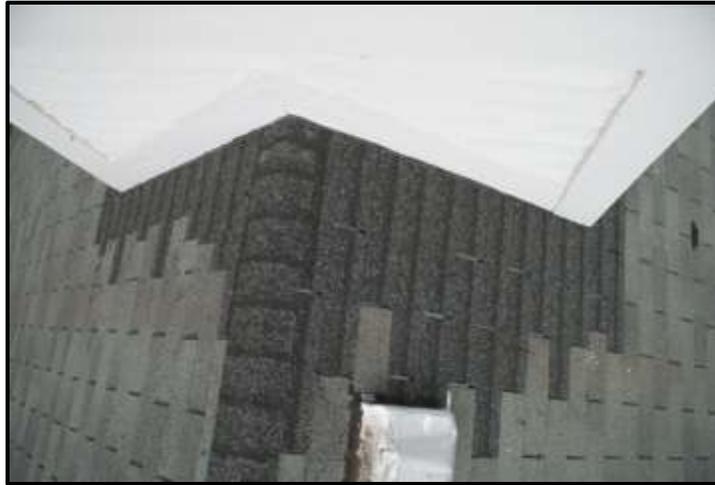
**Photo III-B-39**

Attic ventilation is provided by small wall vents in the south gable end and two roof vents on the east face. The age of the roof is not known but it appears to be in reasonably good condition. Some patching or replacement of shingles around the tower is seen in Photo III-B-39, completed with the tower restoration project as described in Appendix D.

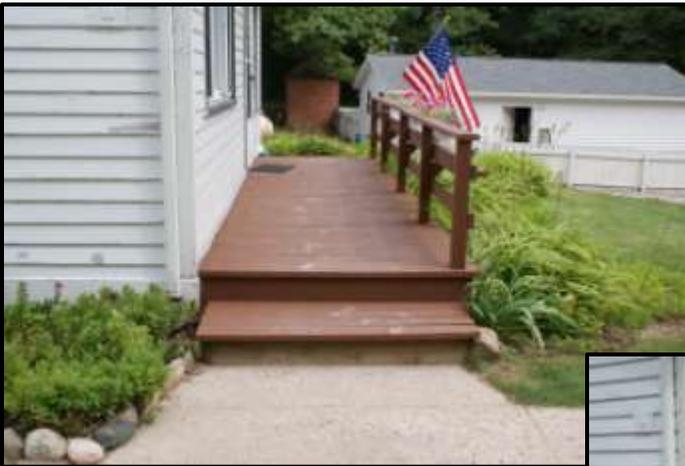
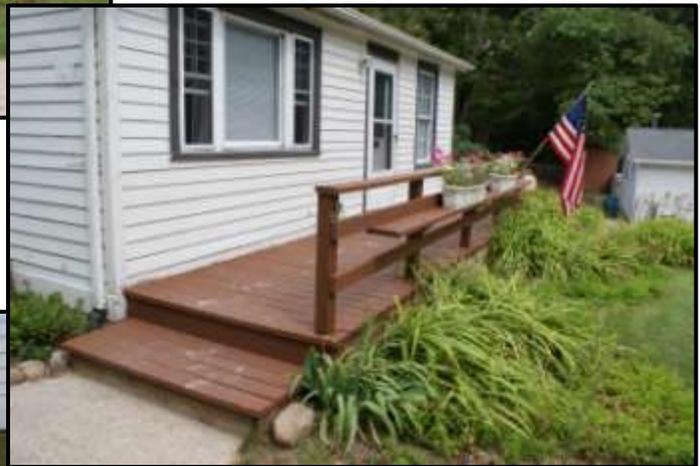
Other exterior features include a wood deck, two concrete porches and a basement stairway and hatch. The wood deck is located on the south end of the dwelling at the rear entry. This deck is seen in Photos III-B-42 and III-B-43. The deck, along with the wood railing, is in reasonably good condition however it conceals the foundation wall and wood siding and is not appropriate to the period of the building. There is a concrete porch located at the main public entry to the building on the north wall as seen in Photo III-B-44. Because of the large step up to the door threshold, a portable wood step is placed in front of the door. The concrete porch is in good condition. A wood handrail, constructed of 2 x 4 lumber, is attached to the side of the concrete. This rail is in poor condition and does not function well with the small wood step.

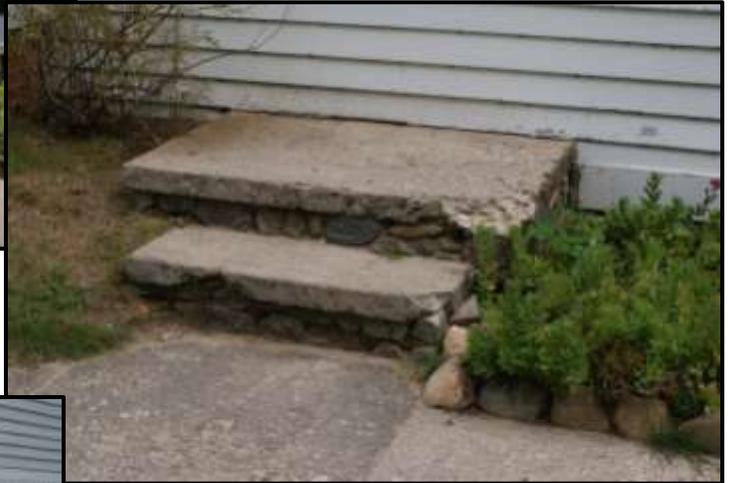
Photo III-B-46

The second concrete porch is located on the west side of the lean-to structure, as seen in Photos III-B-45 and III-B-46, and was located at an entry door, no longer extant. This porch is constructed of stone masonry with a concrete step and landing surface. There is considerable deterioration of the concrete surfaces and the stone masonry walls.

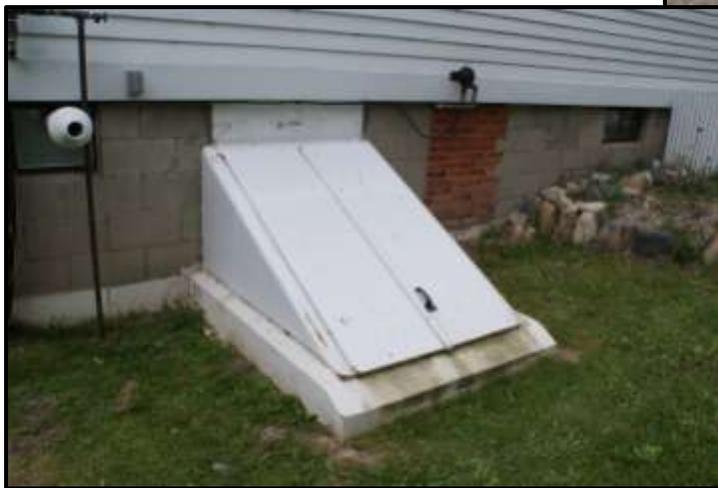
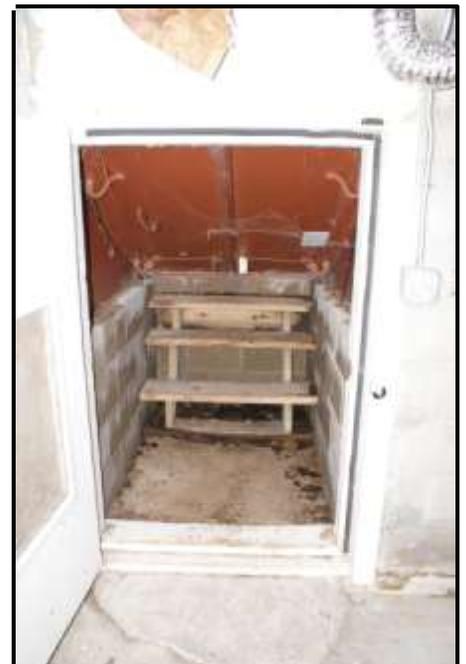
On the east side of the dwelling there is an exterior basement access stair with a metal hatch door. Refer to Photos III-B-47 and III-B-48. The concrete masonry walls show considerable staining from moisture.

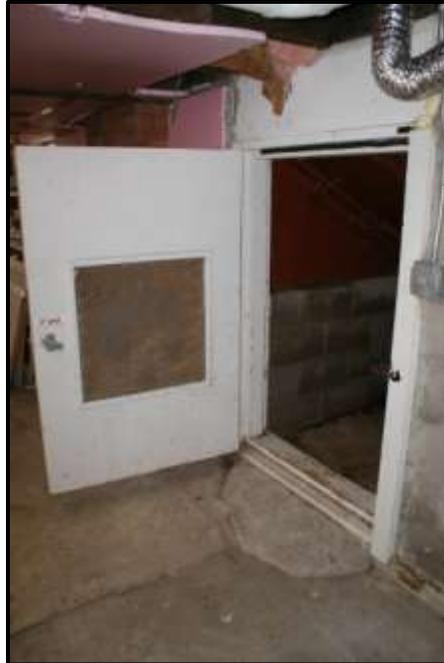
Photo III-B-49

Access from the stair hatch into the basement is through a 3'-2" wide x 4'-10" high door constructed of plywood, as seen in Photo III-B-49. This door, which is in poor condition, has a small vent area. The metal stair hatch cover is in good condition.

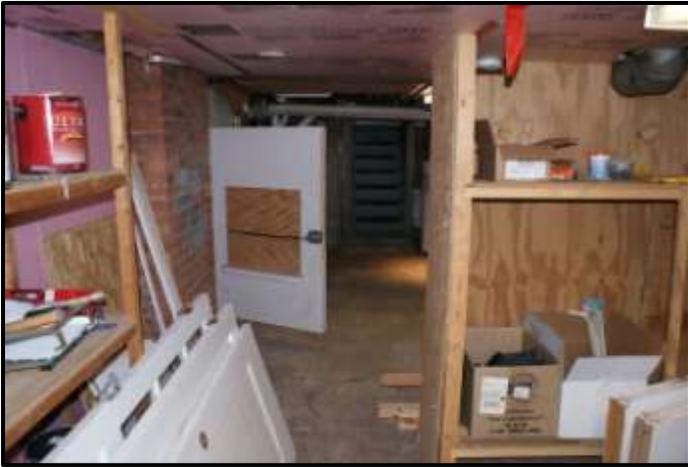
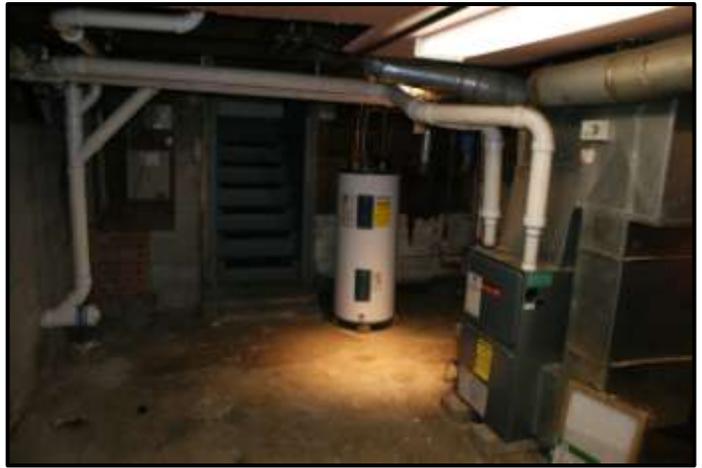
The basement is used for storage as well as housing mechanical, electrical and plumbing systems as seen in Photos III-B-50 and III-B-51. Basement walls are exposed unpainted concrete masonry units and brick. Rigid polystyrene insulation board has been applied to many wall and ceiling surfaces although it has been removed or has broken away in many locations. Fiberglass batts are also found in the first floor joists although this material is also removed or displaced in some areas, particularly where mechanical and electrical systems are found. Refer to Photos III-B-52 and III-B-53. It should be noted that rigid polystyrene insulation is not intended to be left exposed due to its smoke and flame spread rating characteristics.

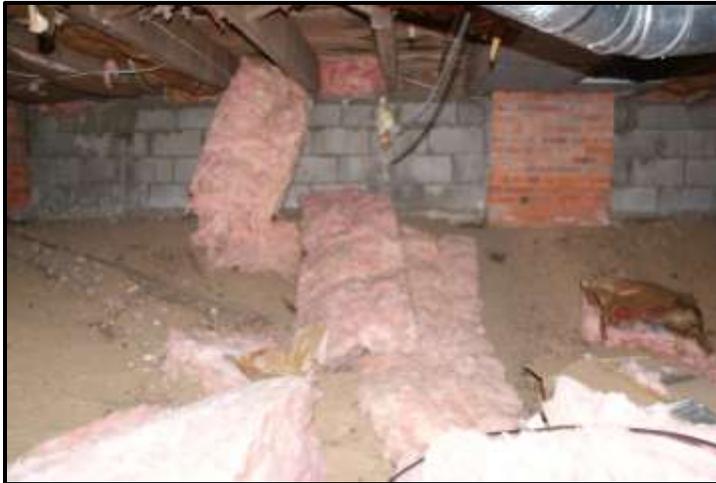
**Photo III-B-54**

In the crawl space area on the west side of the building there is no wall insulation and the fiberglass insulation in the floor joists has fallen out of place as seen in Photo III-B-54. The overall condition of all insulation in the basement and crawl space is poor.

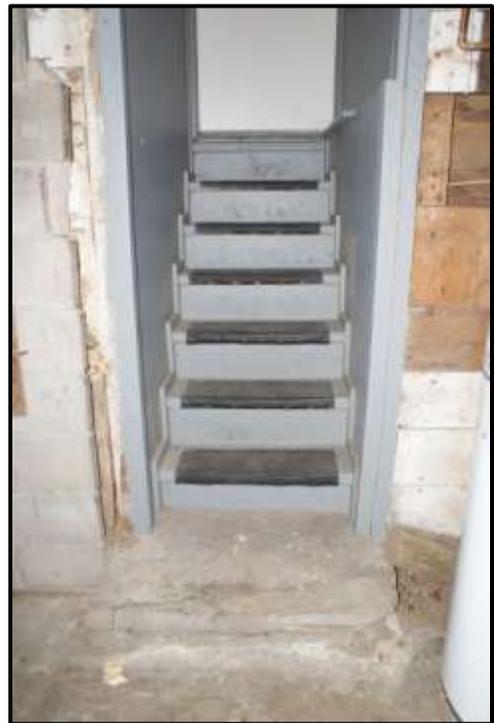
**Photo III-B-55**

The basement is accessed from an interior stair from the first floor kitchen, Photo III-B-55 or from the exterior hatch as seen in previous Photos III-B-47 and III-B-48. The interior wood stair is in good condition although it lacks a handrail. This stair terminates at a concrete step which is somewhat deteriorated. Wall openings provide access to the crawl space on the west side of the building and the crawl space below the lean-to structure. There are no doors or covers over these crawl space access openings.

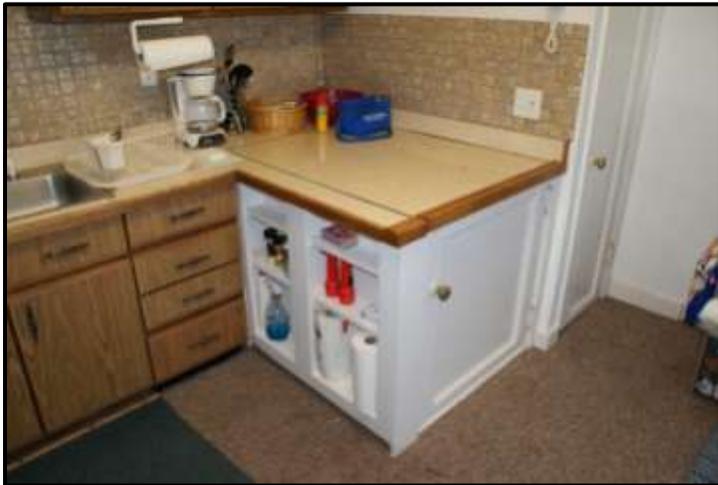
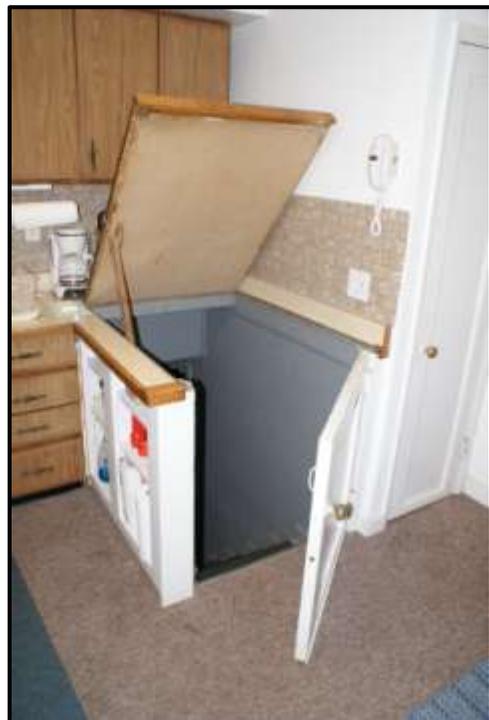
The Kitchen and Dining Room are located at the rear of the building in the single-story lean-to structure. An interesting feature is the hinged counter top and door as seen in Photos III-B-56 and III-B-57 that open to provide access to the basement stair. Kitchen cabinets with a plastic laminate counter are seen in Photo III-B-58. Interior finishes include carpet, painted gypsum board or plaster and painted wood trim. Appliances include a refrigerator, Photo III-B-59, and an electric range, Photo III-B-60. A box-out finished with painted wood shingles conceals ductwork for the exhaust hood above the range, also seen in Photo III-B-60.

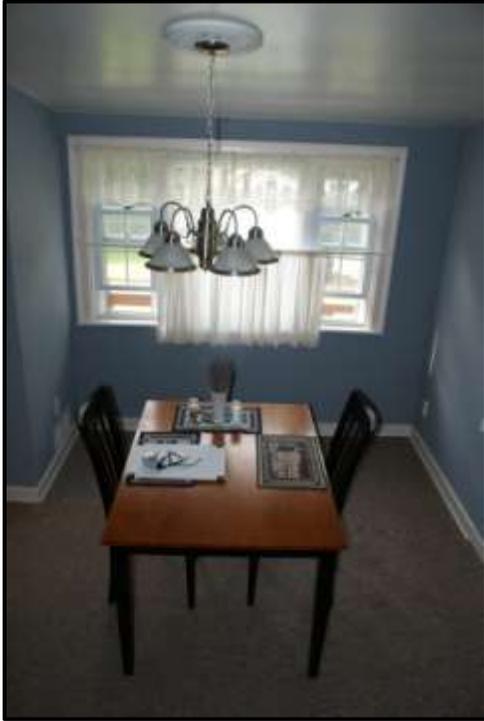
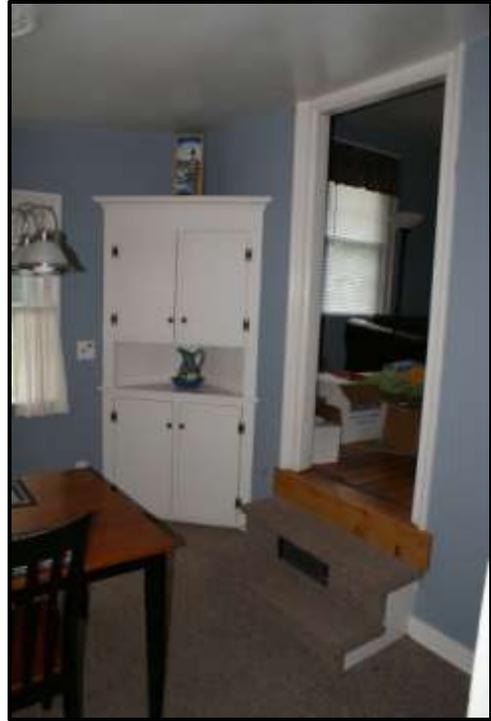
Adjacent to the Kitchen is the Dining Room, as seen in Photo III-B-61 and III-B-62. A built-in hutch is located in one corner adjacent to the entryway to the Living Room, which is 1'-9½" higher than the Dining Room floor level. Interior finishes include carpet, painted gypsum board or plaster and painted wood trim.

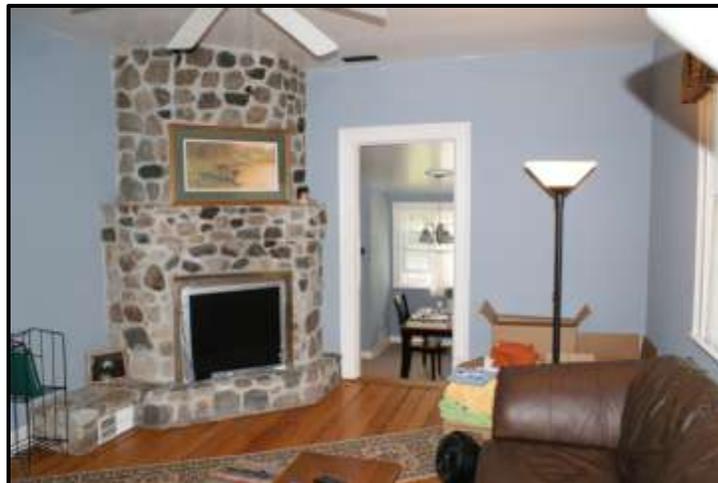
Photo III-B-63

The Living Room includes a field stone fireplace constructed around the original brick masonry chimney, Photo III-B-63, and a built-in cabinet constructed in an original door opening to the Hallway, Photo III-B-64. Flooring in this room is 5¼" wide wood flooring. Details of the flooring and the painted wood trim are seen in Photos III-B-65, III-B-66, and III-B-67. A door from the Living Room provides access to the public exhibit room, as seen in Photo III-B-68.

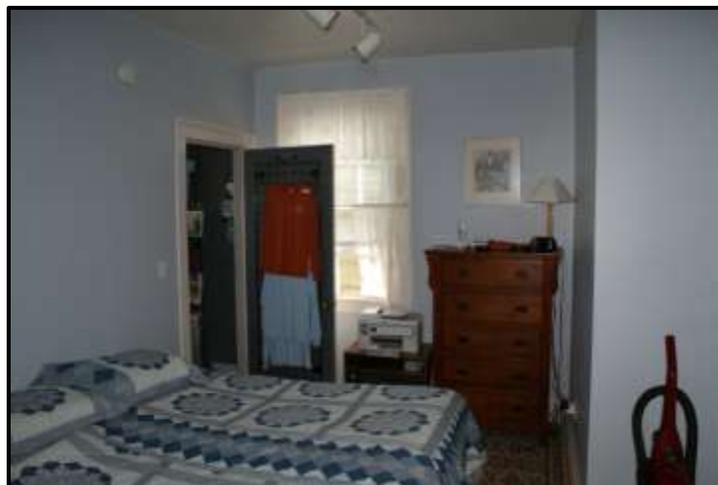
Photo III-B-69

The Bedroom is accessed from both the Living Room and the Gift Shop and has the same interior finishes as the Living Room. Refer to Photo III-B-69. The Bathroom, Photo III-B-70 which includes a laundry area, Photo III-B-71, is only accessed through the Bedroom. Flooring is carpet in the bathroom area and sheet vinyl in the laundry/shower area. This flooring material was not removed to observe the type of condition of any underlying material. The bathroom is only for use of the residents and is not available to the visiting public.

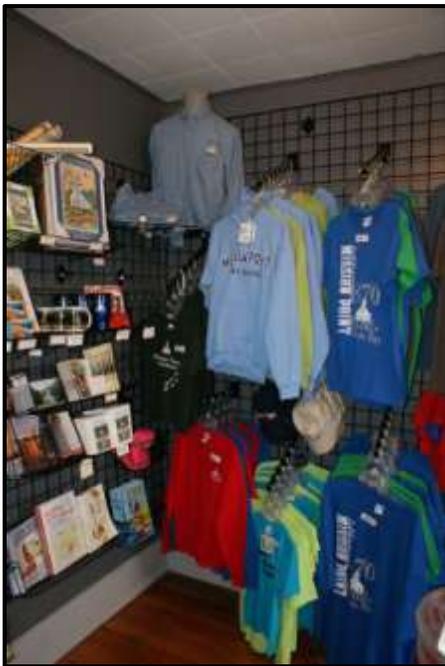
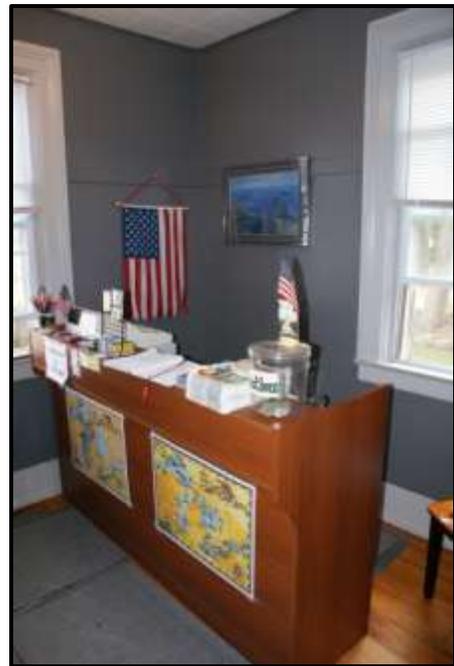
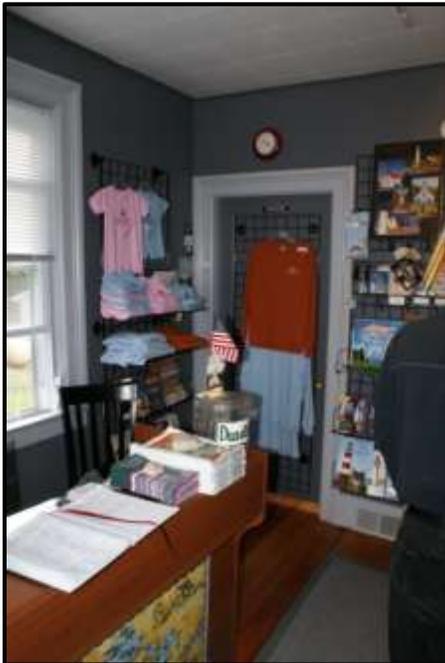
The public, or museum side of the first floor, consists of a room designated as the Gift Shop where merchandise and tickets are sold, an entry Hallway and Exhibit Room. The Gift Shop is seen in Photos III-B-72, III-B-73 and III-B-74. Interior finishes include hardwood flooring, painted wood paneling, and gypsum board or plaster walls, painted wood trim and 12" x 12" acoustic ceiling tiles. The customer service counter where tickets and merchandise are sold is also seen in Photo III-B-73.

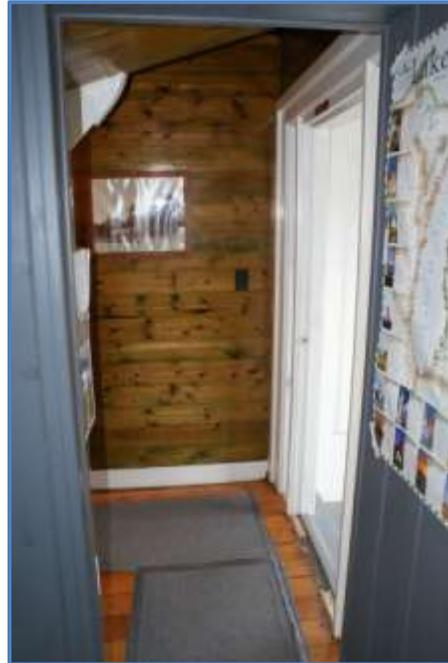
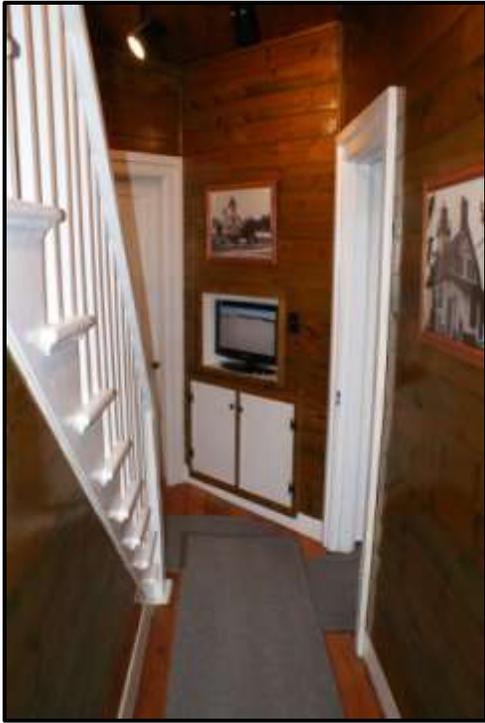
A narrow hallway transitions from the Gift Shop and provides access for visitors to the stairway and to a small Exhibits Room. The Hallway, as seen in Photos III-B-75 and III-B-76, is finished with stained and varnished horizontal wood paneled walls and ceiling. Wood trim is painted. A small video monitor and built-in cabinets are located in a former door opening. The Exhibits Room contains some period furnishings and displays for visitors. Photos III-B-77 and III-B-78 show the interior finishes which include hardwood flooring 5'-10" high painted wood wainscoat, painted wood trim and 12" x 12" acoustic tile ceilings. The small Entry used by visitors has both a storm/screen door and an inward swinging insulated metal door. The door from the Entry into the building is flanked by sidelights as seen in Photo III-B-79. This door has been removed and is presumed to be one of the doors stored in the basement.

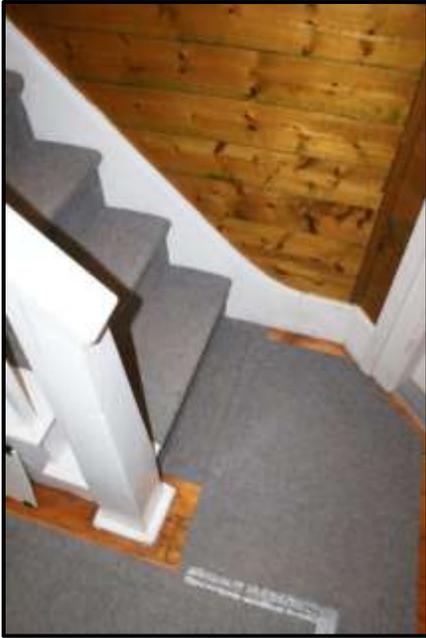
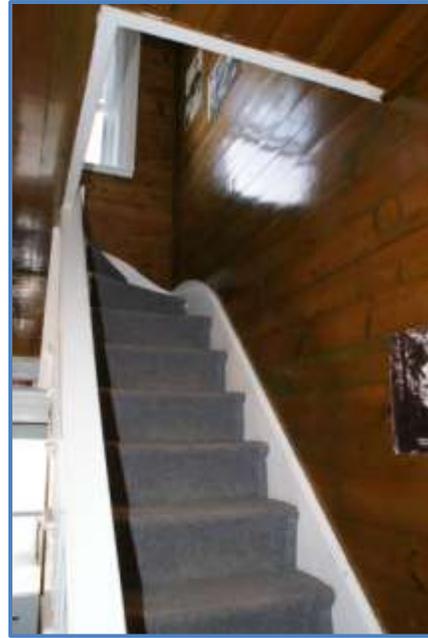
The stairway leading to the second floor is wood with a painted finish on all components. The stair treads and risers are covered with carpet. The horizontal wood paneling continues up the stairway as seen in Photos III-B-80 and III-B-81.

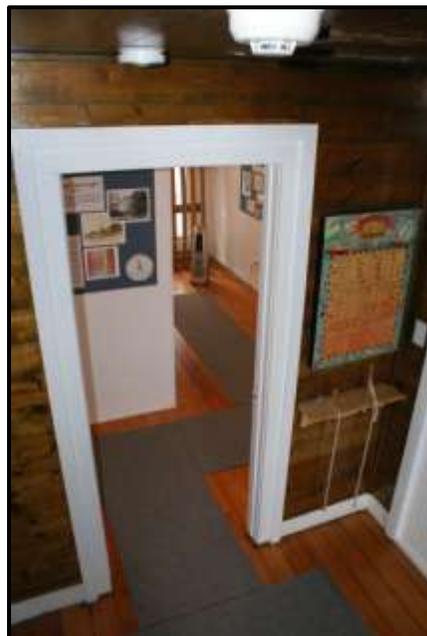
**Photo III-B-82**

The second floor of the building, which is open to visitors, includes a small Hallway, a Storage Closet, and Exhibit Room. The horizontal wood paneling wall material continues through to this second floor Hallway, which also has hardwood flooring. Refer to Photo III-B-82. An enclosed display area with a Fresnel lens exhibit is seen in Photo III-B-83. This display area occupies a former closet space. The Exhibit Room contains a number of displays and a center kiosk with a video monitor. Refer to Photos III-B-84 and III-B-85.

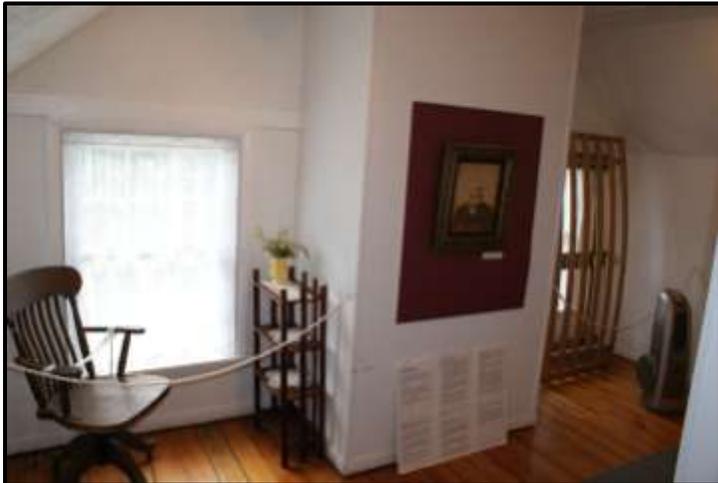
Photo III-B-86

The masonry chimney is covered over with gypsum board as seen in Photo III-B-86. Finishes in this room include hardwood flooring and a "swirl" texture finish on the gypsum board walls and ceilings. Painted wood trim transitions to a modern Ranch style casing as seen in Photo III-B-87.

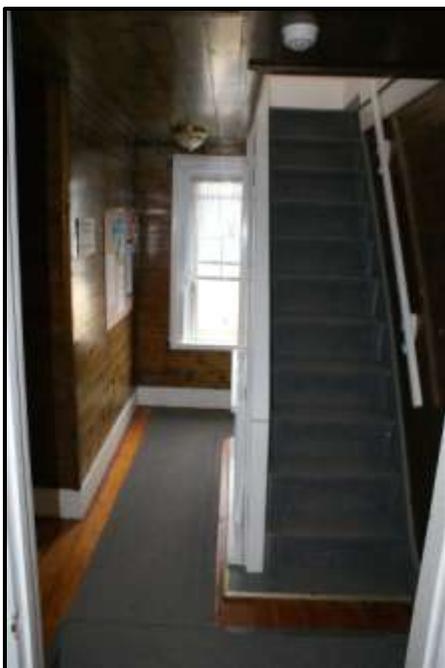
Photo III-B-88

A steep narrow stair, Photo III-B-88, provides access from the second floor to the first landing in the Light Tower. All walls, ceiling and flooring at this landing level are 5¼" wide painted wood material. Other wood trim, such as the simple stair newel posts and handrail, Photo III-B-89, and window casing, Photo III-B-90, are also painted. A small landing, Photo III-B-91, and a very steep ladder-type stair, Photo III-B-92, provide access to the Lantern through a small hatch.
