**HISTORIC STRUCTURE REPORT  
FOR  
MISSION POINT LIGHT STATION  
PENINSULA TOWNSHIP, MICHIGAN**

**Prepared by:  
U.P. Engineers & Architects, Inc.  
102 W. Washington Street, Suite 217  
Marquette, MI 49855**

**Final Report  
October 31, 2012**

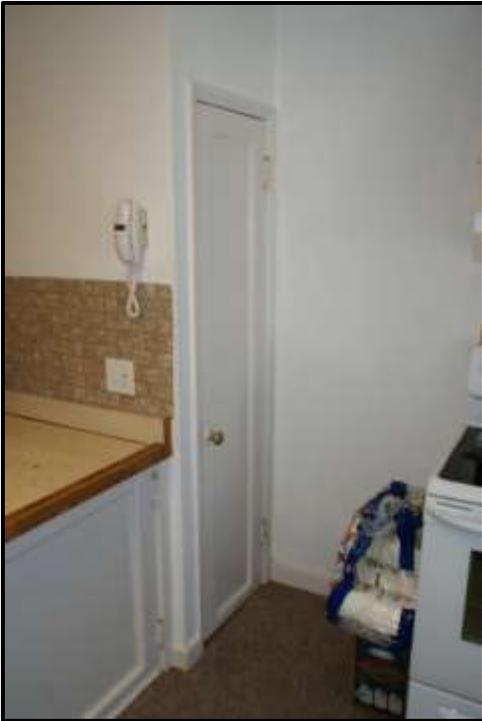
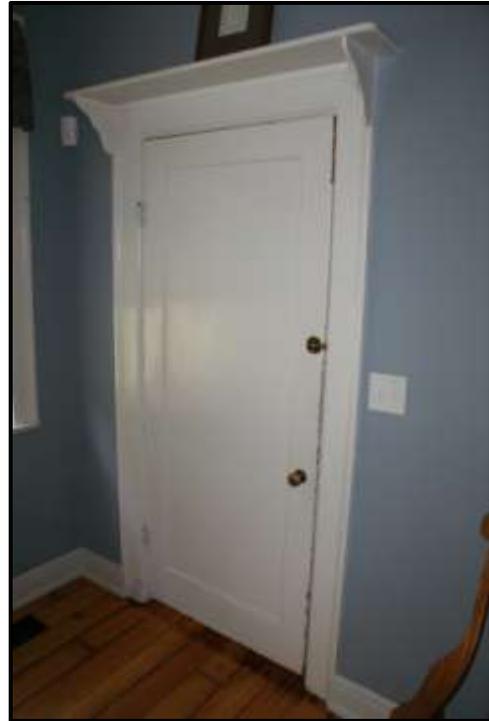
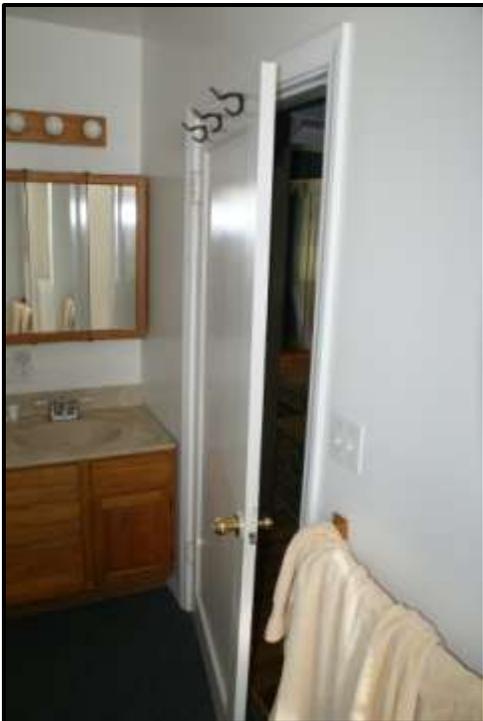
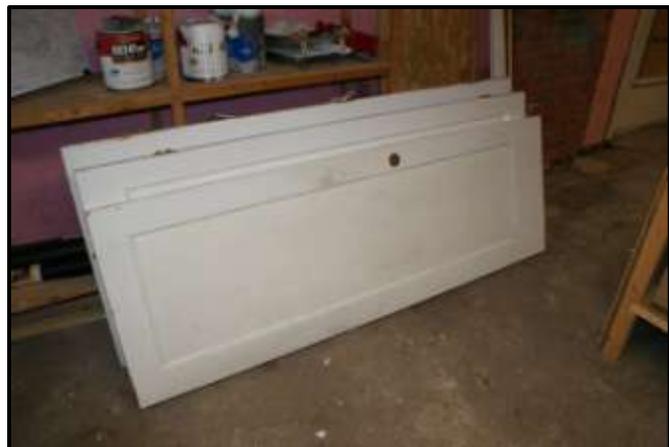
Interior doors throughout the Light Tower/Keeper's Dwelling are wood, single panel doors with a paint finish. Door hardware is typically a simple knob passage set although other locks have been added on some doors. Various interior doors, including those stored in the basement, are seen in Photos III-B-93, III-B-94, III-B-95, and III-B-96.

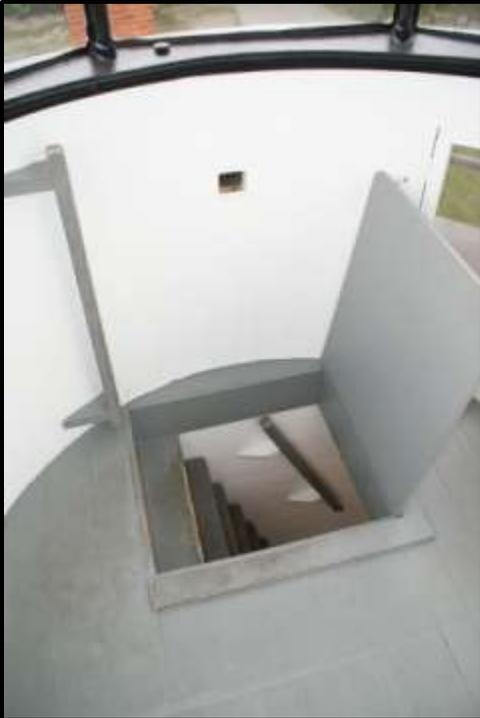
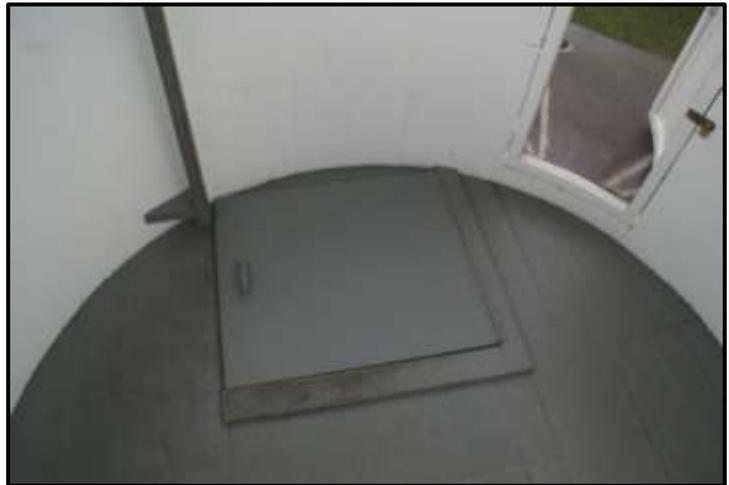
The Lantern, which no longer has any navigational aids, is a cylindrical structure with an inside diameter of 6'-3" and nine glass panels. The solid base wall measures 3'-4" high and glass panels measure 2'-2½" wide x 3'0" high. A wood hatch door, as seen in Photos III-B-97 and III-B-98, provides access into the Lantern.

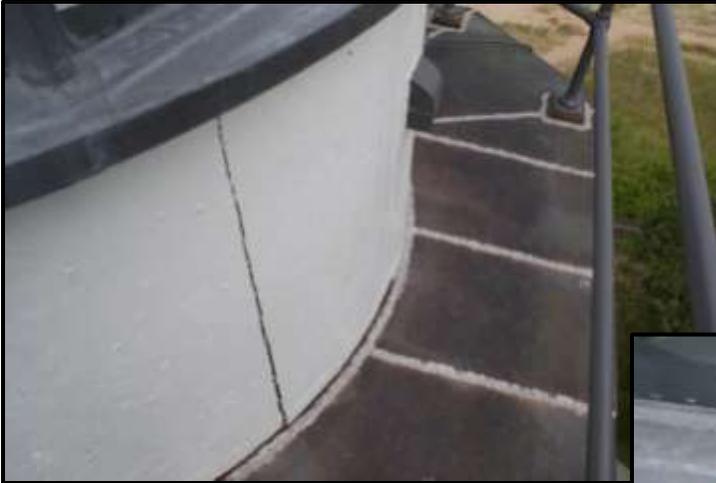
Photo III-B-109

The exterior base walls of the Lantern are vertical wood boards with a paint finish. There are some large vertical cracks in this material as seen in Photo III-B-109. Interior or exterior wood paneling was not removed to examine the metal structure of the lantern base. The exposed metal surface at the base of the windows has been covered with some type of rubber membrane and sealant. This material appears to be trapping moisture and contributing to rusting and deterioration of the metal structure as seen in Photo III-B-110. Other exterior components of the metal glazing frame appear in sound condition with some minor deterioration of the paint finish. Refer to Photo III-B-111.

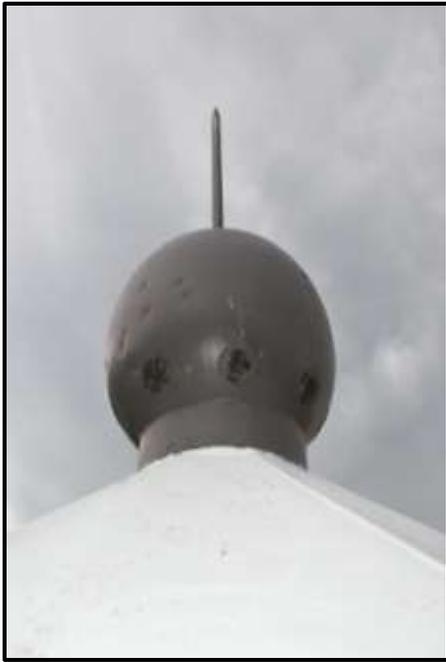
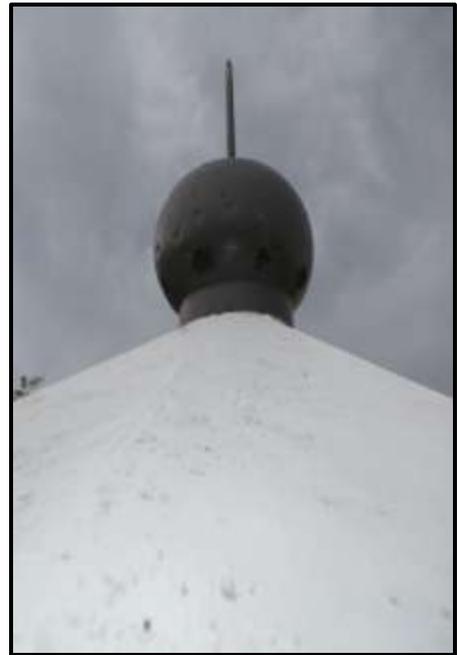
The metal roof and ventilator ball are in good condition with some deterioration of the paint finish, as seen in Photos III-B-112 and III-B-113. There is no gutter system on this lantern roof. The exterior surface of the Lantern deck has been covered with copper sheeting with soldered joints as seen in Photo III-B-114. The copper sheet transitions to a copper flashing that terminates at the Lantern wall. There are some gaps and open joints at this flashing material. Deck railings are constructed of 1<sup>5</sup>/<sub>8</sub>" outside diameter metal pipe and are secured to the deck with plate brackets as seen in Photo III-B-115. Railings are in good condition with some minor paint deterioration.

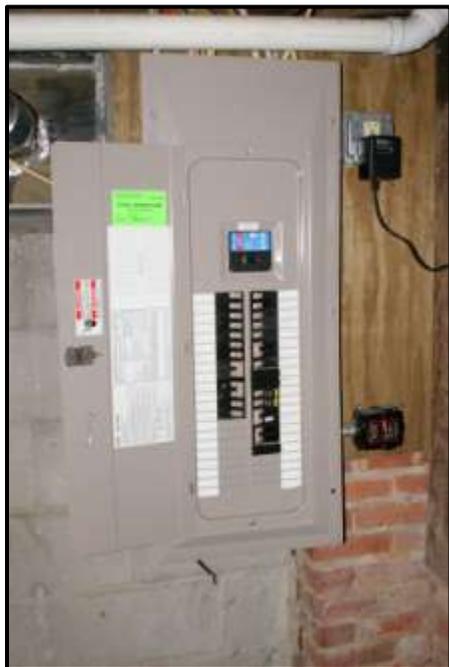
Photo III-B-116

The Light Tower/Keeper's Dwelling is an occupied residence and has functional electrical, plumbing and heating systems throughout. The building is served by a 200 amp electrical service panel located in the basement as seen in Photo III-B-116. There are a number of unused circuit breaker locations on the panel, indicating that this service has adequate capacity. Sheathed Romex cable can be seen at different locations in the basement indicating that new wiring has been installed in the recent past. Refer to Photo III-B-117.

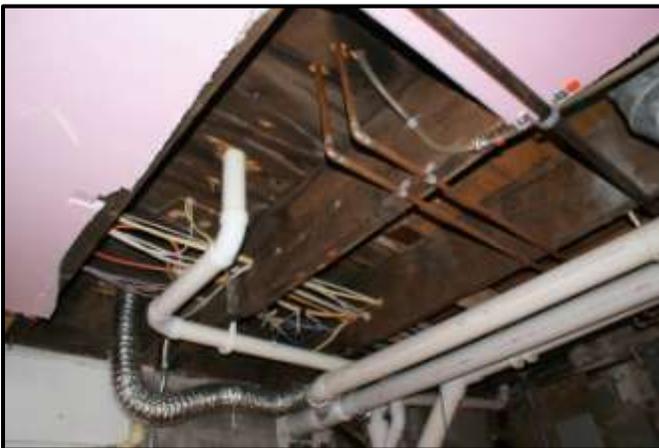
**Photo III-B-123**

Plumbing consists of kitchen, bathroom, and laundry fixtures located on the first floor. All fixtures appear in good condition. Copper water supply lines are visible in the basement, Photo III-B-123 along with PVC sanitary water line piping, Photo III-B-124. Water lines are not insulated.

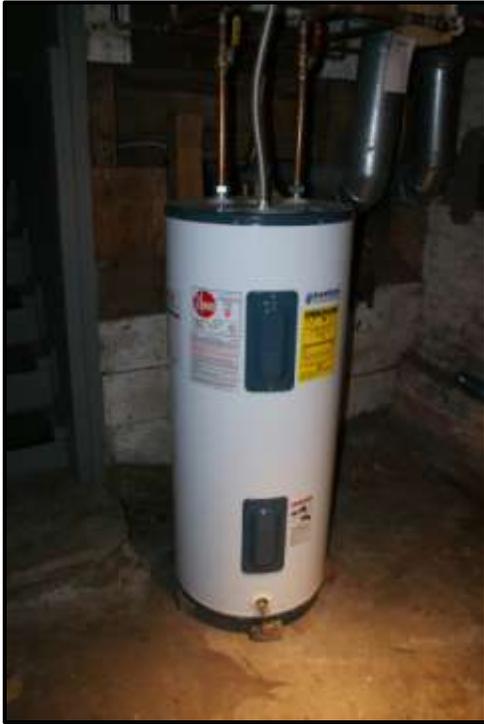
**Photo III-B-125**

A 40 gallon electric hot water heater is located in the basement. The unit tag indicates a manufacturer date of 4/2007. This heater is seen in Photo III-B-125. Adjacent to the heater is the well pressure tank, Photo III-B-126. The location of the water well is not known, however the supply line enters the building from the west. The basement floor was wet around the pressure tank indicating some possible water leaks, although none were evident.

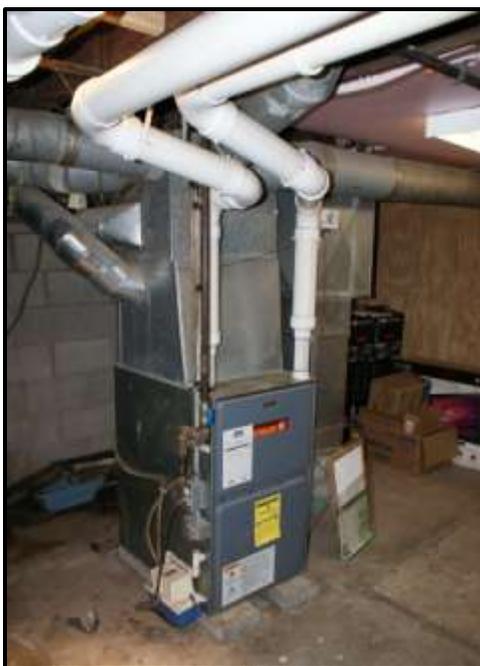
Photo III-B-127

The building is heated with a propane-fired forced-air furnace located in the basement. This unit, a "Conquest 90", has an installation sticker with a date of January 1996. Refer to Photo III-B-127. Uninsulated metal ductwork is located throughout the building terminating at supply diffusers and return grilles located in most rooms of the building. A standard thermostat is located in the first floor bedroom. There is no air conditioning in the building.

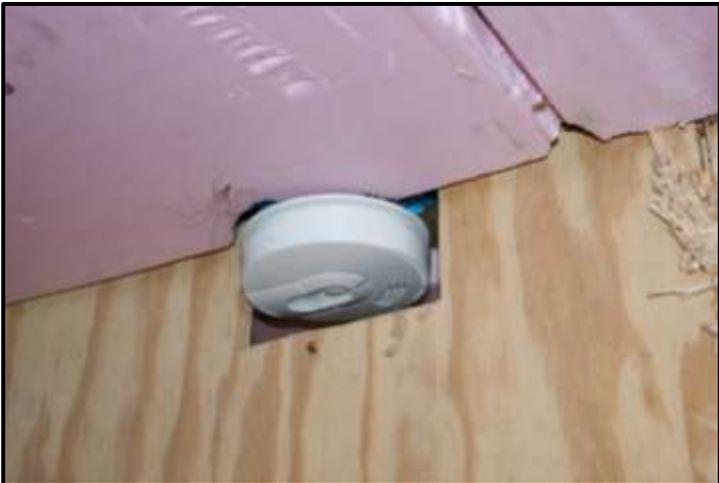
Photo III-B-129

Smoke detectors are located throughout the building. One detector in the basement is improperly surrounded by plywood, as seen in Photo III-B-129.

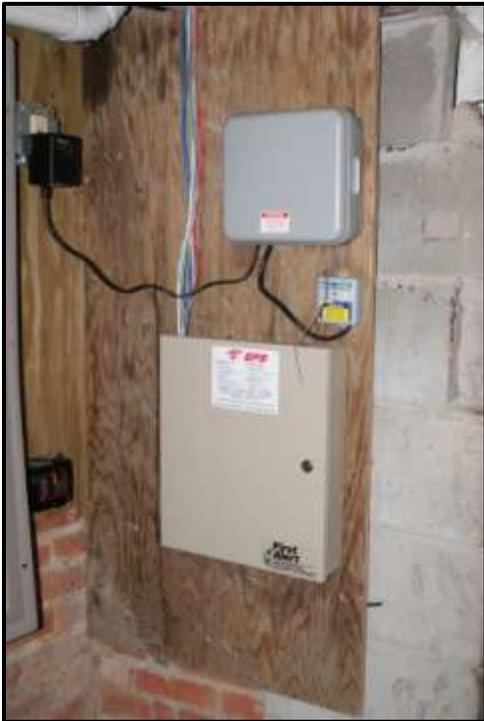
Photo III-B-130

An alarm system is also installed in the building with the main panel located in the southeast corner of the basement. Refer to Photo III-B-130. A control station is located in the Kitchen near the rear entry door. It is presumed that this system is remotely monitored but the service company is not known.

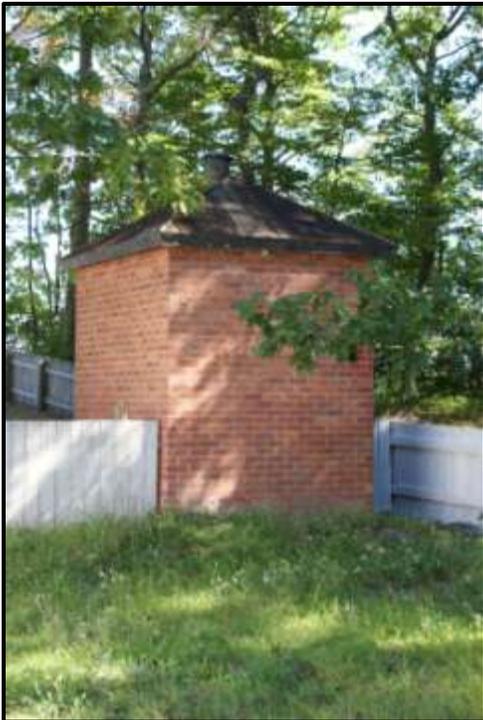
Photo III-C-1

The Oilhouse is a small brick masonry structure with a metal roof originally constructed in 1895. See Photos III-C-1 and III-C-2. The building, which measures 9'-0" x 7'-0½", is located east of the Light Tower/Keeper's Dwelling and was used to house flammable liquids in a secure location separate from other structures. With solid masonry walls, and metal ceiling panels, metal roof and metal door, the Oilhouse is a non-combustible structure. The Oilhouse is not currently being used.

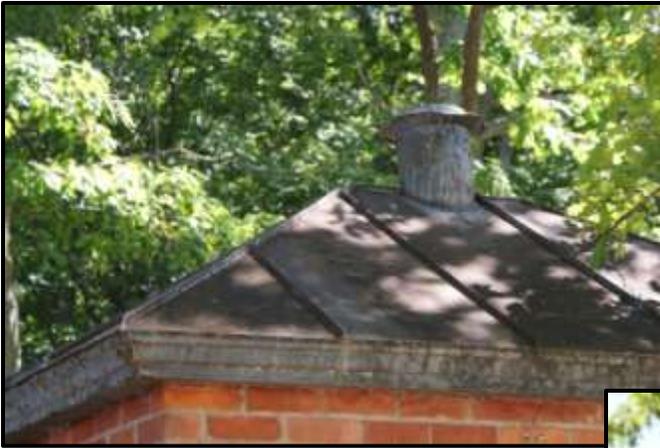
Photo III-C-4

The metal roof and metal cornice are in good overall condition as seen in Photo III-C-4. There are a few small holes and some damage in the metal cornice as seen in Photos III-C-5, III-C-6 and III-C-7. The ventilator cap is missing from the roof ventilator pipe. The paint on all metal surfaces is in poor condition.

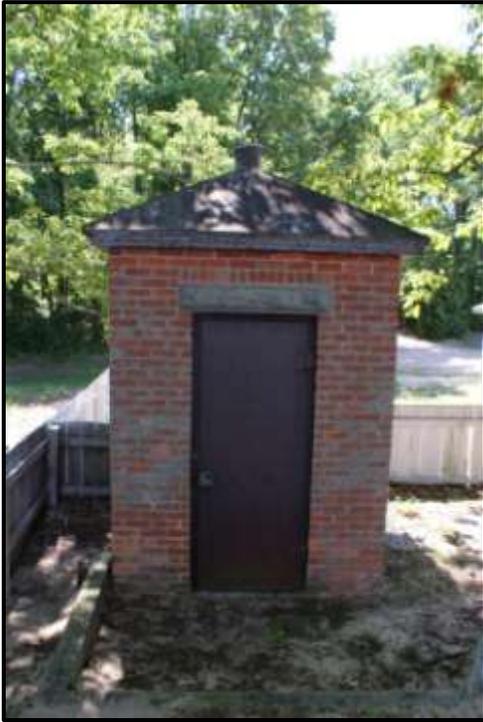
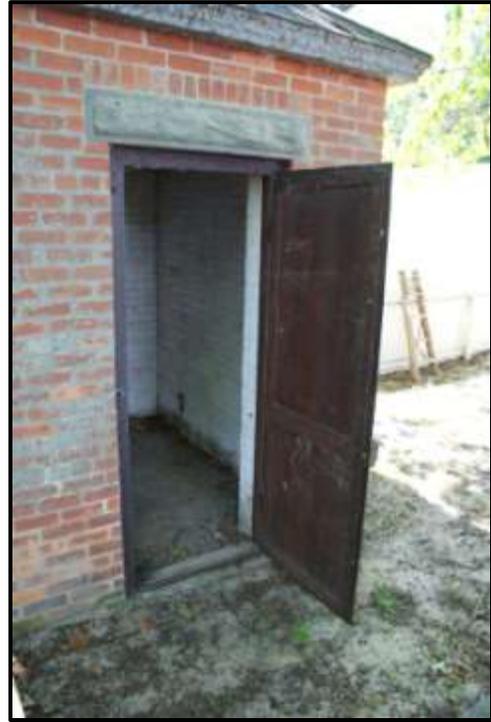
The Oilhouse has a heavy metal door and frame that is in good structural condition however, interior and exterior surfaces are pitted and rusted with peeling paint as seen in Photos III-C-8 and III-C-9. There is a metal threshold on top of the stone sill. Door hinges are in good working order, however, the original lock mechanism is missing, with a surface mounted lock mechanism applied to the door face as seen in Photo III-C-10.

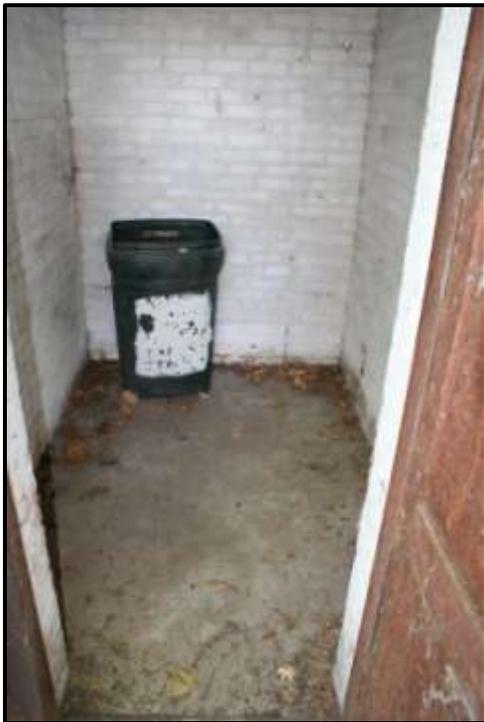
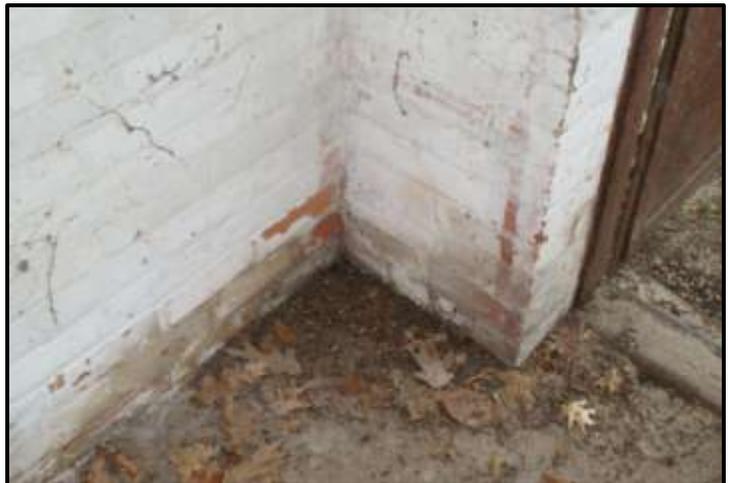
The interior walls of the Oilhouse are painted brick masonry and the floor is a painted concrete slab. There is some minor cracking in the masonry and the paint finish is chipped and peeling in some areas as seen in Photos III-C-11 and III-C-12. The ceiling is covered with metal panels that are painted. The panels are in sound condition however the finish is deteriorated with flaking/scaling paint as seen in Photo III-C-13. At two locations on the interior brick masonry wall face, approximately 8" above the floor, there are wall openings, presumably to vent the wall cavity. One such opening on the east wall is seen in Photo III-C-14.

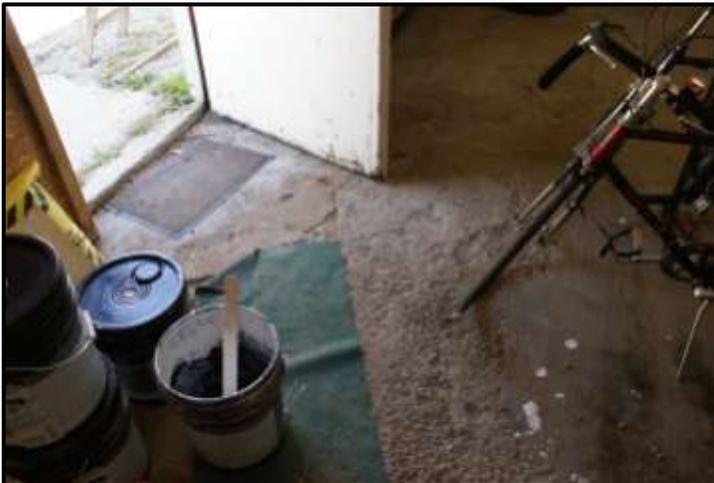
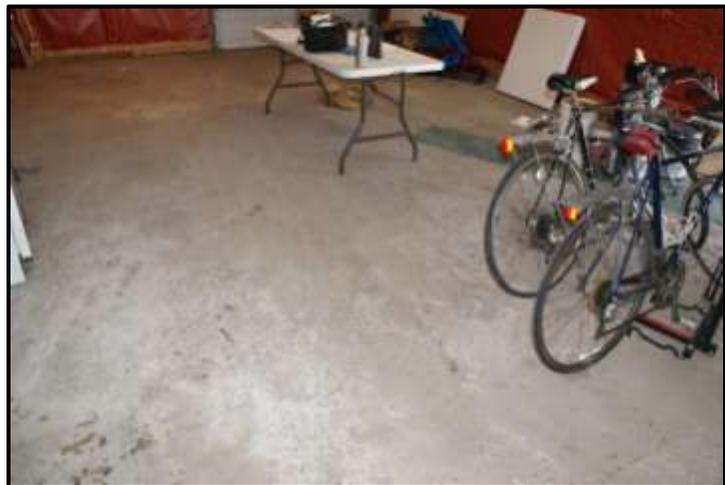
The Garage floor is a concrete slab of unknown thickness. The floor slab is in poor condition with many areas spalled and uneven. Based on this current condition, it appears as though the workmanship of the original installation was poor. Photos III-D-4 and III-D-5 show the poor surfaces of the floor slab.

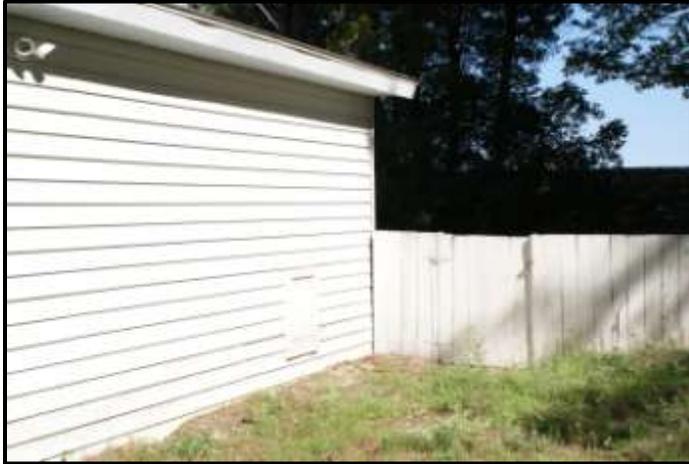
**Photo III-D-10**

The exterior walls of the Garage are covered with a painted horizontal metal siding with a five inch exposure. In an area that could be observed there was no other siding below this material. Fascia and soffits are trimmed with metal as seen in Photos III-D-8. Soffit panels are perforated for ventilation. The metal siding is in average condition with some damaged areas such as the southwest corner, as seen in Photo III-D-9. On the east and north walls, the surrounding grade is higher than the finish floor elevation, allowing the metal siding and inner wall construction to be partially buried below grade. This condition is seen in Photo III-D-10, and exposes the siding to damage from lawn cutting equipment as well as ground water run-off.

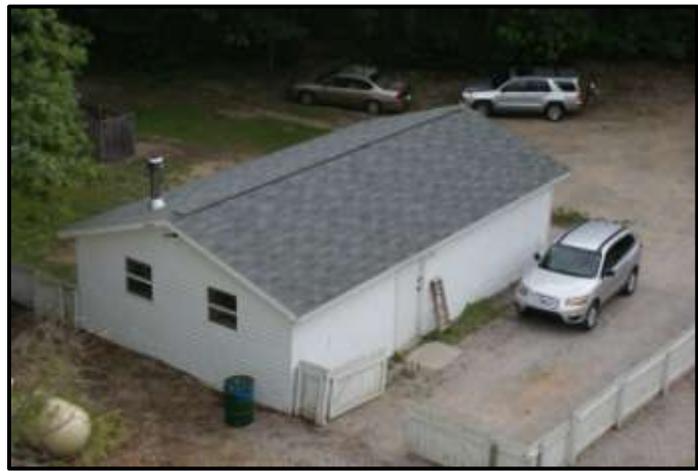
**Photo III-D-11**

The Garage roof is covered with asphalt shingles as seen in Photo III-D-11. The shingles are in relatively good condition and include a ridge vent. There is also a metal chimney that penetrates the roof, but is no longer connected to any type of heating unit.

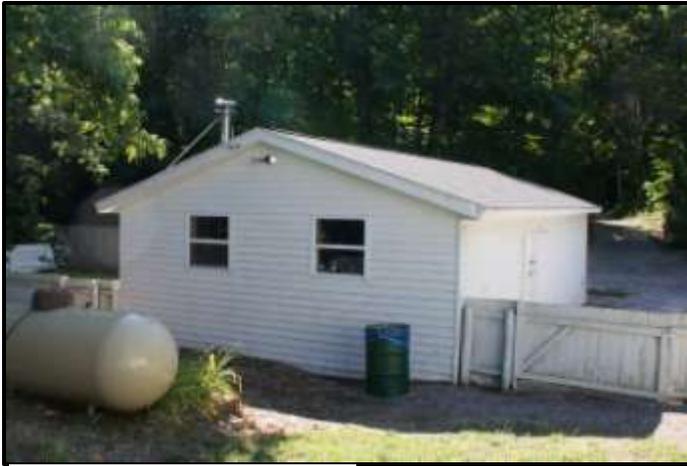
Photo III-D-12

There are four windows in the Garage; two double hung vinyl windows on the north wall, seen in Photo III-D-12, and two wood double hung windows on the south and east walls. All windows are in poor condition.

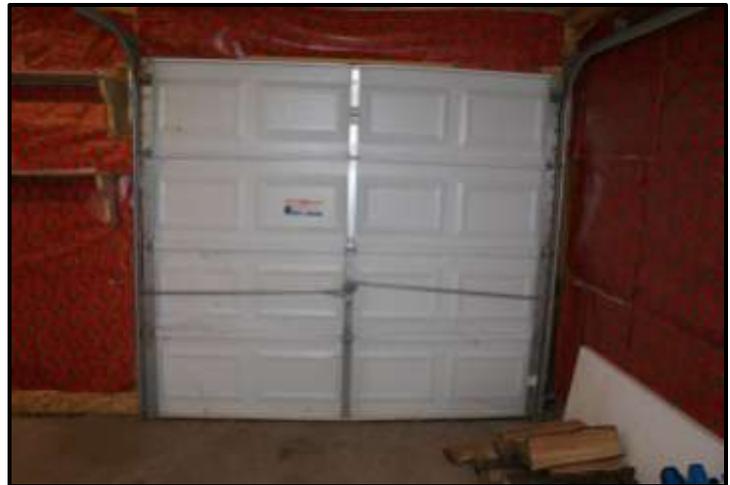
Photo III-D-13

On the south wall there is an insulated metal overhead door that measures 7'-11" wide x 6'-6" high. This door, seen in Photo III-D-13, is manually operated and is in reasonably good condition. A single pedestrian door measuring 3'-8" wide x 7'-0" high is located on the west wall. Refer to Photos III-D-14 and III-D-15. It appears as though an original 1<sup>3</sup>/<sub>4</sub>" thick door is intact but now covered with <sup>5</sup>/<sub>8</sub>" plywood on both inside and outside faces. This door is in poor condition with only a padlock hasp and handle for hardware. It should also be noted that there is a 2" step down into the Garage at this door. There is also a small wood access door through the wall at the northeast corner of the building. This access door is in poor condition.

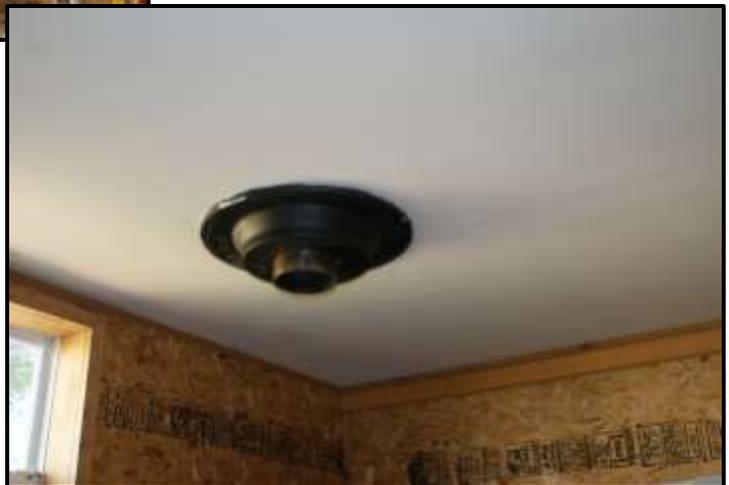
**Photo III-D-19**

A small ceiling access hatch, seen in Photo III-D-18, provides access into the truss/attic space. There is approximately 8" of blown cellulose insulation above the gypsum board ceiling. Photo III-D-19 shows the abandoned metal chimney and metal collar where it penetrates the ceiling.

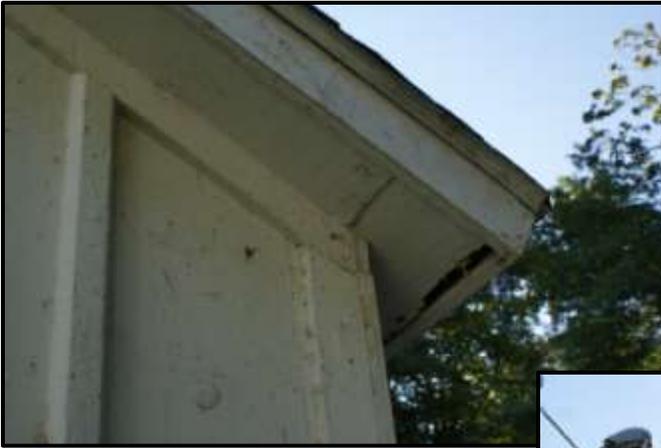
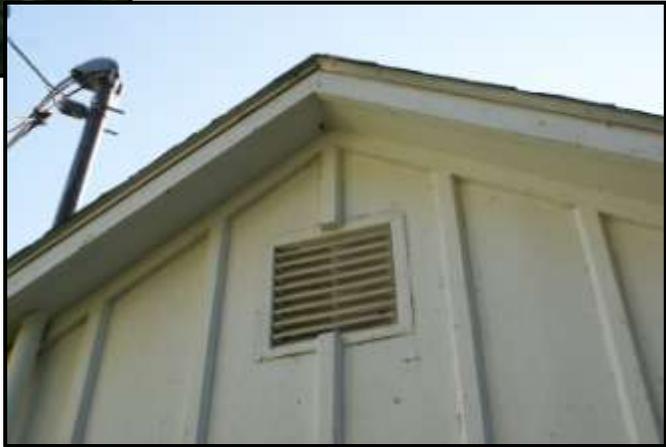
The exterior walls of the Storage Building are sheathed with vertical wood board and batten siding with battens spaced 12" o.c. As previously indicated, the board and batten siding is in poor condition with considerable damage along the lower wall surfaces. All surfaces are painted and the paint is in poor condition. Fascia and soffits are painted wood. There is some minor deterioration of some wood material. Paint is in poor condition. Fascia and soffits are seen in Photos III-E-8 and III-E-9 along with a metal louver located in the gables for attic ventilation.

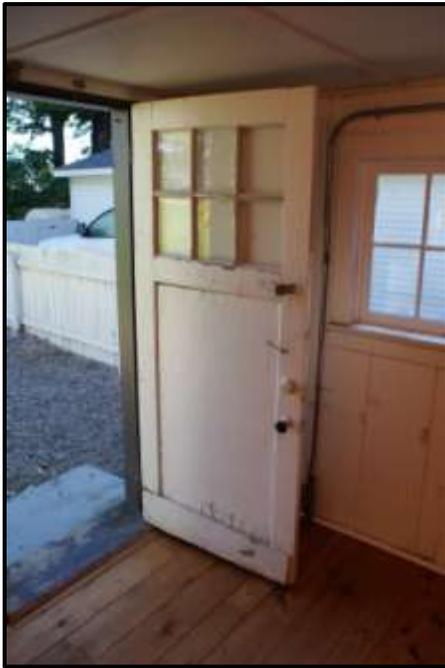
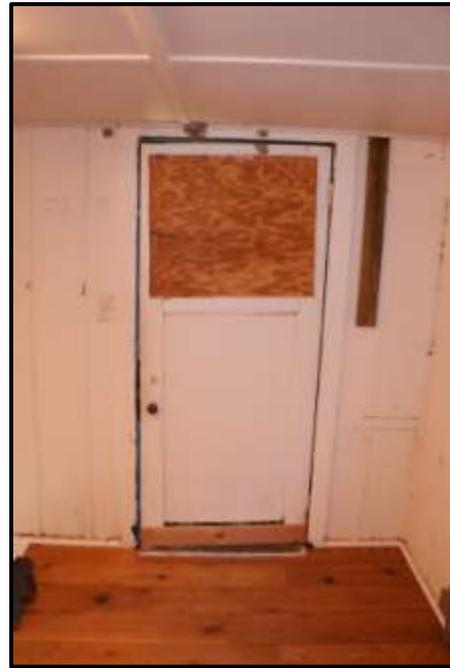
There is a single 2'-10" x 6'-8" door into the building as seen in Photos III-E-11 and III-E-12. The painted wood door is a single panel door with a six light vision panel. The glass is covered with a plywood security panel on the interior face. The inset panel and the bottom rail of the door are badly deteriorated. The paint finish is also in poor condition. Hardware consists of a lockset, cylindrical lock, a padlock hasp and hinges. Photo III-E-13 shows a small step constructed of wood framing and plywood outside of the entry door.

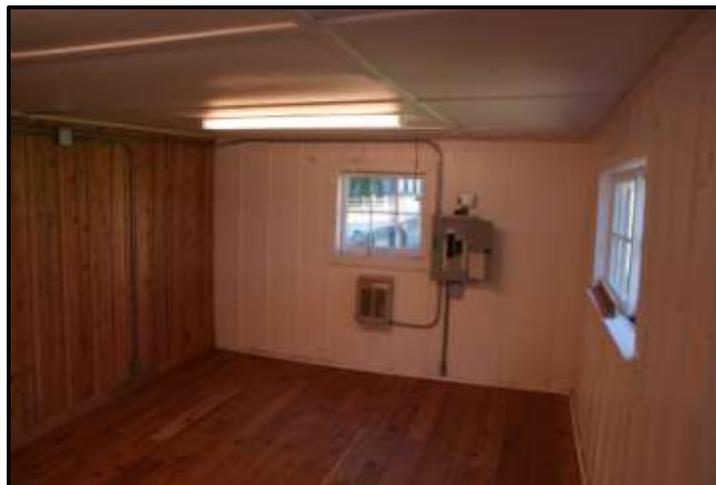
Photo III-E-20

The interior of the Storage Building is one large room as seen in Photos III-E-20 and III-E-21, with a low ceiling height of 6'-9½". Interior walls are also covered with vertical board and batten siding and wood trim. Approximately half of the interior wall surface appears to have original material that is painted and in reasonably good condition. The south wall and a portion of the east are covered with an unfinished rough-sawn cedar board and batten material, as seen in Photo III-E-22.

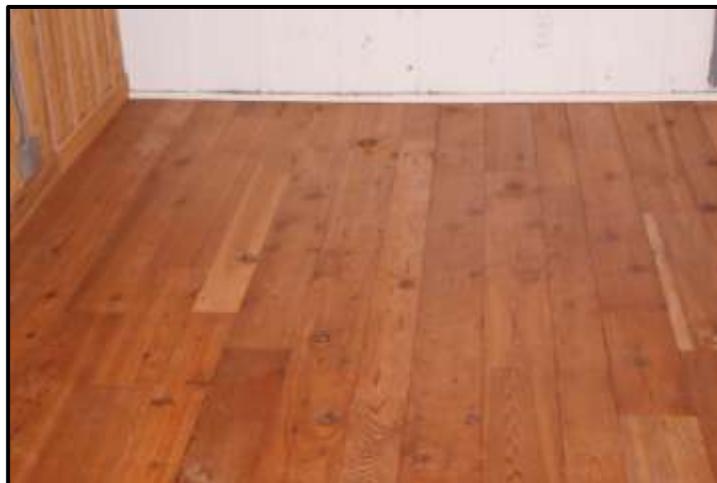
Photo III-E-23

The ceiling is covered with painted gypsum board that has wood batten strips placed 4'-0" on center over the joints. It is not known if there is any insulation above the ceiling. The building floor is covered with newer knotty pine plank flooring in 5" and 7" widths. This flooring, which is seen in Photo III-E-23, is in good condition. The new wood floor transitions to an original wood threshold at the doorway. This painted wood threshold has some deteriorated areas.

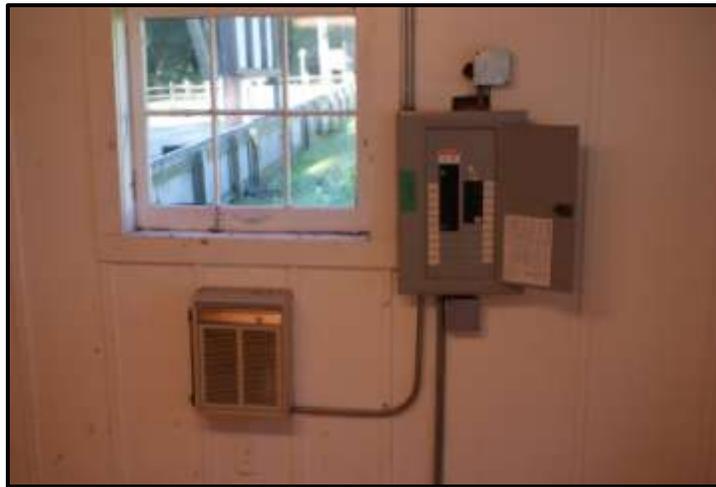
**Photo III-E-24**

A 100-amp electrical service panel is located on the west wall of the building along with a small wall mounted electric unit heater. See Photo III-E-24. The service panel is fed from an overhead line from a utility pole west of the building. The electrical service entrance and meter is located on the west wall as seen in previous Photo III-E-15. Electric service from this 100-amp panel is fed to the Garage via underground conduit, seen in previous Photo III-E-6.

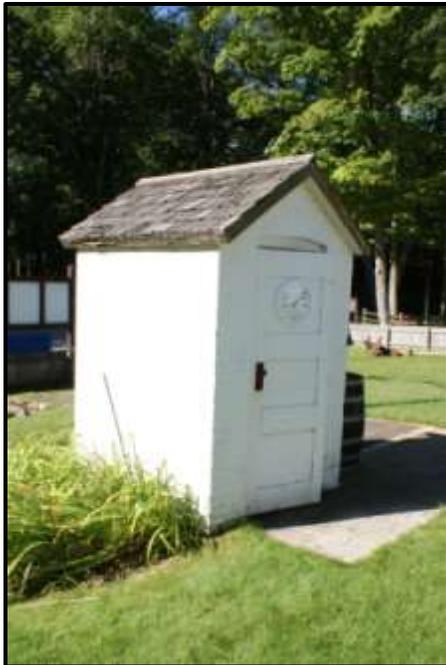
**Photo III-F-1**

The Well House located south of the Light Tower/Keeper's Dwelling, is a small painted brick masonry structure with a wood frame roof, measuring 4'-11" x 5'-10" in plan. The original construction date is estimated to be 1870. This building, as seen in Photos III-F-1, III-F-2, and III-F-3, is not currently used for any purpose, and a wood entry door is screwed to the wood frame for security. A concrete sidewalk surrounds the Well House on two sides.

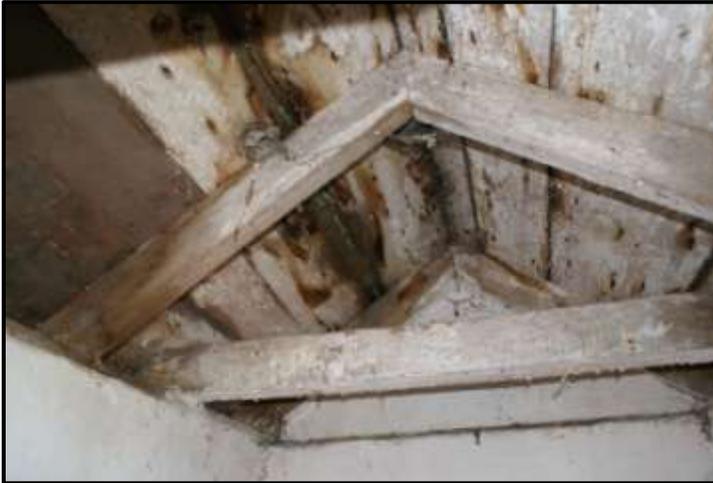
**Photo III-F-6**

The roof of the Well House is framed with simple wood rafters and wood sheathing, which is seen in Photos III-F-6 and III-F-7. There is considerable water staining and rot and all elements are in poor condition.

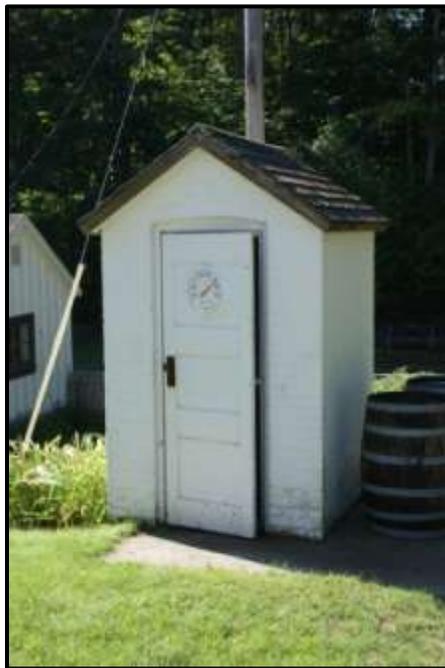
Photo III-F-8

Exterior brick masonry walls are painted. The brick masonry is in good condition and the paint is in good condition. There is some moss/mildew on the lower section of the exterior wall surfaces. The Well House door, Photo III-F-8, is a 3-panel wood door which is painted, however this door appears to be an interior door based on the interior style door knob and escutcheon. The door is screwed to the wood frame, and is non-functional, requiring removal of the screws to partially open the door. The door is split on one side and in poor condition. The wood frame is intact and in reasonably good condition. The wood shingle roof and wood trim as seen in Photo III-F-9 and III-F-10 are in poor condition with signs of rot and other deterioration.

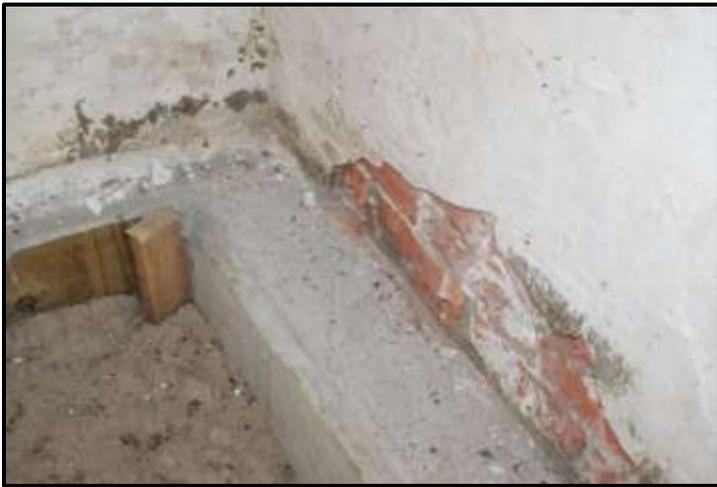
Photo III-F-11

The interior surfaces of the brick masonry walls are coated with plaster which is applied directly to the brick surface. This surface is in poor condition with many sections of damaged, loose or missing plaster as seen in Photos III-F-11 and III-F-12. The exposed wood rafters and roof sheathing have remnants of a paint finish, however it is in very poor condition. Refer to previous Photos III-F-6 and III-F-7. There are no interior features or elements other than a small wood bracket as seen in Photo III-F-12. There is an exposed sand floor.

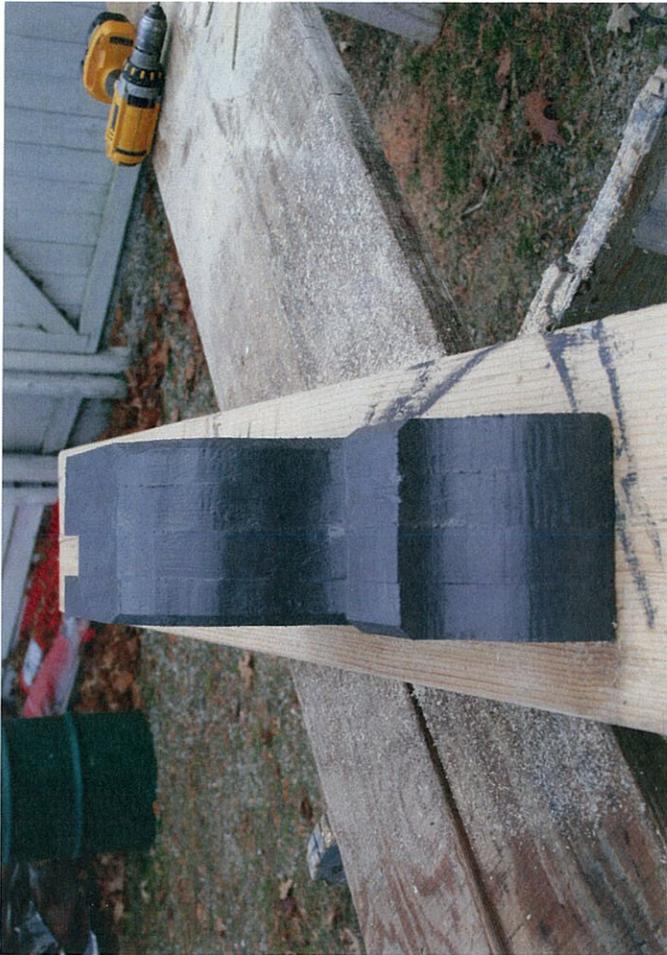
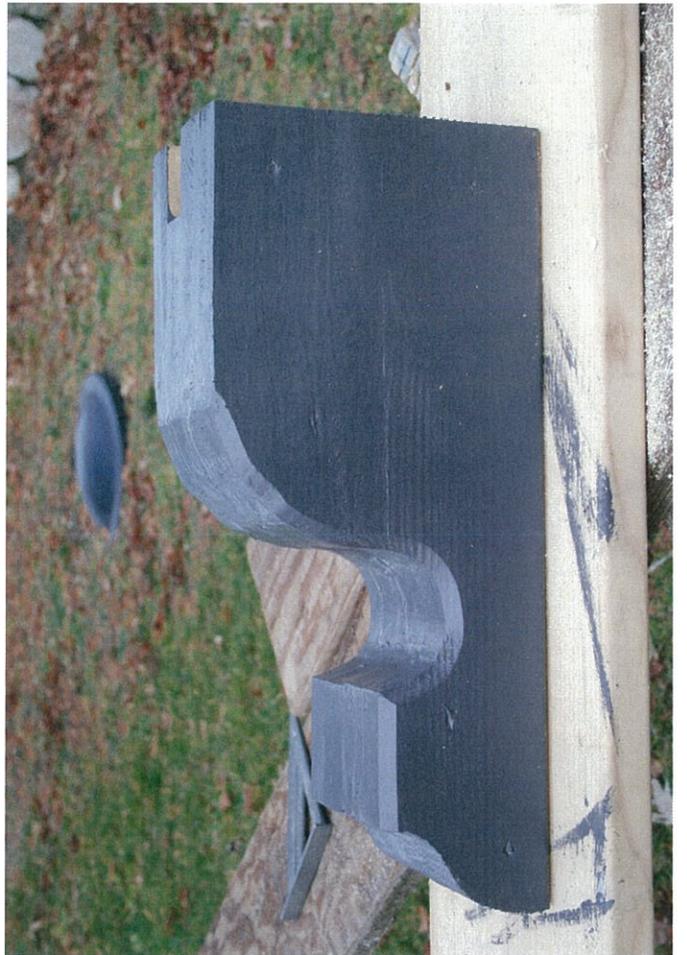
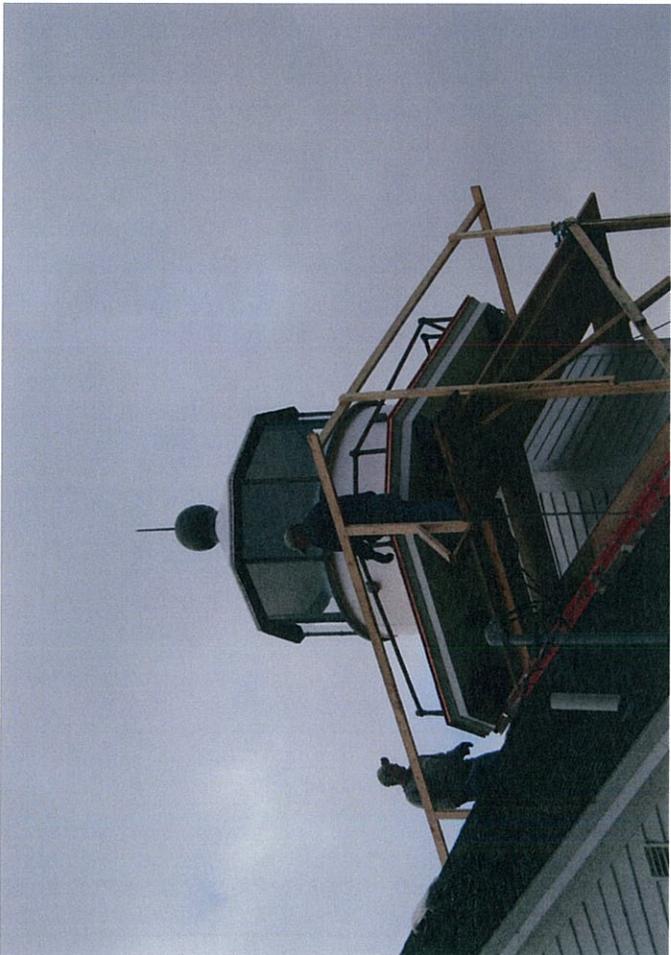
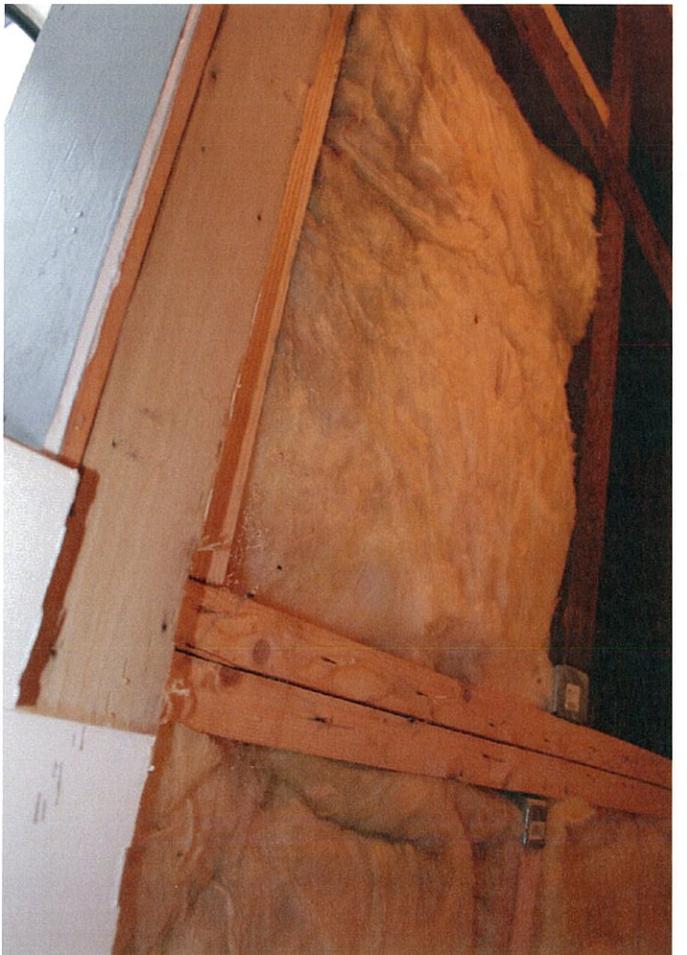
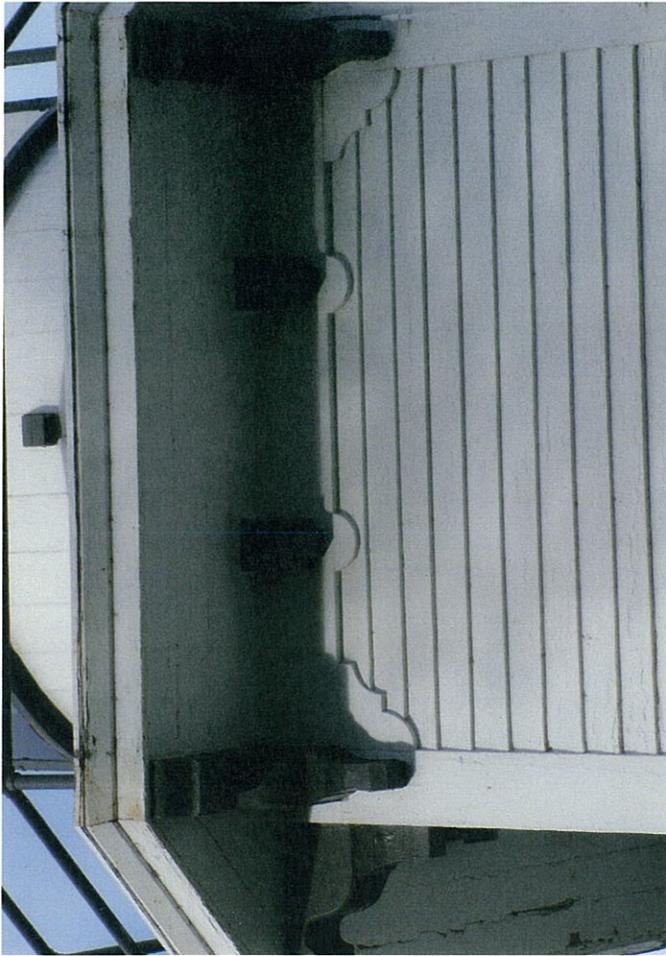
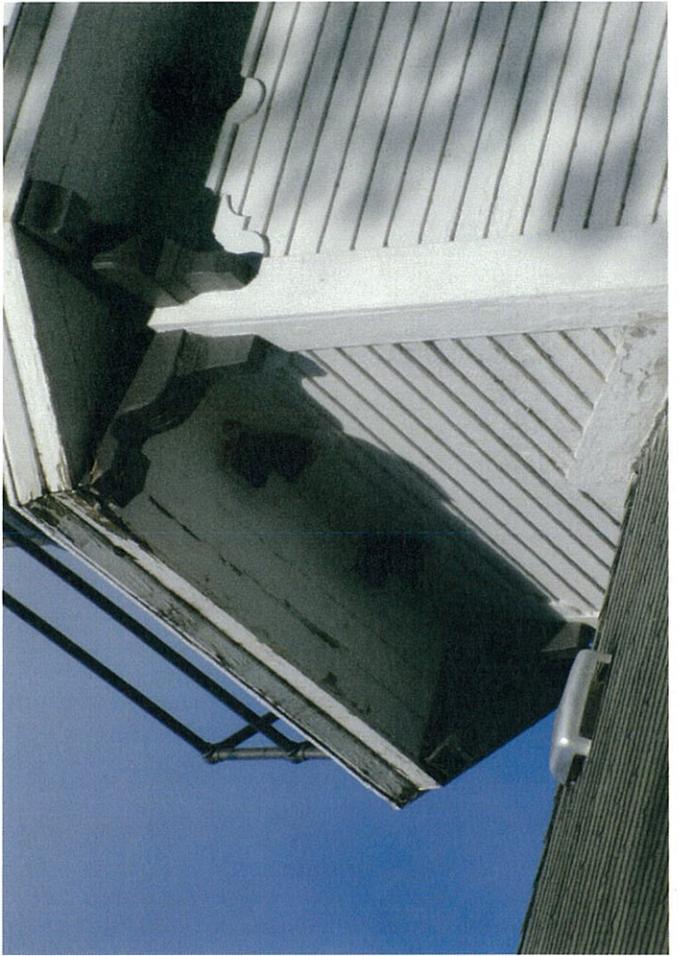
APPENDIX C  
LIGHT TOWER AND LANTERN RESTORATION PROJECT

In 2009 the Light Tower and Lantern underwent an extensive restoration and repair. As a wood frame structure, extensive rot and deterioration of structural and decorative elements was discovered prior to restoration work. Photographs of this project are included in this section.
