**HISTORIC STRUCTURE REPORT  
FOR  
MISSION POINT LIGHT STATION  
PENINSULA TOWNSHIP, MICHIGAN**

**Prepared by:  
U.P. Engineers & Architects, Inc.  
102 W. Washington Street, Suite 217  
Marquette, MI 49855**

**Final Report  
October 31, 2012**

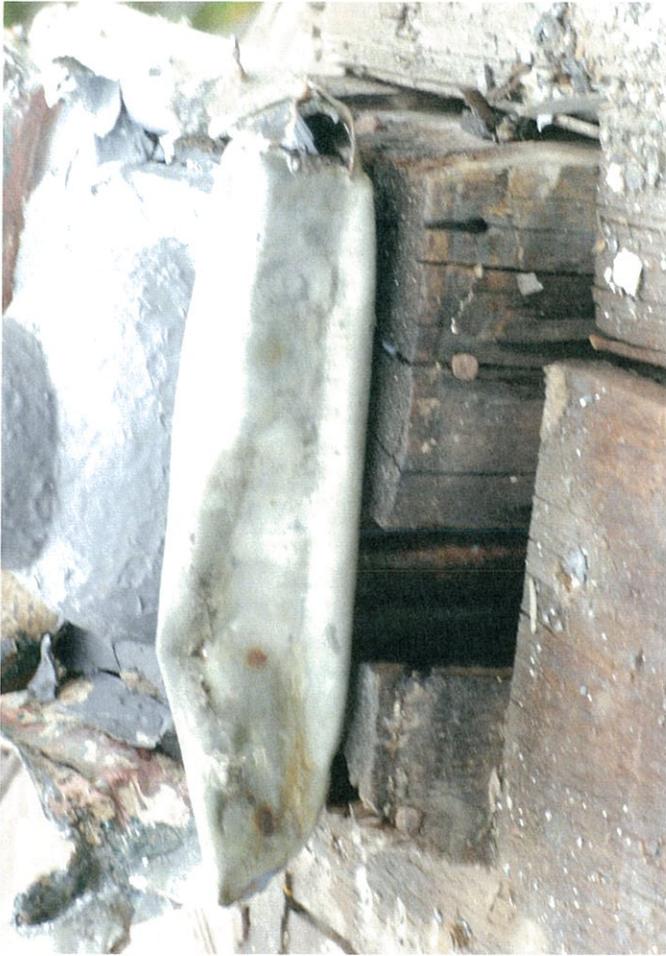
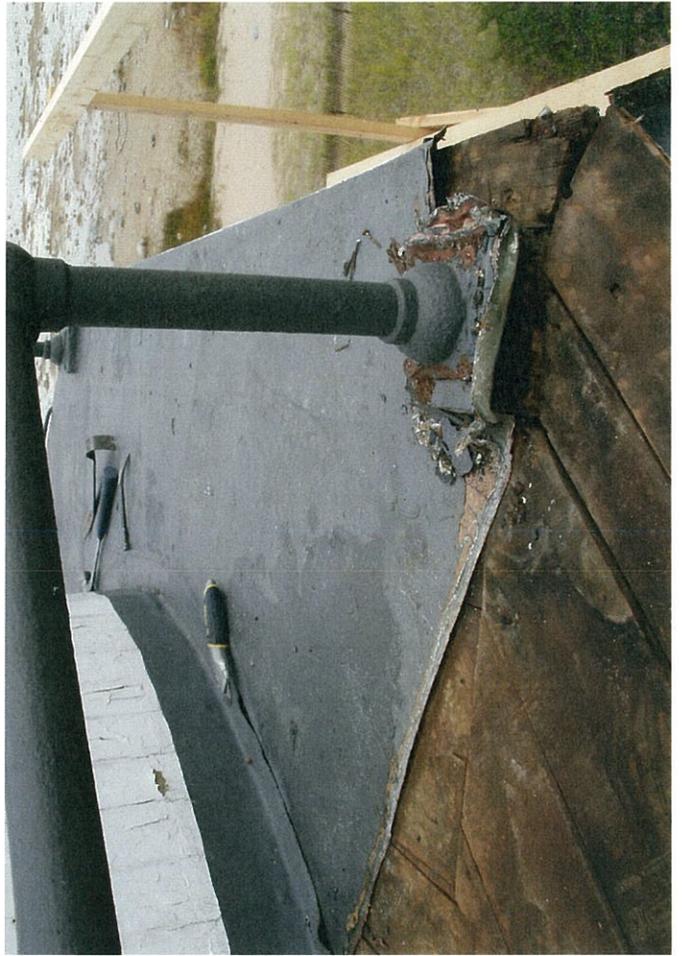
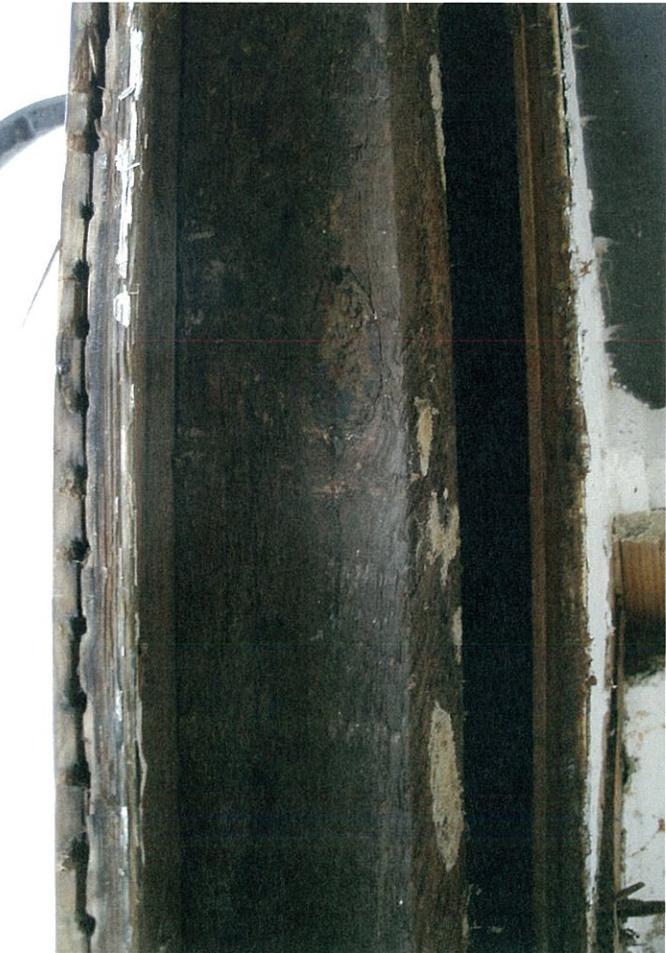
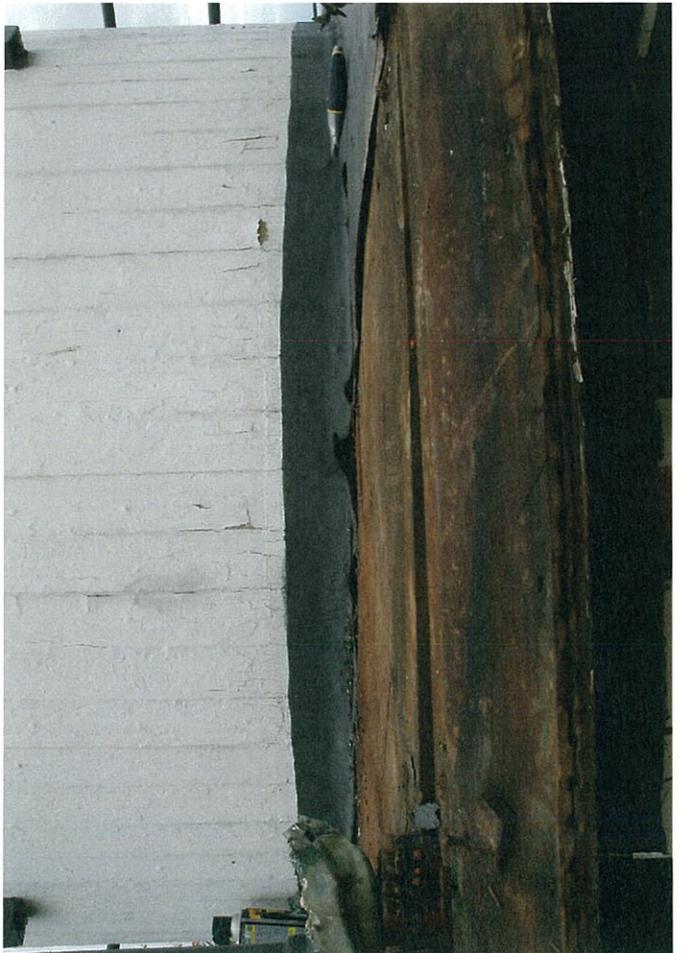
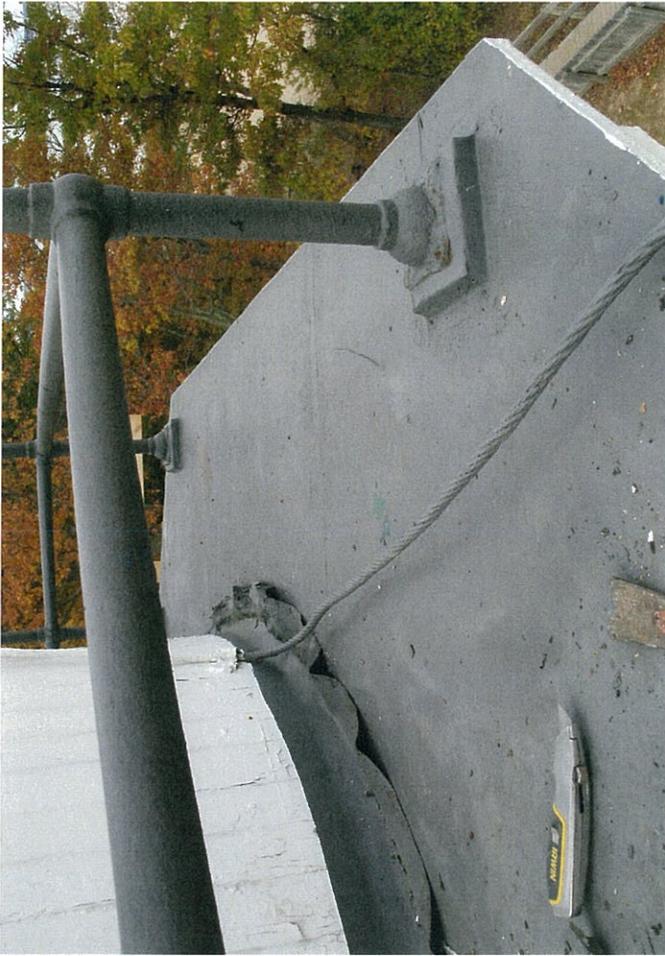
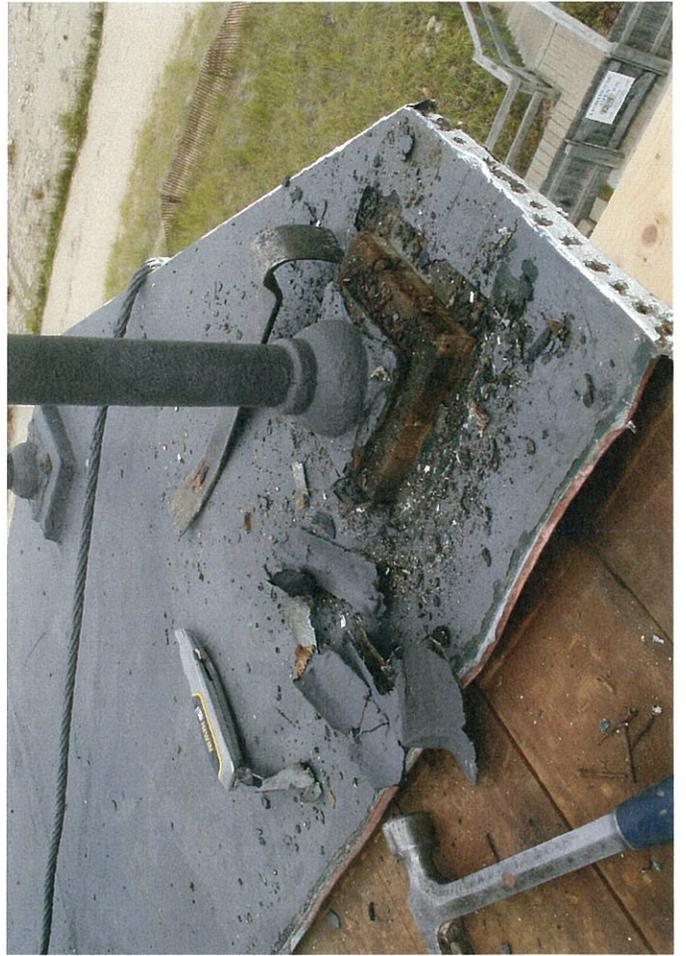
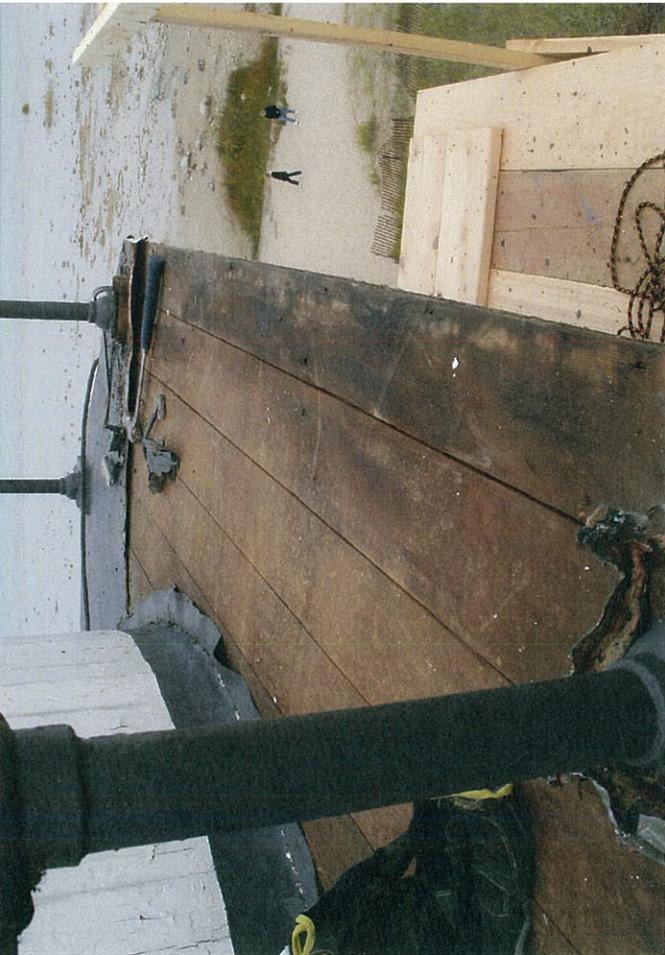
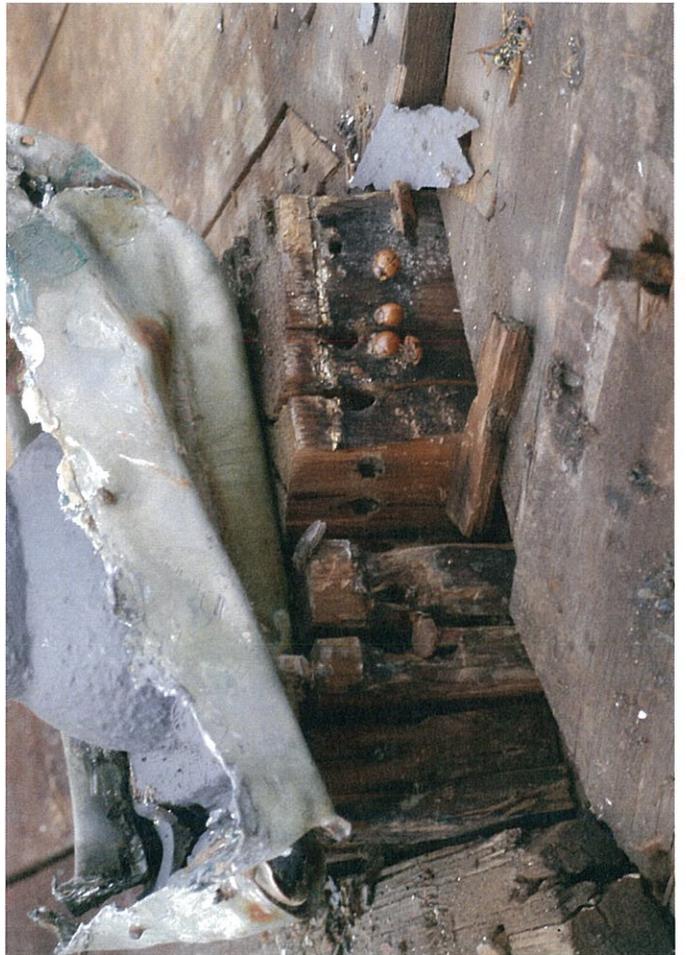
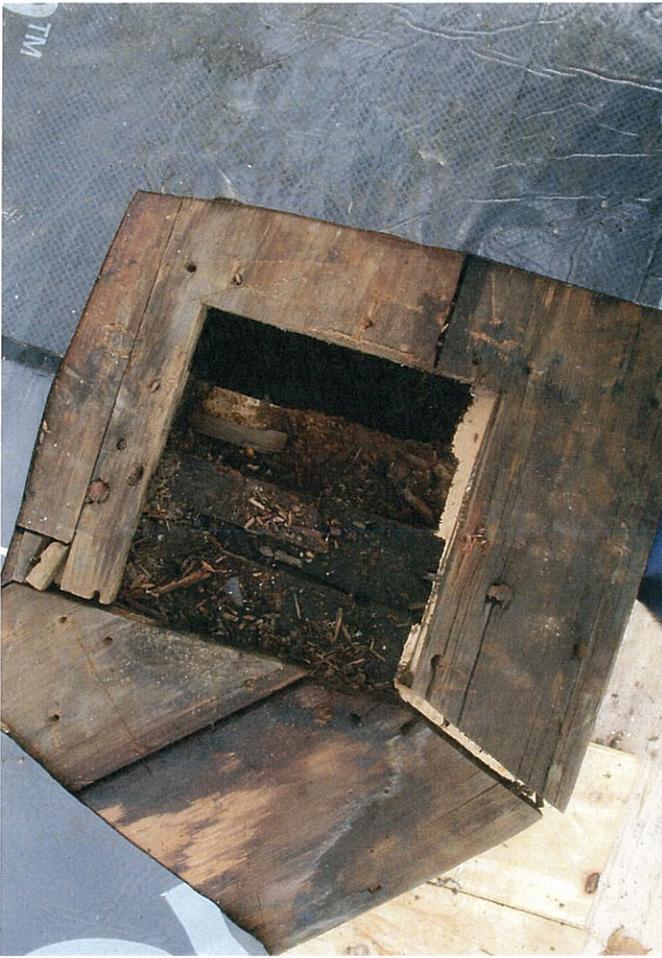
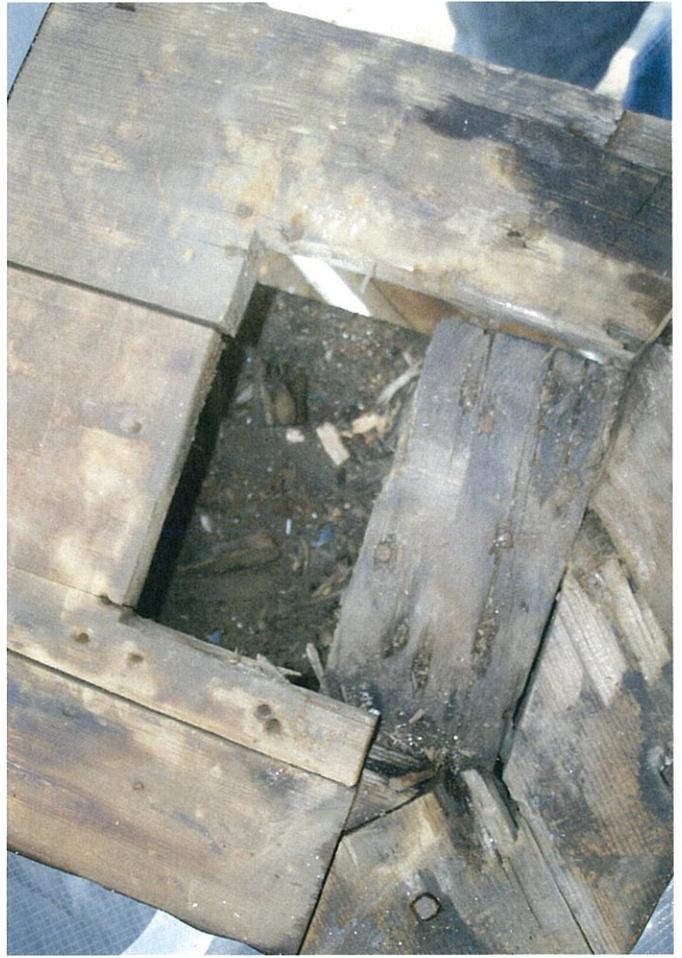
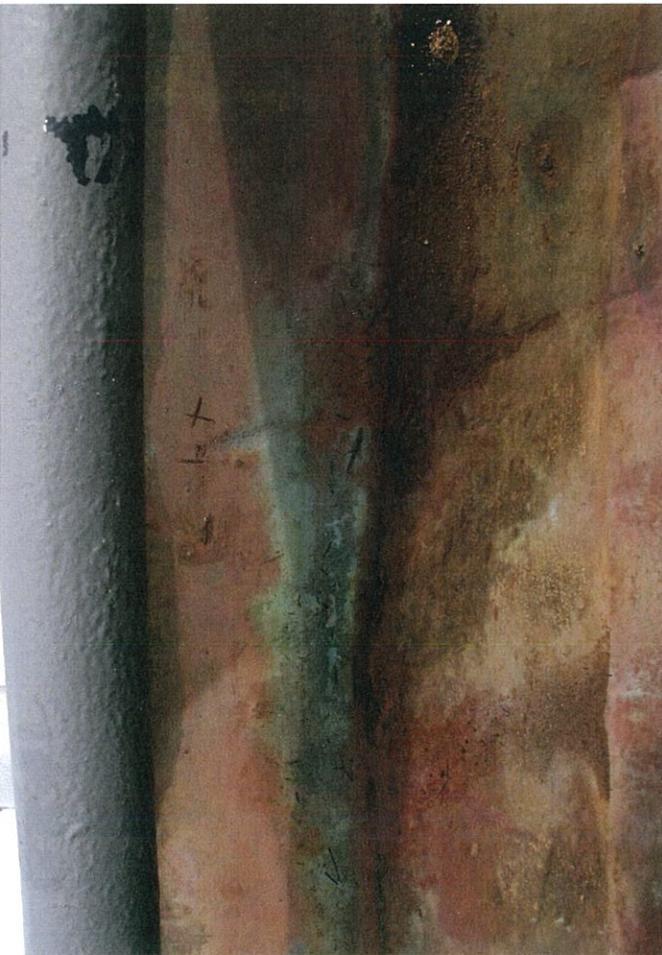
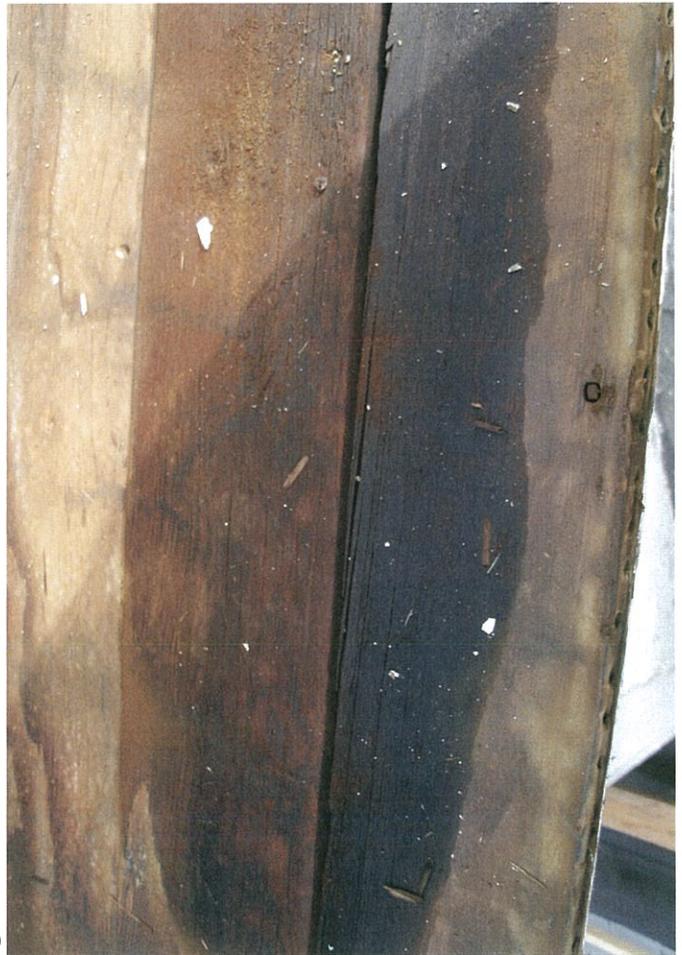
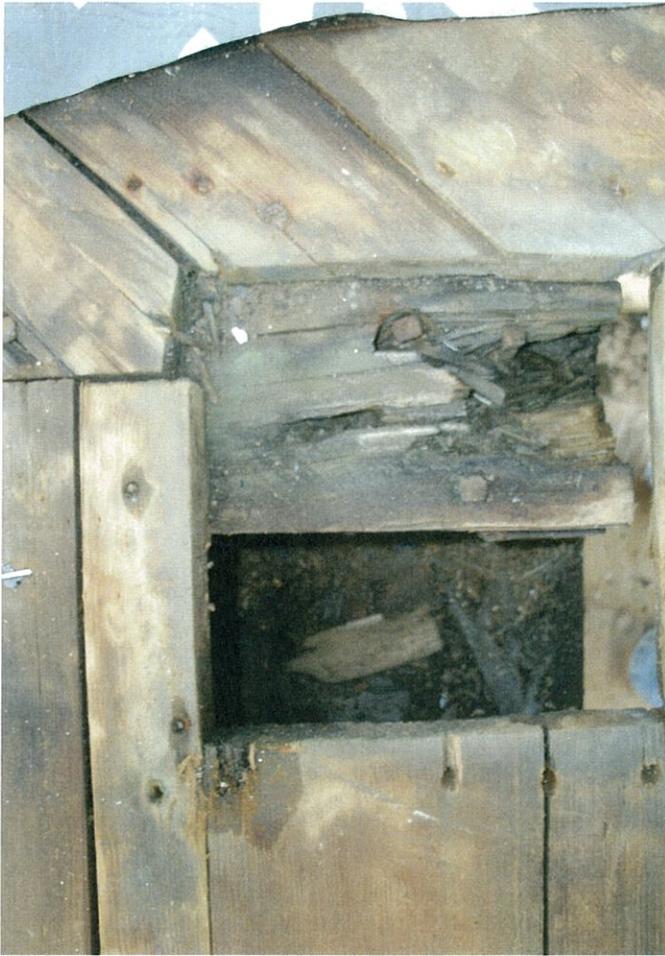
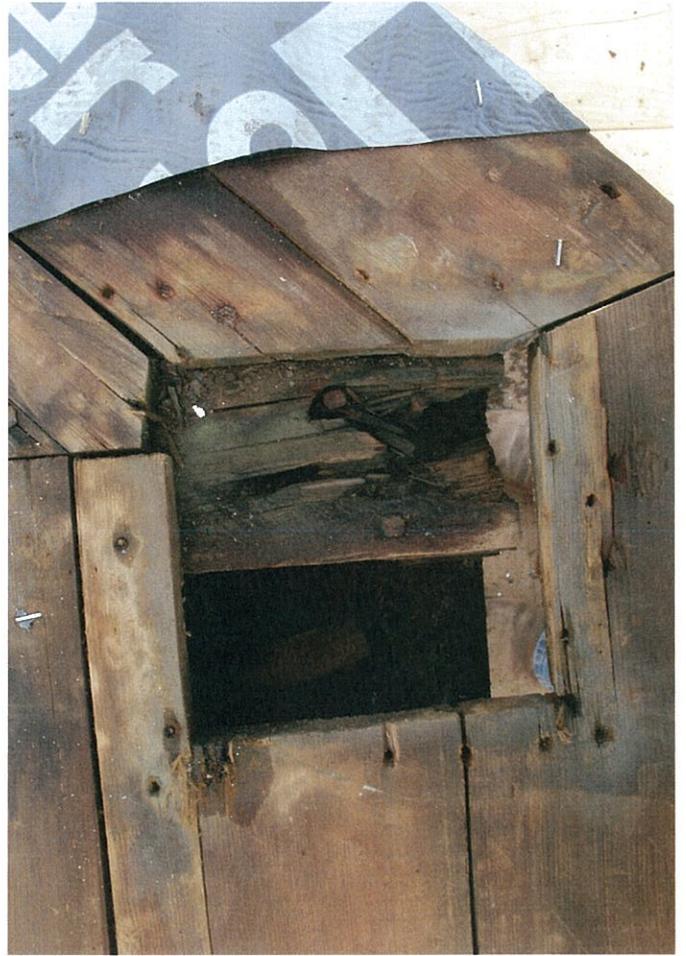
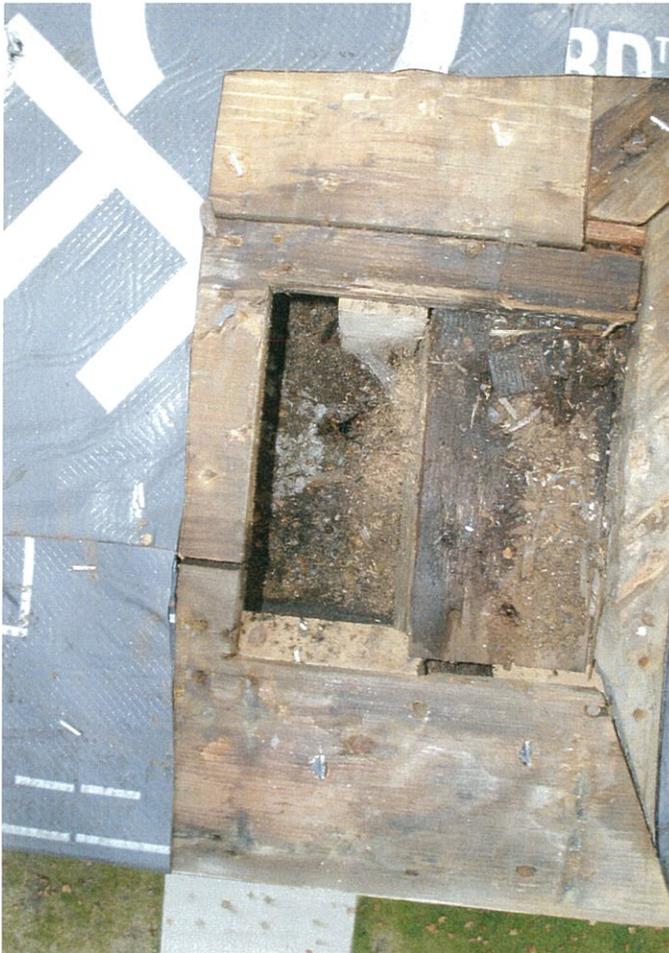
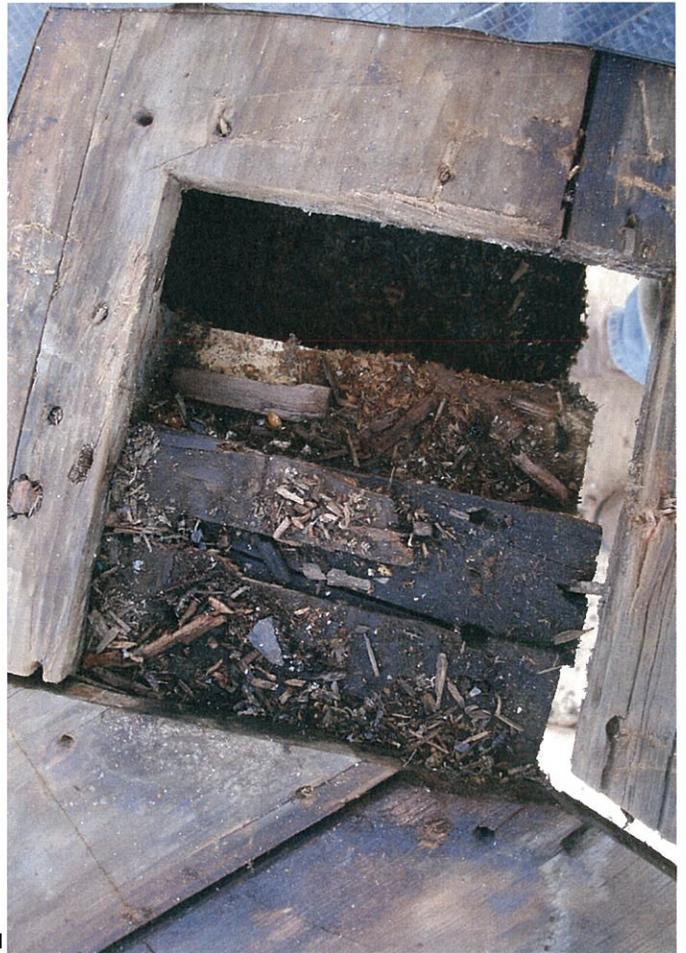
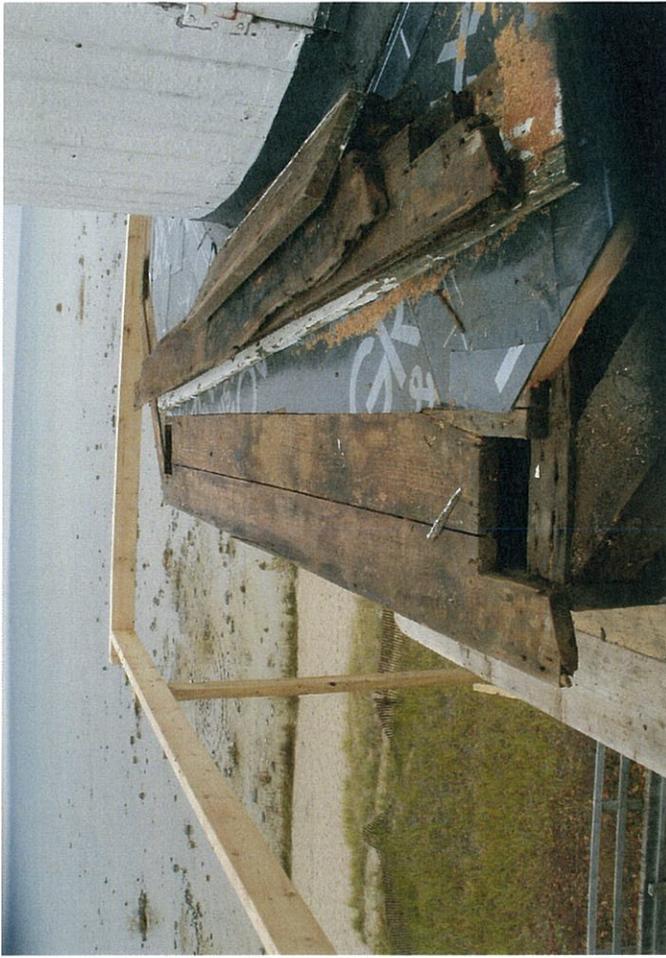
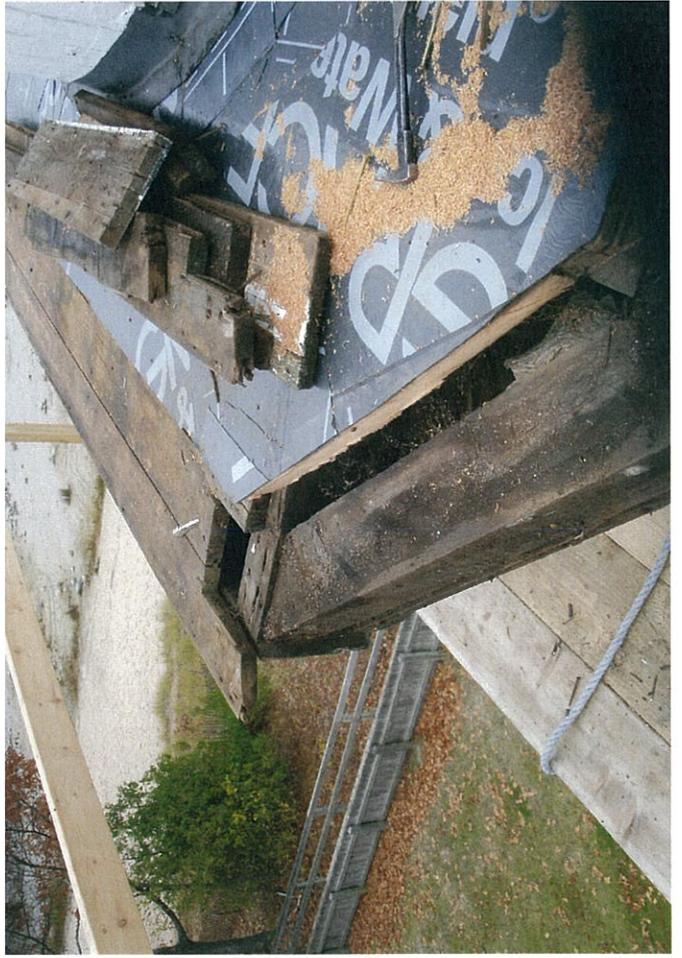
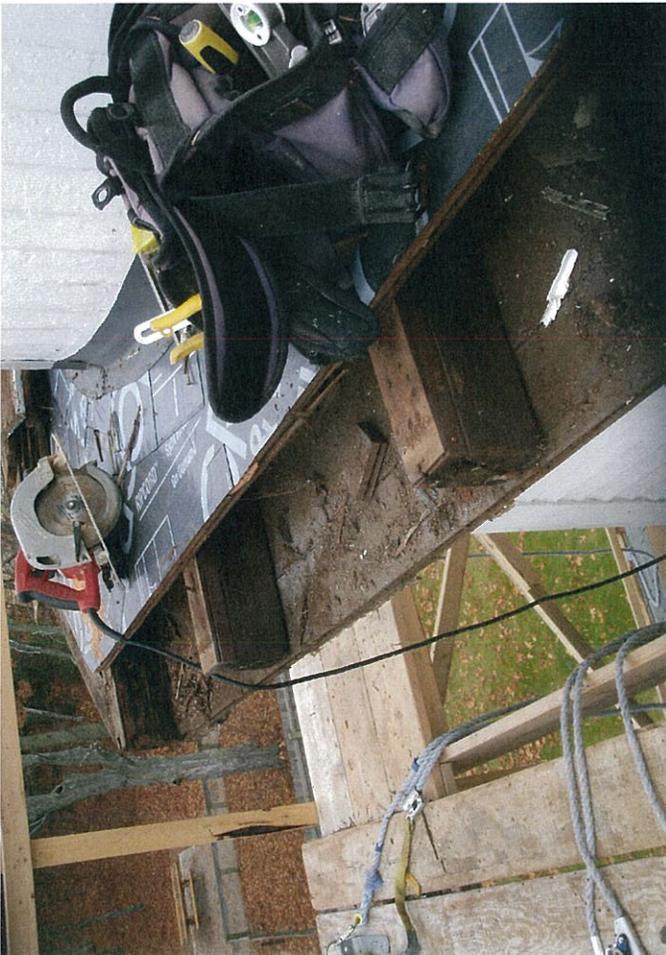
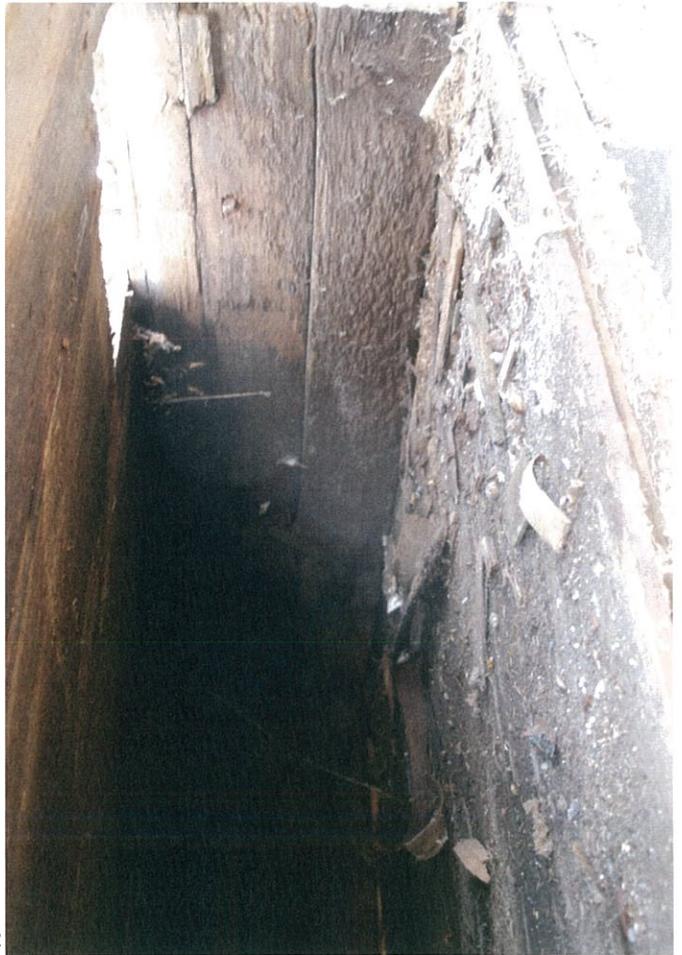
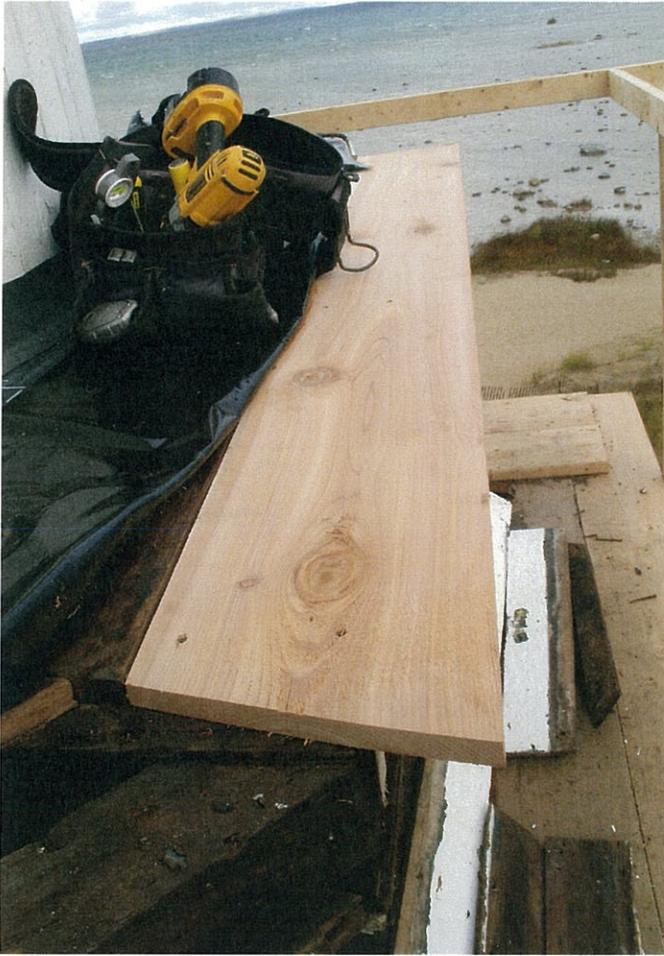
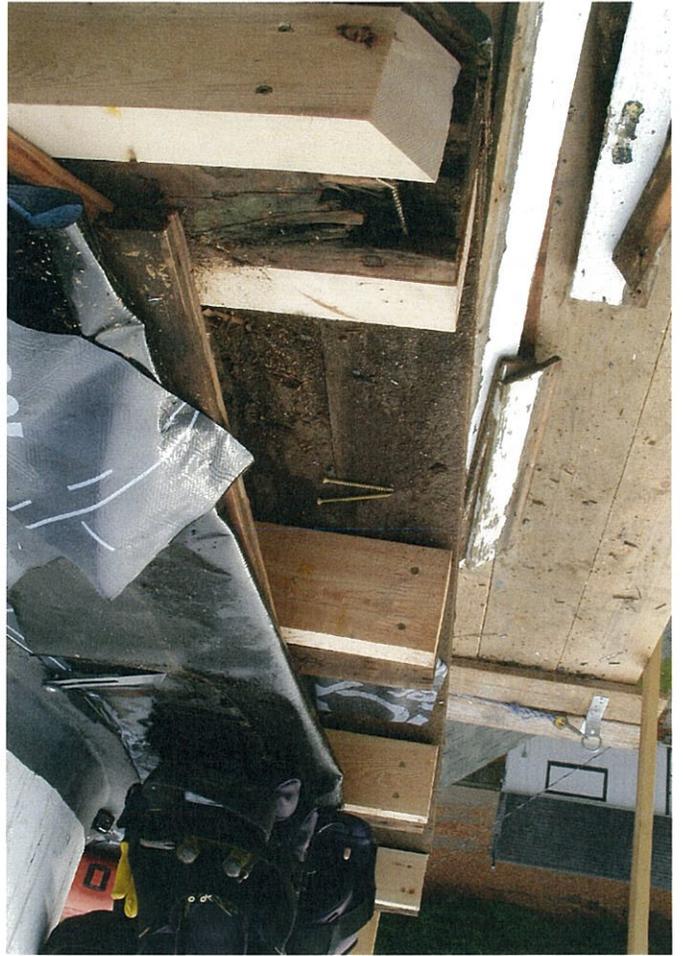
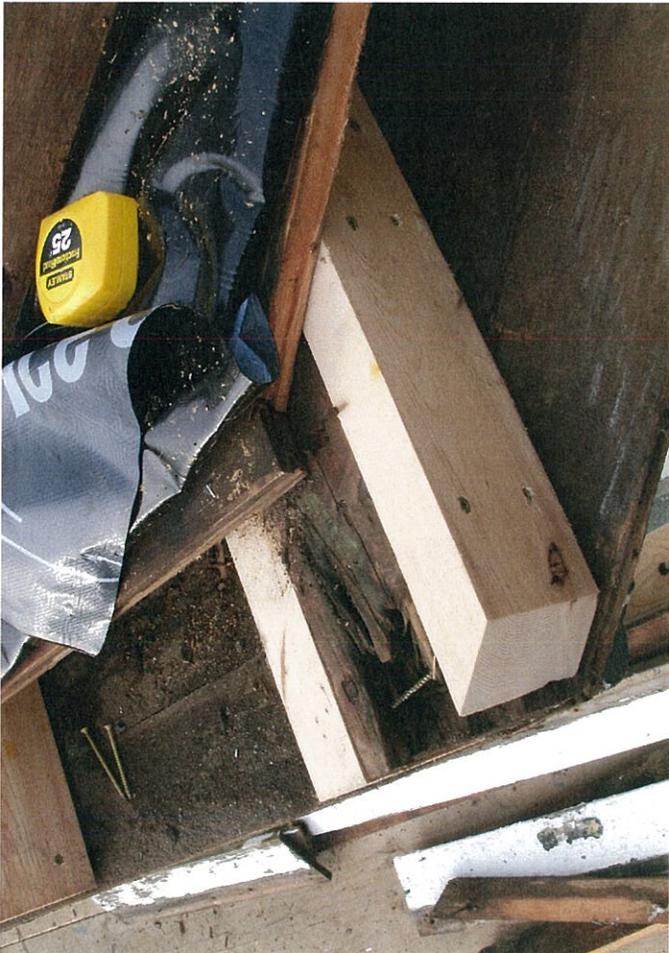
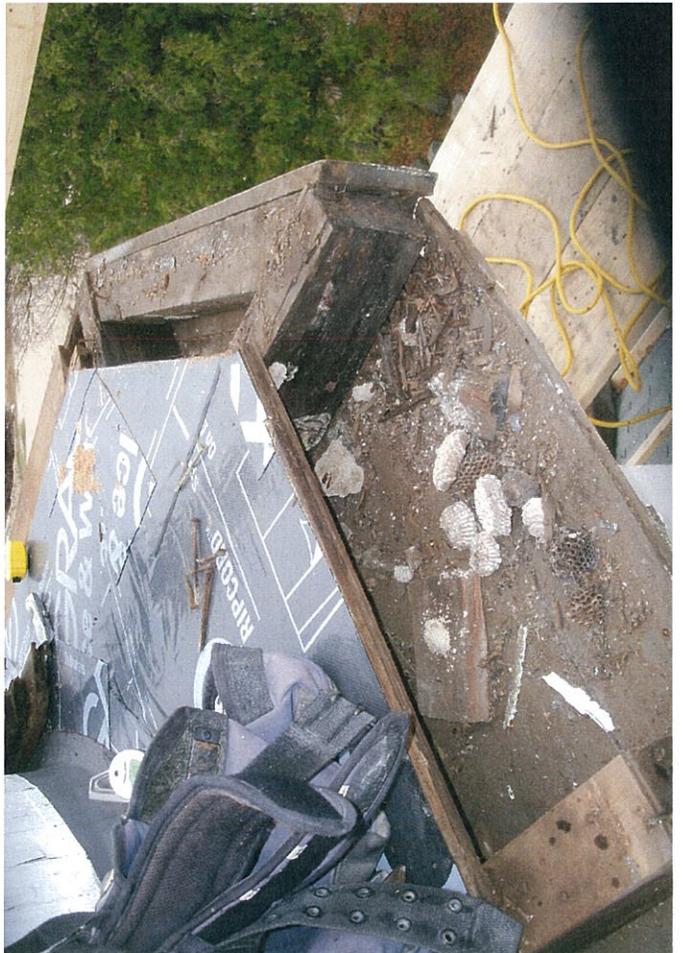
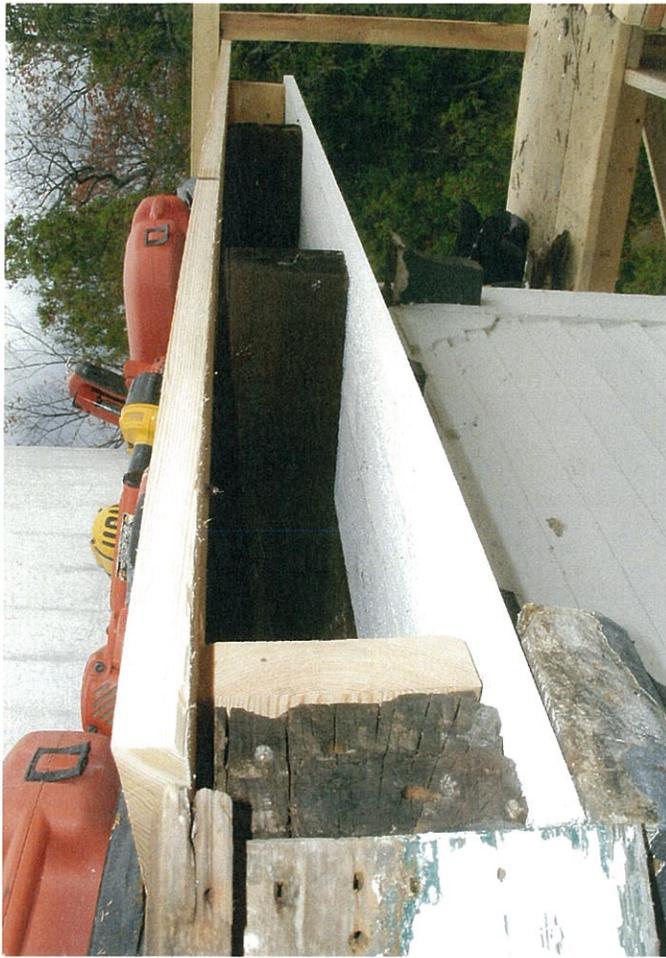
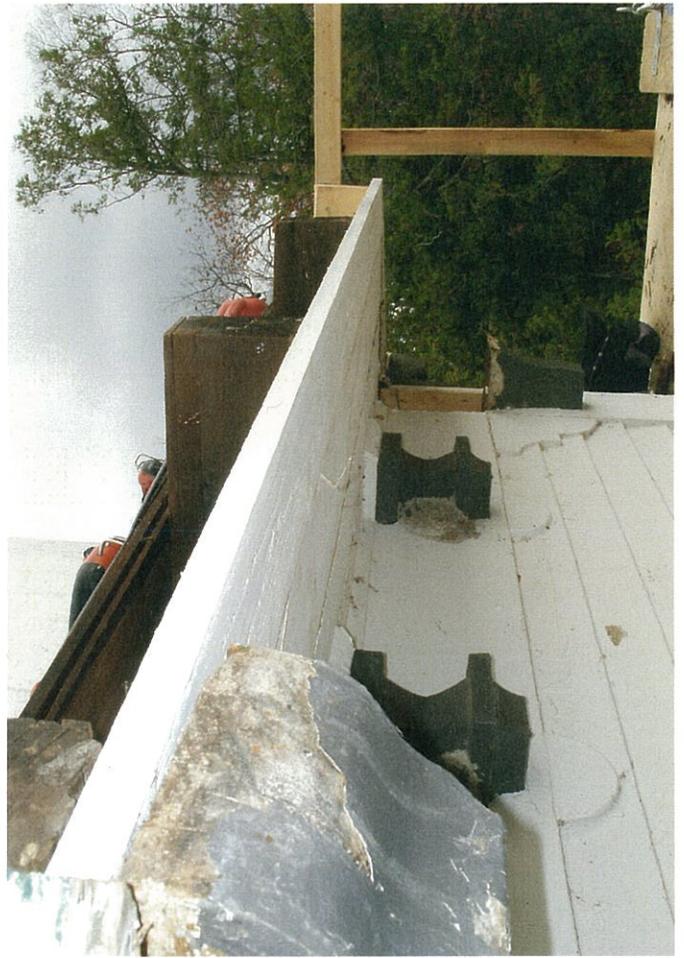
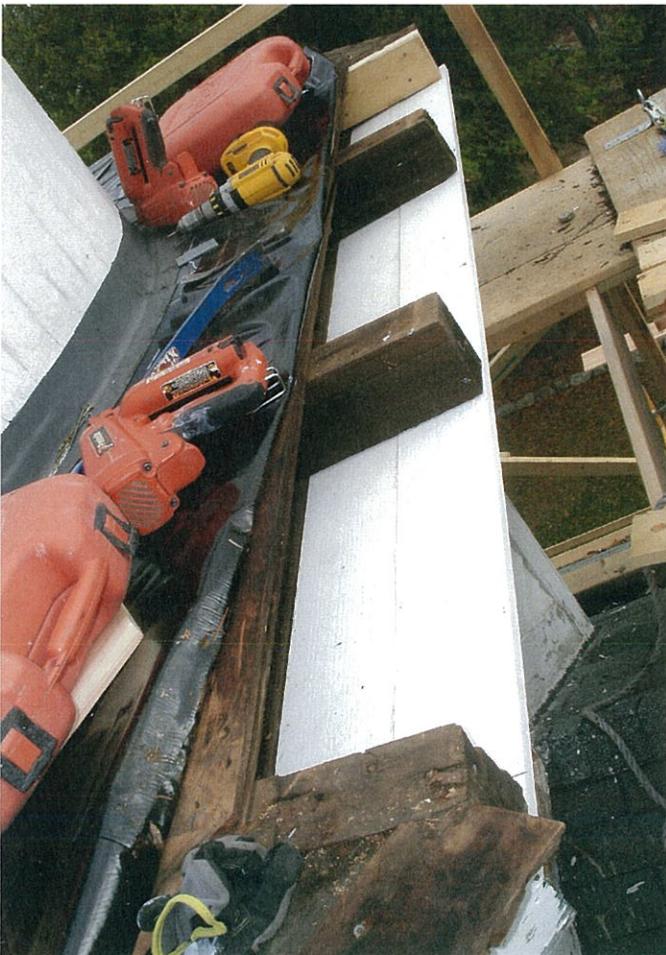
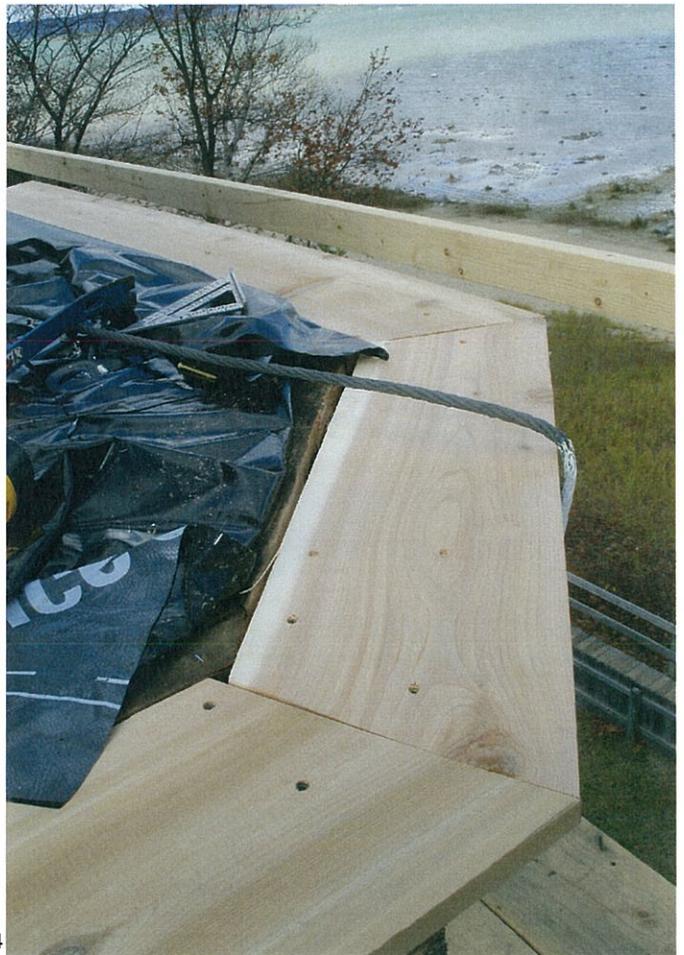
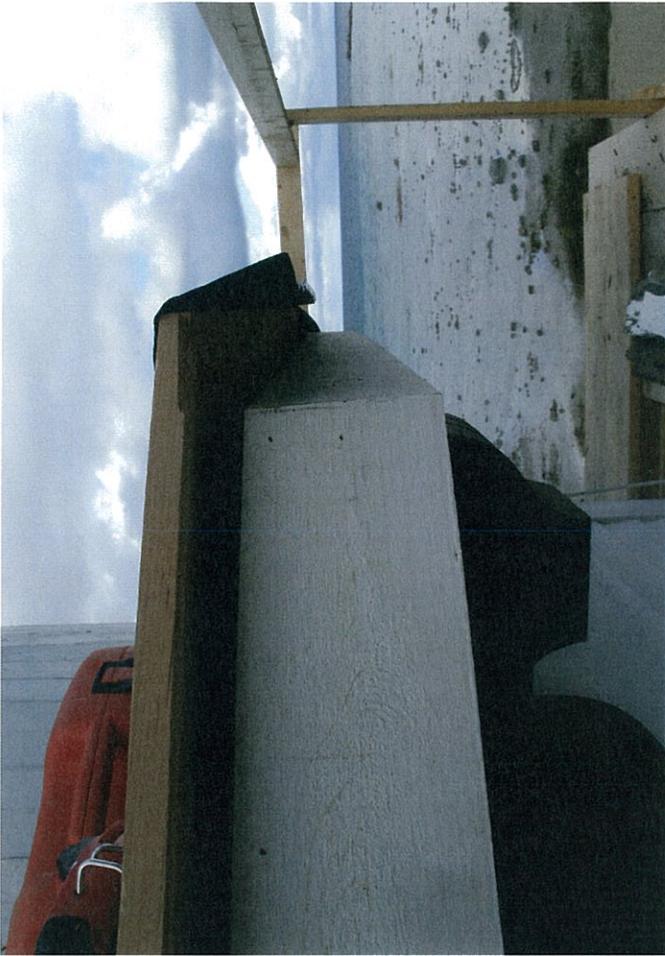
In 2009 the Light Tower and Lantern underwent an extensive restoration and repair. As a wood frame structure, extensive rot and deterioration of structural and decorative elements was discovered prior to restoration work. Photographs of this project are included in this section.
