**HISTORIC STRUCTURE REPORT  
FOR  
MISSION POINT LIGHT STATION  
PENINSULA TOWNSHIP, MICHIGAN**

**Prepared by:  
U.P. Engineers & Architects, Inc.  
102 W. Washington Street, Suite 217  
Marquette, MI 49855**

**Final Report  
October 31, 2012**

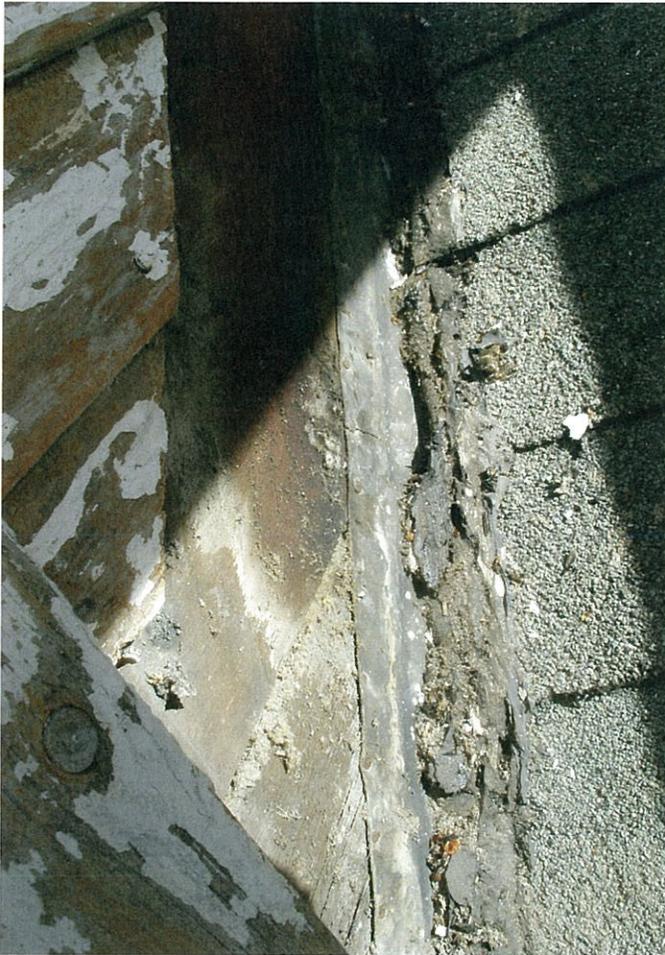
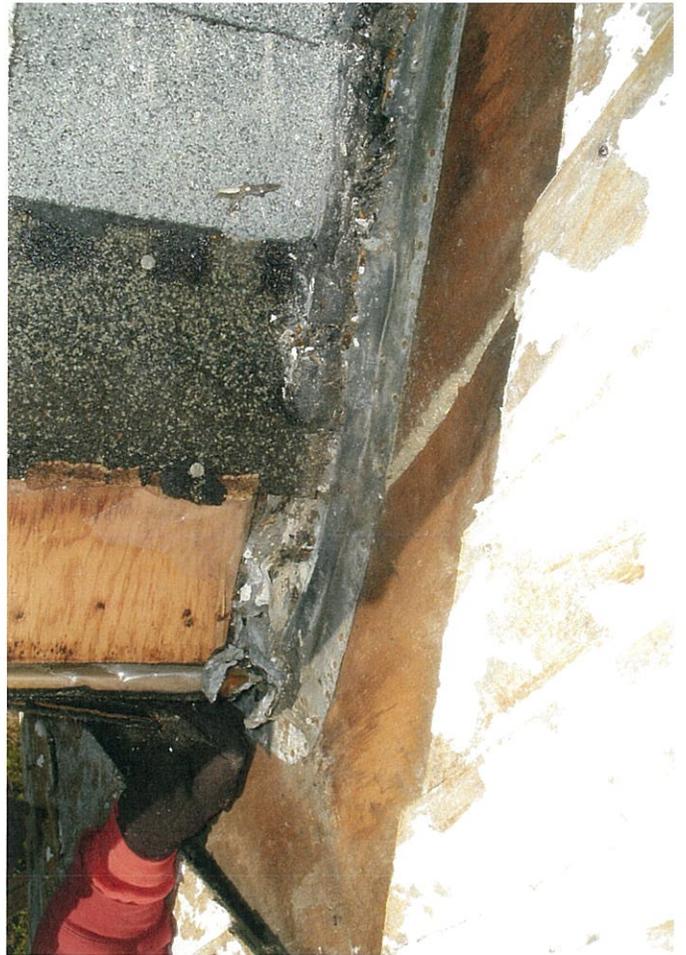
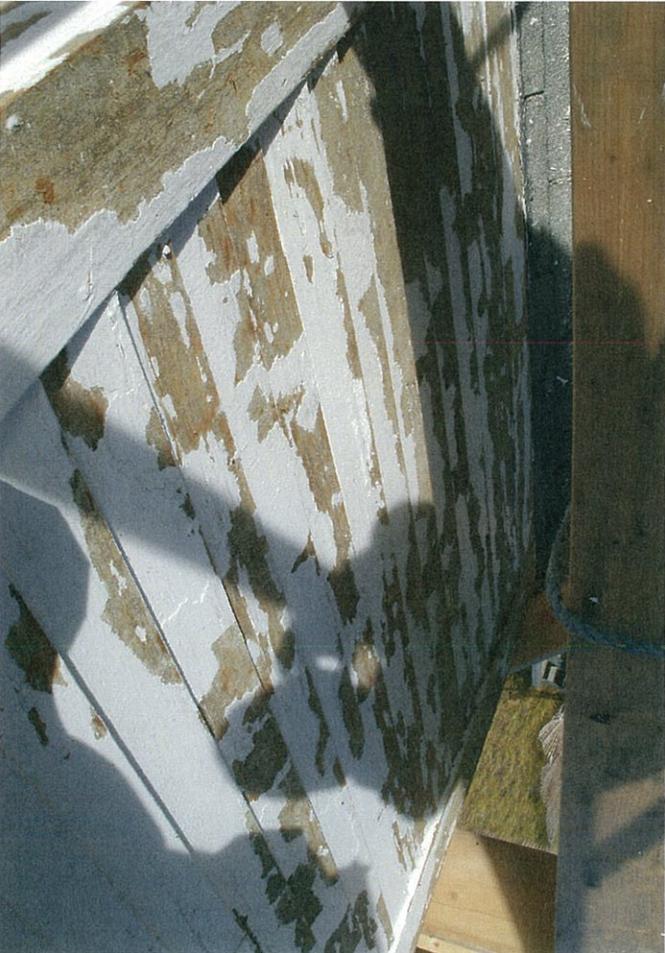
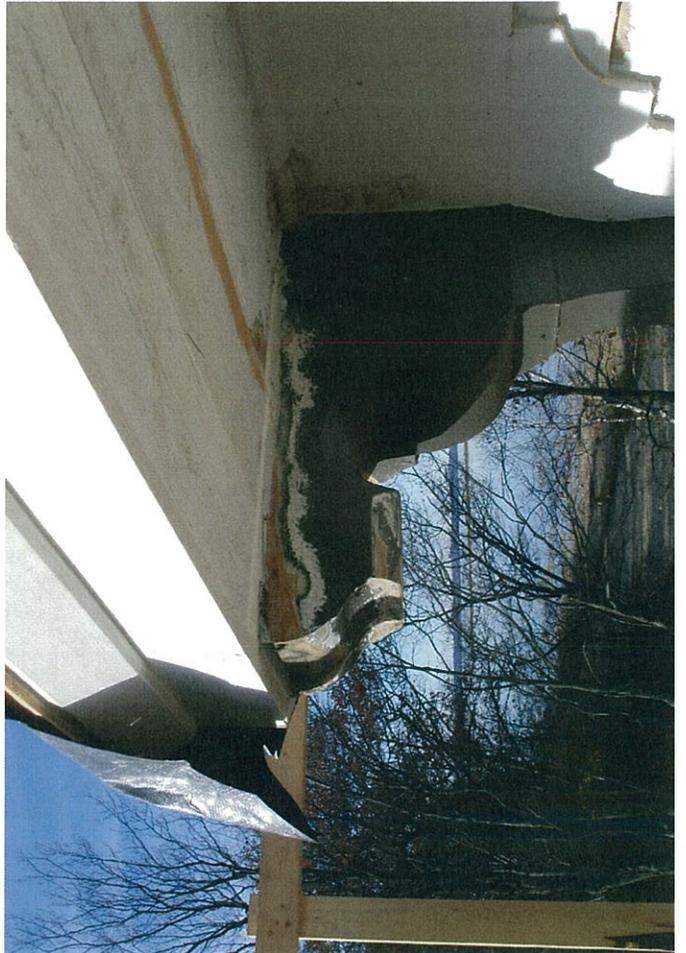
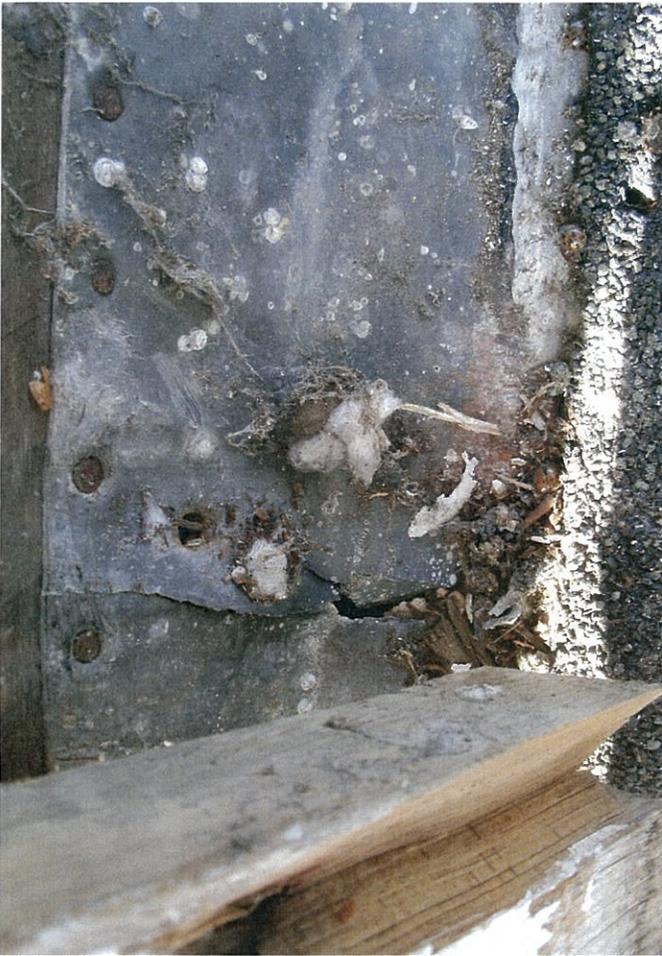
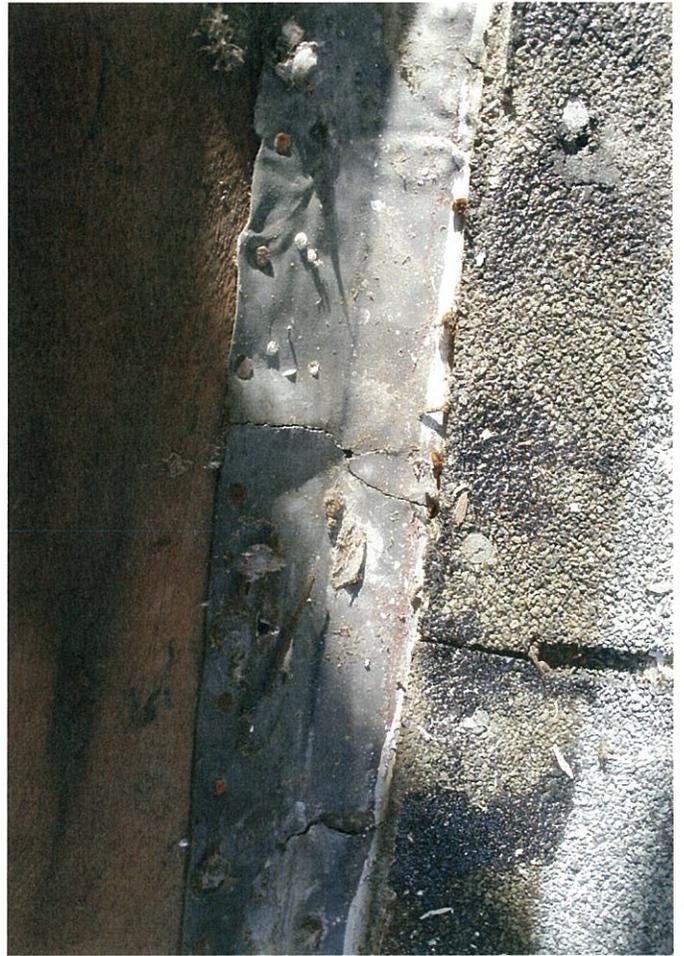
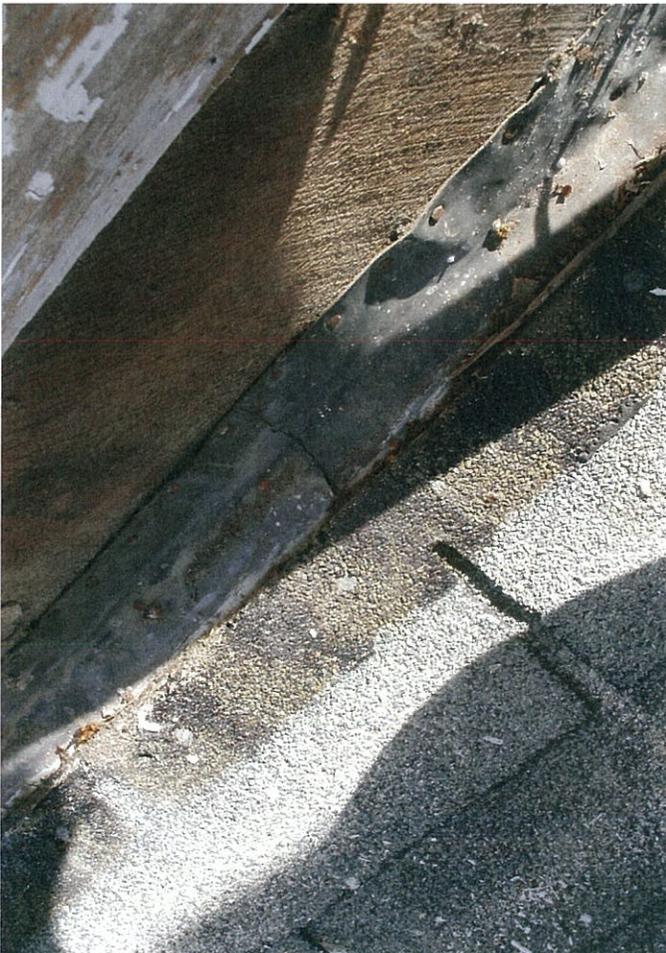
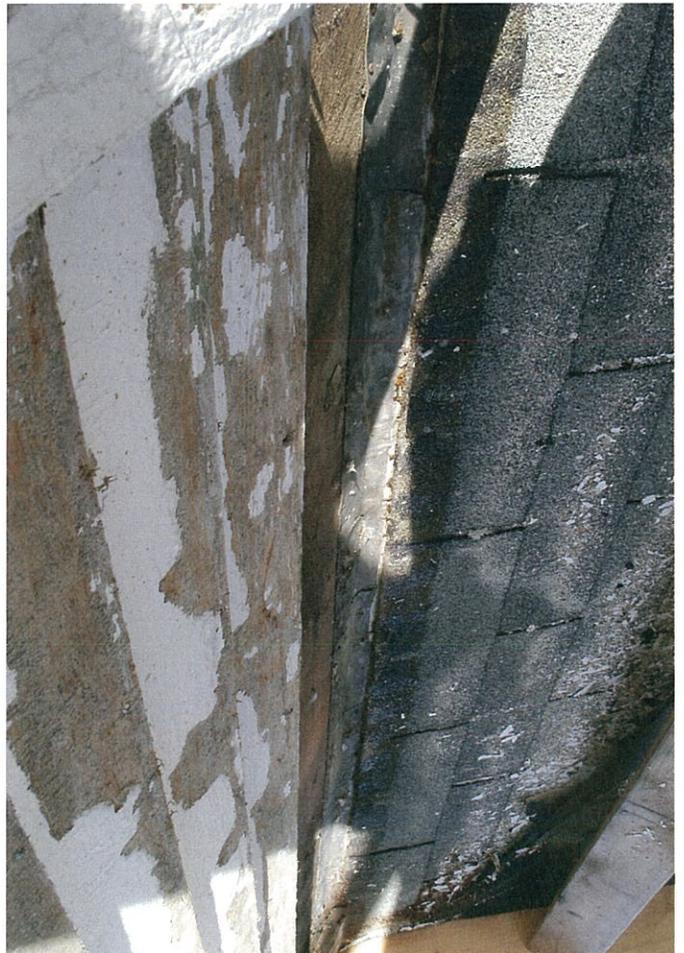
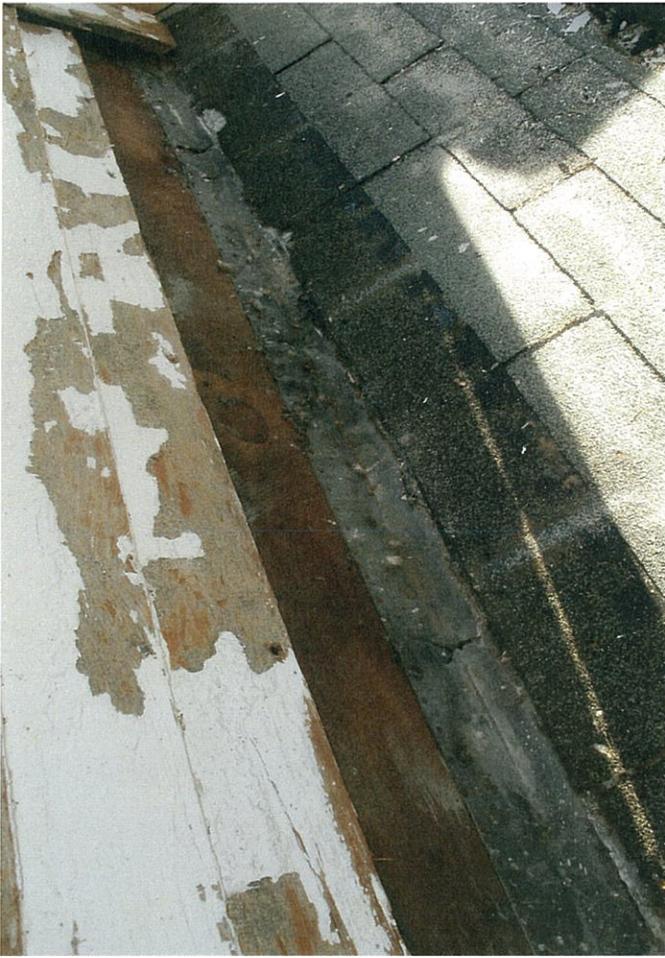
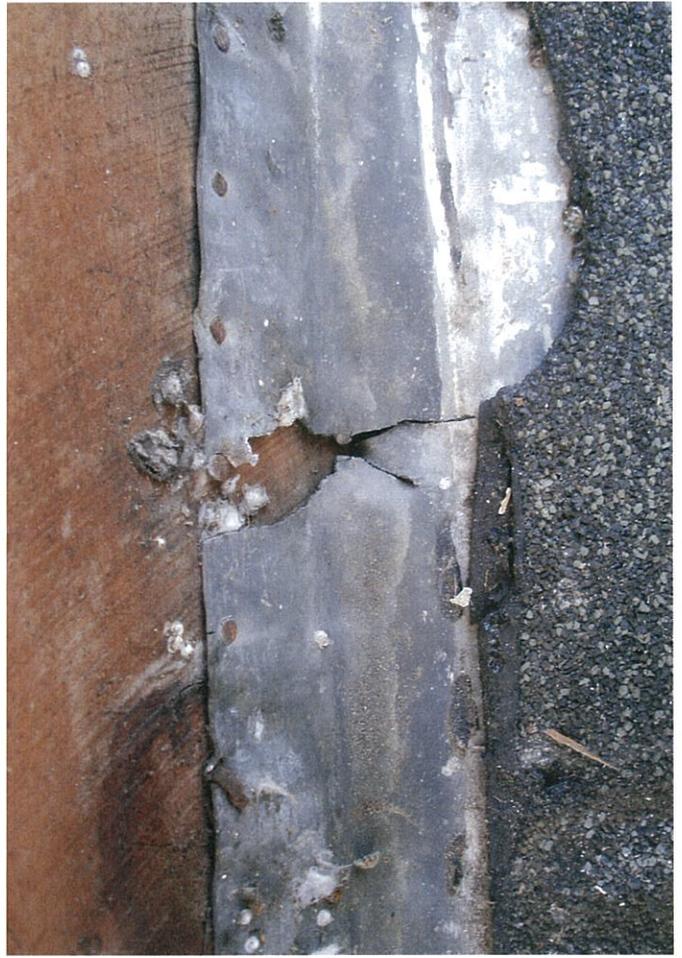
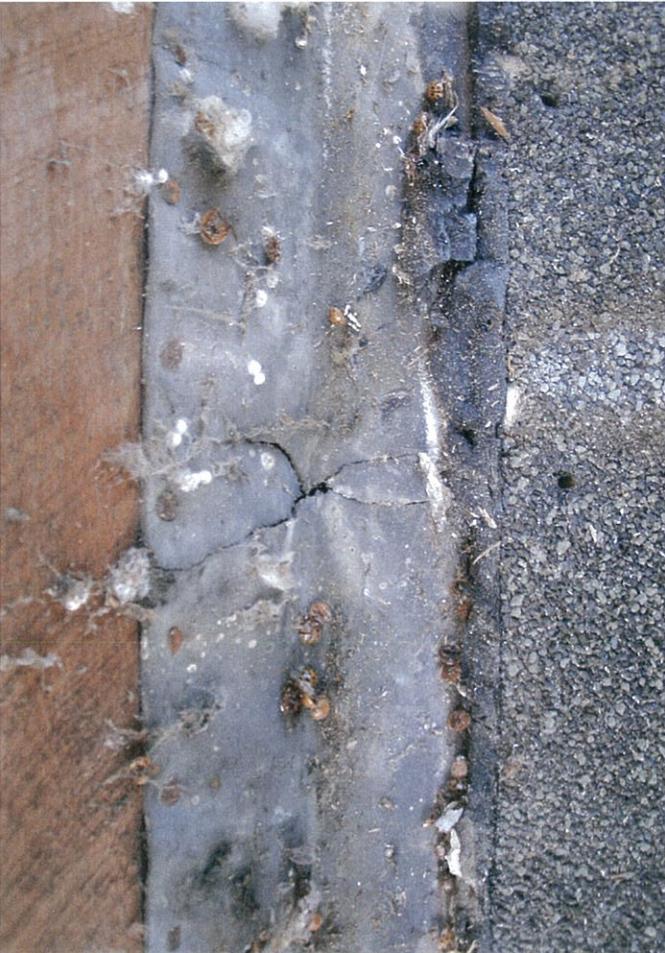
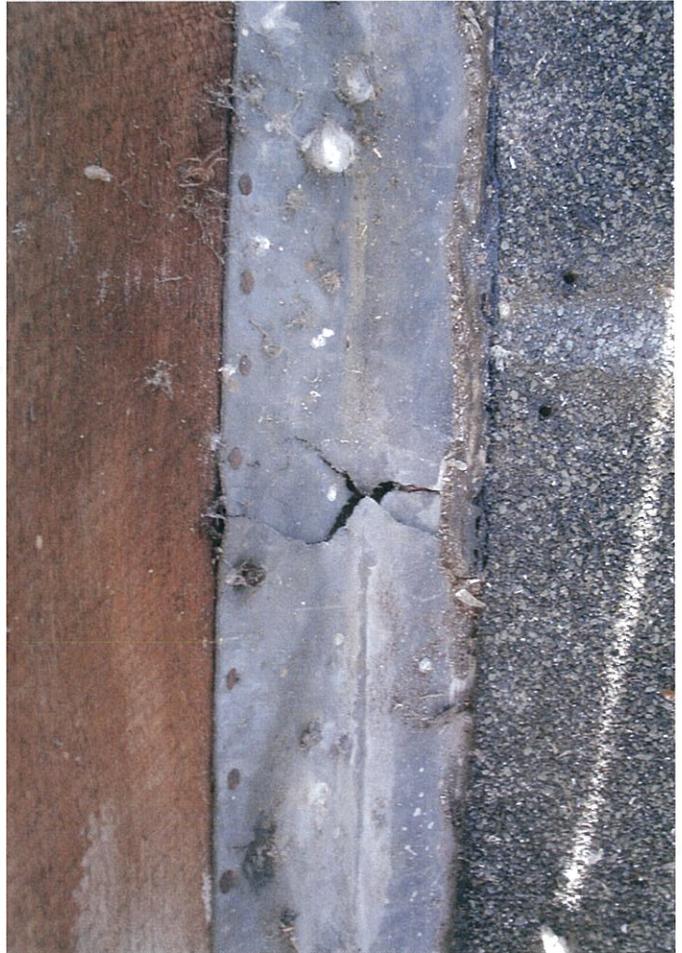
In 2009 the Light Tower and Lantern underwent an extensive restoration and repair. As a wood frame structure, extensive rot and deterioration of structural and decorative elements was discovered prior to restoration work. Photographs of this project are included in this section.
